KAWANA STP UPGRADE ISSUES.....UNPLUGGED!!

Stephen Will, *Operator,*

Sunshine Coast Water

*33rd Annual Qld Water Industry Operations Workshop
Indoor Sports Centre, Carrara – Gold Coast
3 to 5 June, 2008*

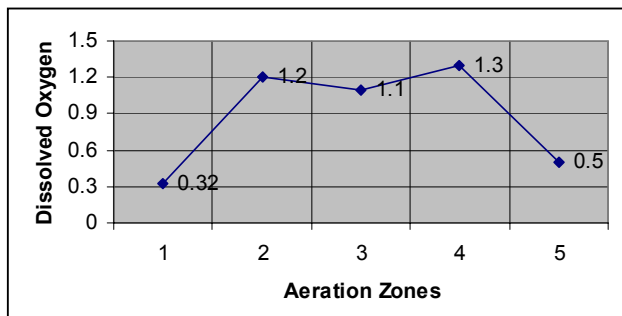
Figure 1: Aeration zones dissolved oxygen levels

A glimpse of the typical DO trend in the aeration zones performance under load during the hours from 7am until 3pm is shown in Figure 1 below shows. Notice that the DO drops in zone # 5. This could be because of the aerators not keeping up with the hydraulic capacity, but this is yet to be confirmed. DO is only achieving set point of 1.5 in zone # 5 during off peak flow periods.
