**BE CAREFULL WHAT YOU WISH FOR -
IMPLEMENTING A FILTER INSPECTION PROGRAM**

John Day, *District Manager, Central Water,*

*3rd Annual WIOA NSW Water Industry Engineers & Operators
Conference*

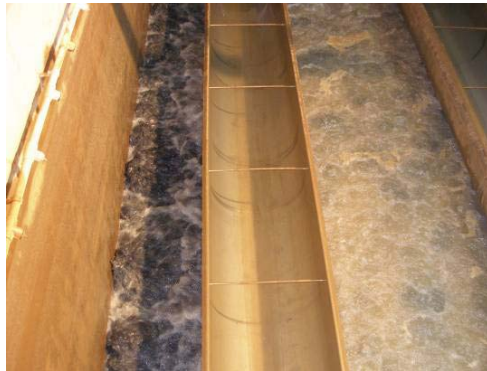
2.1 Kyabram Plenum Floor

Figure 1: *Kyabram filter in air scour*

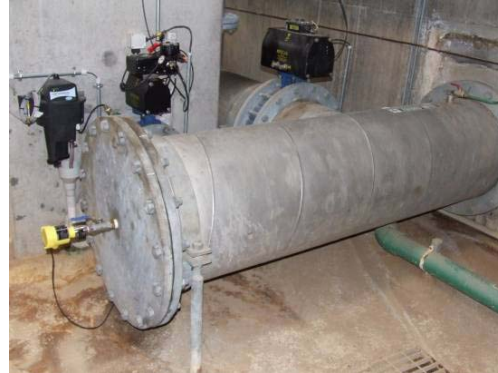
Figure 2: *Pressure indicator*

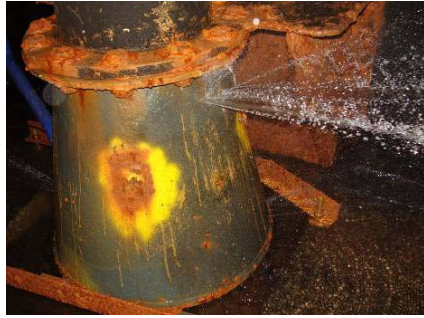
- The backwash foot valve was in need of replacement (Fig 3)
- The Plenum trough needed removal of rubbish (Fig 4)
- All nozzles needed replacing (Fig 5)
- New media required to return the filter to an operational state (Fig 6)

Figure 3: *Back Wash foot valve*

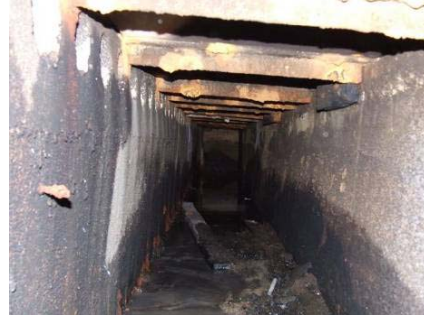
Figure 4: *Rubbish in the plenum trough*

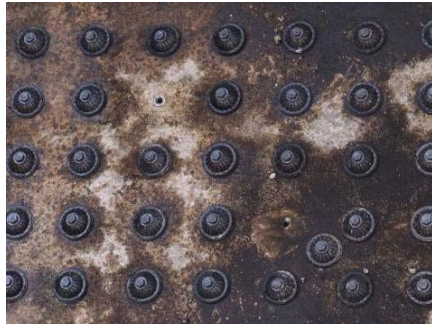
After media was removed using a vacuum truck, it was visually clear that a high proportion of nozzles were partially broken or in need of repair. Next was a determination of how much media had made its way through the rest of the system.

Figure 5: *Broken filter nozzles*

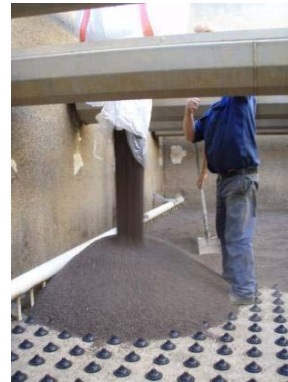
Figure 6: *Rebuilding the Filter*

The replacement nozzles were sought from WTA and filter media from River sands. The nozzles stayed with the original design but the media purchased was a change from the media removed from the filter. The following is a breakdown of the new media chosen:

- Filter Garnet – nominal size of 2.4-4.8mm
- Filter Gravel – nominal size of 1.5-3.0mm
- Filter Sand – nominal size of 0.56- 0.7mm
- Filter Coal – nominal size of 1.2-1.4mm

We changed from filter rock to filter garnet which has become a standard within GVW due to its effectiveness in staying in a settled layer due to its higher weight.

Peter Mosse was again approached to supply a rebuild summary sheet stepping us through the process of reinstating the filter. This step by step sheet mimics the WIOA Practical Guide book on filters. Rebuilding the filter was completed within the three months upon ordering the materials and has resulted in a rebuilt filter at a fraction of the cost of using contractors for the labour component of the job. Another positive of undertaking the rebuild in-house has been improving the skills of our own people to help with the filter examination process in the future. The choice of filter garnet over filter rock looks to be giving a better result, as lower turbidity's are being obtained from the

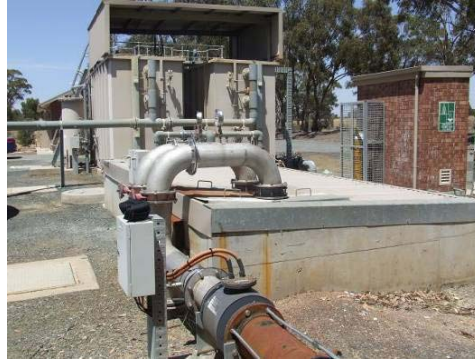
Rushworth's DAFF plant posed a problem that was not necessarily about condition of the filter but more about its design. No wind protection and a lack of access to the filter made inspections hard and unsafe to undertake (Fig 7). To remove these issues the roof over the filter was raised so a walkway could be installed, providing access to the filter. Extra cladding was attached to the sides and end of the DAFF to stop the wind from holding the float back from being removed, which had resulted in the float being dragged into the backwash stopping an effective backwash. This has now resulted in regular inspection being able to be undertaken and a cleaner float that is easily removed.

Figure 7: *The low level of the roof and open end were retro fitted to improve entry to filters and wind holding back float.*
