SHOALHAVEN RIVER CROSSING (NOWRA NSW) SEWER MAIN REPAIR

Steve Glennan

*4th Annual WIOA NSW Water Industry Engineers & Operators
Conference
St Stanislaus' College, Bathurst
20 to 22 April, 2010*

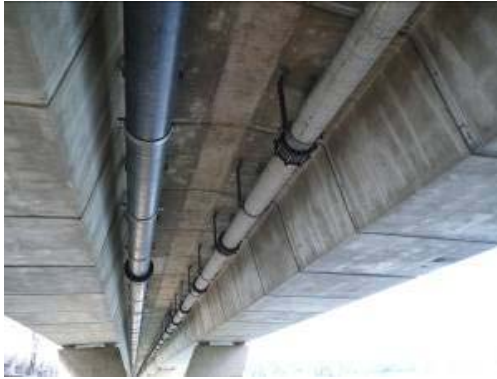
North Nowra is a suburb of Nowra with a population of 5,445 permanent residents, producing approximately 1.2ML of wastewater /day. This is transported to the Nowra STP across the Shoalhaven River Bridge via a 300mm AC pipeline, which is suspended under the bridge. The 300mm AC pipeline is made up of 3.0 metre lengths of AC pipe connected together by 300mm Gibault joints (86 in total). (Figure 2)

Figure 2: 300mm AC main on right

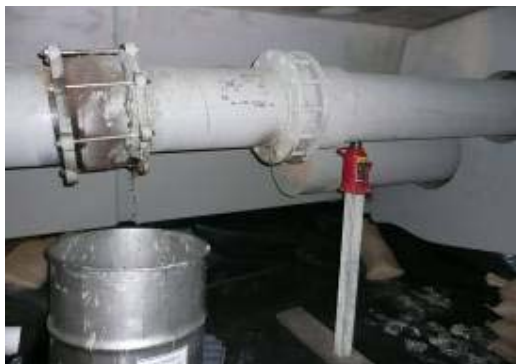
Shoalhaven Water received word that the pipeline appeared to have a minor leak at the northern abutment. Upon investigation it was found that the first gibault joint past the steel expansion/contraction slip joint was leaking. All the wastewater was contained in a stainless steel 200litre drum and natural bund at the abutment which was reinforced by sand bagging; it was pumped out by an effluent tanker. The leak was stemmed initially by tightening up the gibault joint while further investigations were carried out. (Figure 4)

Figure 4: *Initial leak*

The RTA was contacted in regards to the design specifications for the expansion and contraction of the bridge and Shoalhaven Water was advised that the bridge could move between 60 and 70 millimetres at each abutment depending on the bridge concrete temperature variation.

The conclusion reached was that the first two gibault joints on each of the northern and southern abutments were creeping along the pipes as a result of the gap between the pipes being the points of least resistance, instead of the design expansion and contraction joints.

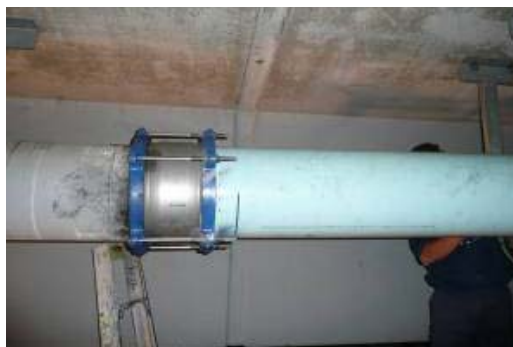
Figure 5: *Temporary repair*

The northern gibault joint had moved to a point where the rubber sealing ring had reached the gap between the two pipes and the decision was made to effect temporary repairs by removing that joint and replacing it and the first section of AC main with a new style multi fit collar and a section PVC pipe while all the materials for permanent repairs were sourced. (Figure 5).

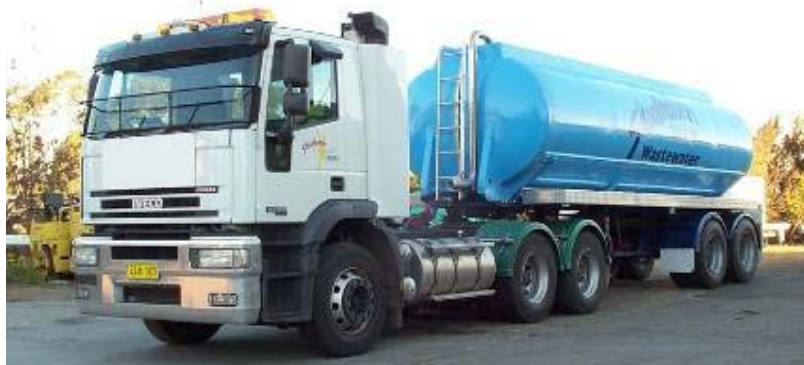
Figure 6: *Effluent tanker*

The bridge crossing was drained down starting at 10pm in the evening and the temporary repairs were completed by 5.00am the following morning in time for the morning peak flows, using a combination of scour points into effluent tankers. Tankers also emptied upstream pumping stations and all Wastewater was transported to the Bomaderry STP for treatment. (Figure 6).

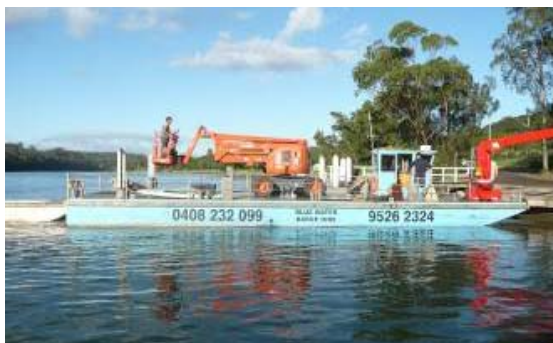
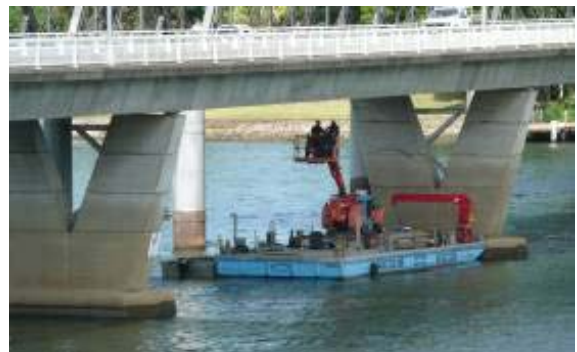
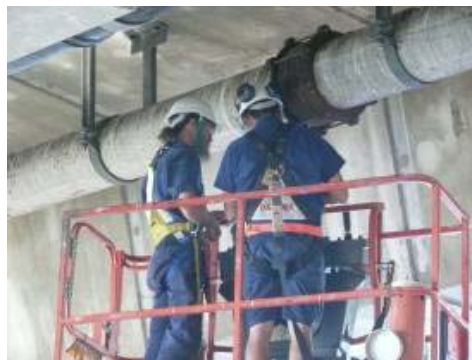
The barge was then manoeuvred into position and held there while the elevated platform was raised and the position of the gibault joints checked and their bolts also checked for the correct tension settings. There were no visible signs of any of the remaining gibault joints having moved. (Figures 7, 8 & 9).

Figure 7: *Barge & elevated work platform*

Figure 8: *Positioning barge*

2.2 **Figure 9:** *Checking gibault joints*
The Permanent Repairs

It was decided to check all the remaining gibault joints for the rest of the length of the main under the bridge before undertaking permanent repairs. This was carried out by the use of a hired barge onto which a mobile elevated work platform was placed.

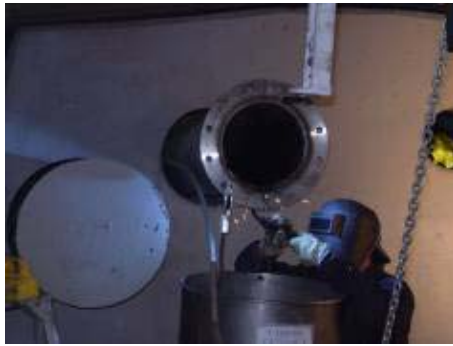
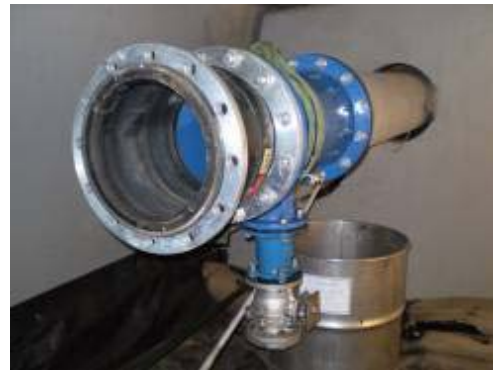
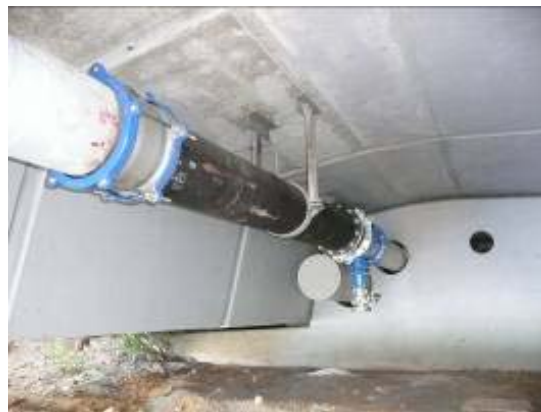
Figure 10: *Welding table flange in place*

Figure 11: *New expansion joint*

Figure 12: *Completed repair*

The permanent repairs consisted of the two existing steel expansion and contraction joints being cut off and in-house fabricated steel table flanges welded onto the steel main where it exited the bridge abutments, to which was bolted a double diaphragm bellow of a suitable pressure rating so as it would flex before any movement of any of the remaining gibault joints. The first sections of AC pipe on each side were discarded and new sections of ductile iron, cement lined (DICL) pipe were fitted in their place with new multifit collars.

Two tee sections and locked scour valves were also added at each repair site, along with a new stop valve and a scour point either side of the stop valve inserted as close to the southern abutment as possible to facilitate any future needs to drain down the bridge crossing for repairs or maintenance. (Figures 10, 11 & 12).
