# PROBLEMS ASSOCIATED WITH OZONE/GAC AS THE FINAL DISINFECTANT

**Roland Passuello**

**Roland Passuello,**  
*Water and Wastewater Plant Operator,*

*64<sup>th</sup> Annual Water Industry Engineers and Operators' Conference  
All Seasons International Hotel - Bendigo  
5 and 6 September, 2001*

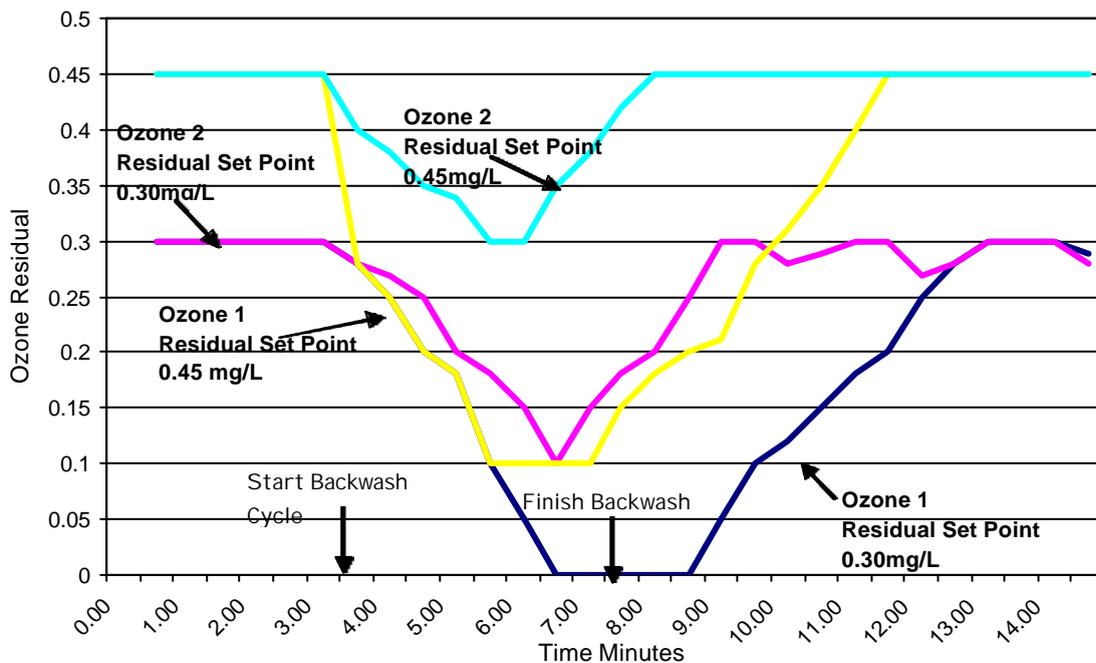
**Figure 2: Trend Graph – Ozone Residual During High Backwash Flows**

*Loss of Ozone during backwash:-* Once the plant performance was monitored using the trend graphs, see **Figure 2**, it was apparent that at 50 l/s the Ozone generators could not maintain the Ozone at 0.3 mg/L during backwash. When backwash was initiated during low flows it was discovered that one generator was in the pause mode when backwash began causing the filters to be backwashed with water that was low or had no ozone thus not effectively disinfecting the filter bed.

To correct this problem the Ozone minimum set point was increased to 0.4mg/L and it was decided to modify and add changes to the PLC control, at this point we entered a program, which was time adjustable on the touch screen. We now can make the ozone generator which was in the pause mode come on before backwash begins. This system will be supplemented with a software modification that the contractors are supplying to adjust the ozone generator to accept a 20 ma signal. This will indicate to the generator to ramp up to full capacity during backwash and remain there until backwash is completed. The first stage of this program change has been operated for a very short time and already has shown promising improvement.
