**WHEN IS RESERVOIR CLEANING NOT JUST
CLEANING?
FOLLOWING THE EVIDENCE TRAIL**

*5th Annual WIOA NSW Water Industry Engineers & Operators
Conference
Exhilarating Events Centre, Newcastle
29 to 31 March, 2011*

David Barry, *Director*, Aqualift Potable Diving Pty Ltd

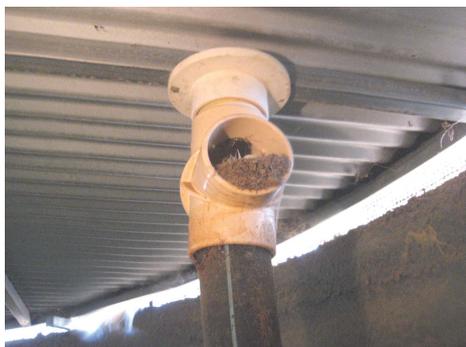
Figure 1: *Birds nest inside overflow pipe* **Figure 2:** *Contamination exposure points*

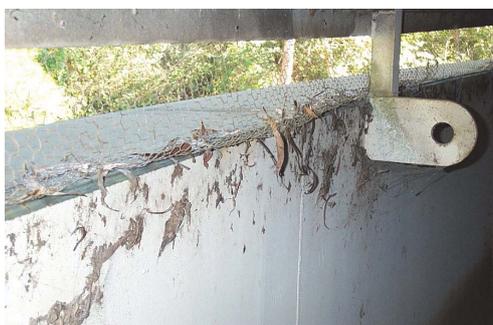
Figure 3: *Ventilation debris*

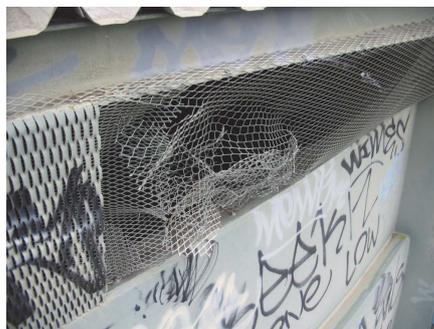
Figure 4: *Ventilation vandalised*

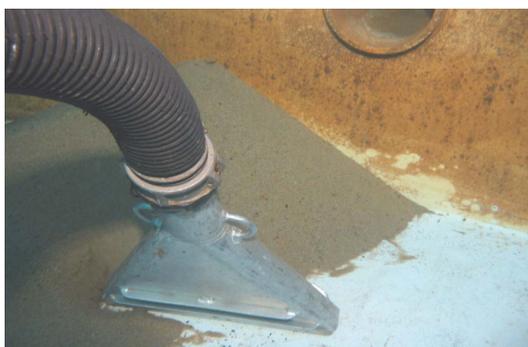
Figure 5: *Sand from Bore casing failure* **Figure 6:** *Sediment profile*

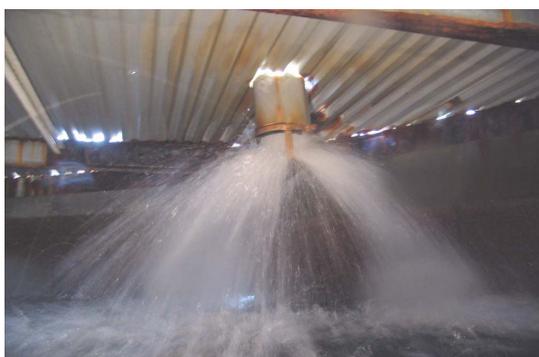
Figure 7: *Roof corrosion*

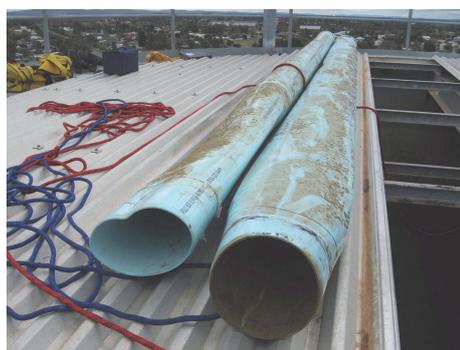
Figure 8: *Collapsed Overflow pipes*

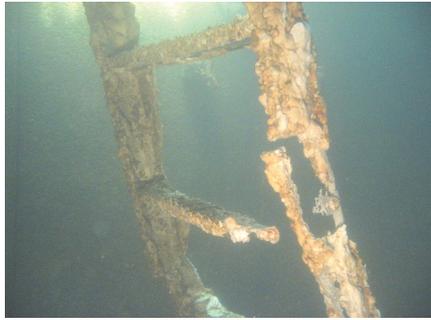
Figure 9: *Corroded ladder*

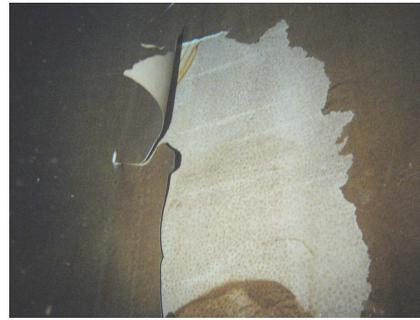
Figure 10: *Coating failure*

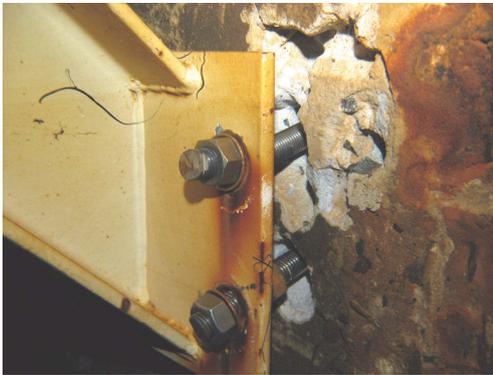
Figure 11: *Support bracket defective*

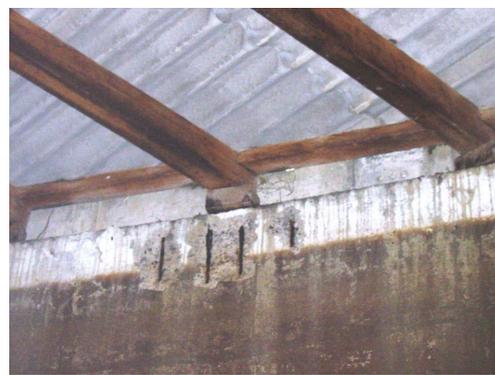
Figure 12: *Concrete structure breakdown*

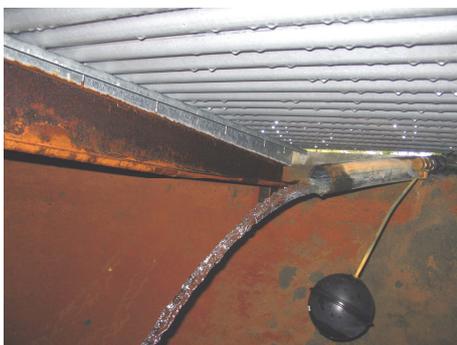
Figure 13: *Roof structure corrosion* **Figure 14:** *Collapsed roof support from corrosion*

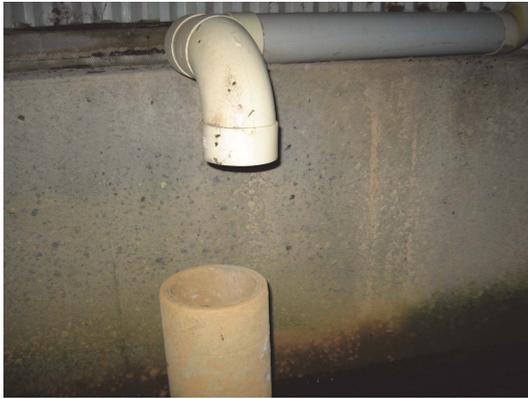
Figure 15: *Mis-aligned internal drainage pipe*

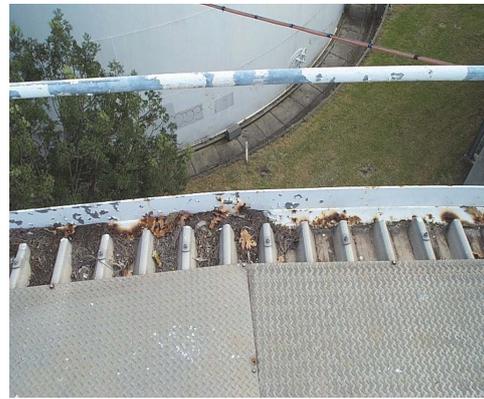
Figure 16: *Debris contained by non draining kick plate*

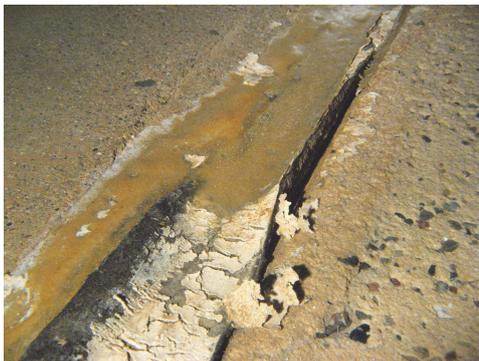
Figure 17: *Subsided floor seal*

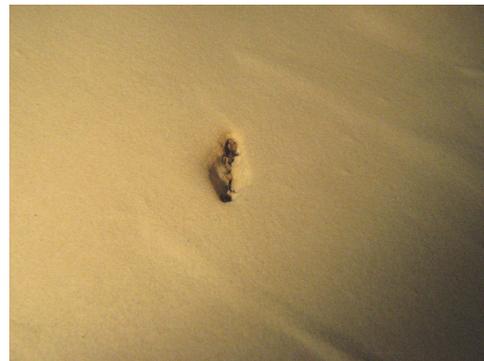
Figure 18: *Floor leak indicated by absence of sediment*
