SERVICE RESERVOIR REFURBISHMENT

*5th Annual WIOA NSW Water Industry Engineers & Operators
Conference
Exhilarating Events Centre, Newcastle
29 to 31 March, 2011*

Stefan Claveria, *Project Manager/Engineer*, Sinclair Knight Merz

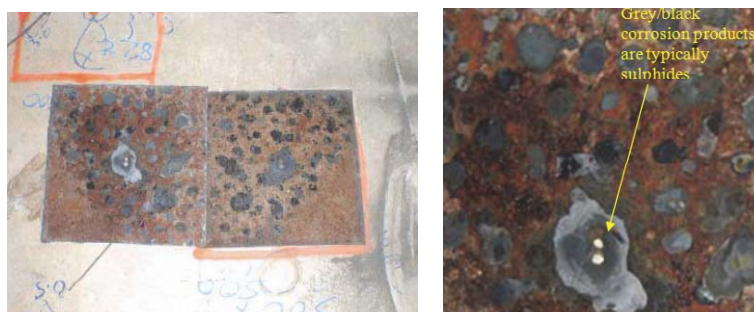
Under floor corrosion and subsequent leakage of coated steel tanks in parts of Victoria has become a significant issue requiring repairs and refurbishments. The cause of the under floor corrosion has been attributed mainly to the use of crushed limestone contaminated with high levels of chlorides, in particular calcium chlorides (Ref. 1). Calcium chloride absorbs water at a min. of 30% relative humidity compared to 78% for sodium chloride. Thus in the presence of calcium chloride, the time of wetness is greater and hence corrosion rates can be greater to the uncoated underside of the steel floor plates (Refer Fig. 1).

Figure 1: *Under floor corrosion examples*

A magnetic flux leakage (MFL) scan of the Sydenham Reservoir's steel floor was undertaken in November 2008 to assess the underfloor corrosion. A number of serious defects showing >70% deterioration (<3mm remaining) were found, the majority of which was concentrated towards the centre of the tank floor. The increase in defects towards the centre is attributed to voids which are created from the flexure in the steel floor plates that can occur during emptying of the tank and through roof uplift (the columns are welded to the floor for uplift resistance).

Injecting a cementitious grout below the steel floor was also recommended as it could provide a high pH environment for the steel underfloor, allows for continued underfloor ICCP use if required, provides a barrier and reduces voids between the steel floor and bedding material to remove corrosion sources, and provides a structural platform for the liner should corrosion of the steel persist. The injection locations were designed to be combined with the corrosion and column locations to reduce the number of patch plates.

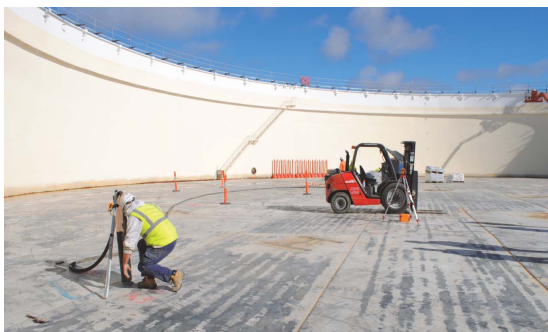
Figure 2: *Cementitious grout injection*

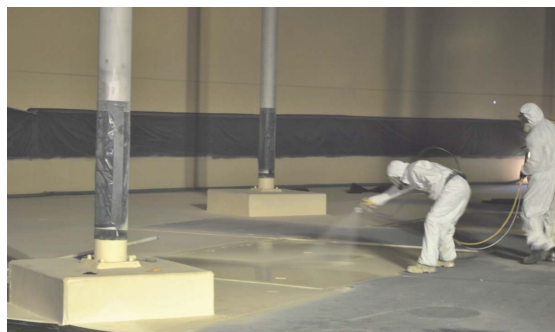
Construction of the floor system was carried out with relatively few problems, although the Polibrid 705E liner application had some minor teething issues as it had not been laid on steel in such a large scale before. However with on site guidance from the supplier (International Paint Pty Ltd) and good QA (including holiday testing) the contractor (McElligotts Pty Ltd) was able to lay the liner successfully in just over 2 months (including injection grouting). After applying the lessons learned to a similar tank, Cowies Hill Tank 1 (62.5m diameter), the liner there was laid in 1 month.

Figure 3: *Polibrid 705E application*

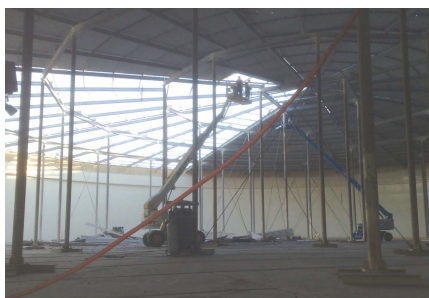
Figure 4: *Deconstruction of the roof*

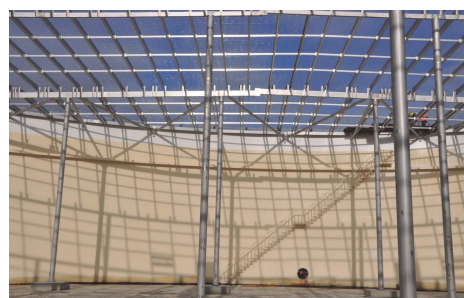
Figure 5: *New stainless steel roof subsystem and safety mesh*

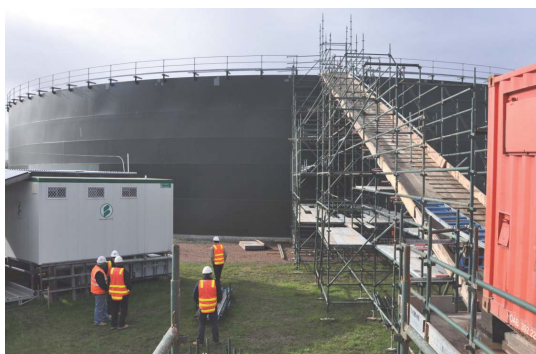
Figure 6: *Scaffold ready for Kalzip installation*

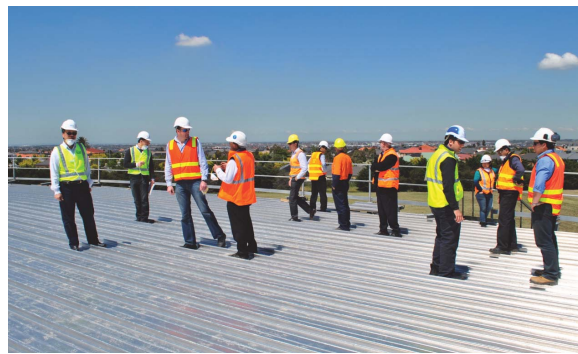
Figure 7: *Completed roof construction*
