MF PRESERVATIONS, ISSUES AND LESSONS LEARNT AT LUGGAGE POINT ADVANCED WATER TREATMENT PLANT

Veolia Water

36th Annual Qld Water Industry Operations Workshop Clive Berghofer Recreation Centre, USQ, Toowoomba 31 May to 2 June, 2011

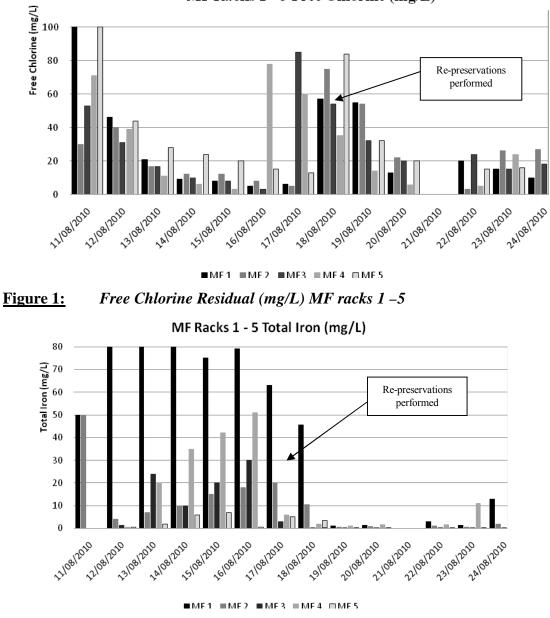
<u>Figure 2:</u> Total Iron (mg/L) MF racks 1 – 5

After the preservations had been completed sampling was conducted on the MF racks to assess the free chlorine and total iron concentrations present. Iron was tested as it was anticipated that there would be some residual carryover as a result of the flocculation/clarification process undertaken upstream on the MF racks. While regular backwashing and chemical cleans are undertaken to remove iron, the effectiveness of these cleans at removing all residual iron is difficult to determine. The iron, when combined with the chlorine, results in precipitation of the iron and could lead to the decay of the preservation solution. Sampling showed elevated levels of iron and chlorine levels that varied significantly between the racks. The results obtained during the first fortnight of sampling indicated that the preservation solution was decaying significantly to the point where all chlorine was being exhausted and elevated iron levels were present. These factors indicated that subsequent re-preservation of the MF racks was required. Figure 2.1 and 2.3 present the free chlorine concentrations in MF racks 1-5 and 6-11 respectively. These figures clearly demonstrate that the free chlorine concentration degraded significantly and increased sharply when re-preservation was performed. Figure 2.2 and 2.4 present the total iron concentrations in MF racks 1-5 and 6-11 respectively. These figures demonstrate an increase in the total iron concentration as free chlorine concentration decreases.

A decrease in the total iron concentration can be seen subsequent to the re-preservation. It was concluded that the chlorine was precipitating out the remaining iron in the MF rack and the iron was slowly being flushed through the racks with time and subsequent flushes/re-preservations. This indicates that re-preservations are necessary on all of the MF racks, in order to retain effective chlorine residual and inhibit biological growth.

As it became evident that secondary re-preservations would be required, a temporary service water line was installed that utilised potable water in order to provide an alternate source of water for the re-preservation process. After the installation of the temporary service water line re-preservations of the MF racks were undertaken. The effect of re-preservation on the total iron concentration can be seen in Figure 2.1 and 2.2, after the 18/08/2010. Post 18/08/2010 a similar pattern was observed with chlorine residuals degrading significantly, however the peak total iron concentrations were not as high as the concentrations observed after the first preservation sequence, which indicates that the total iron was being flushed out by the preservation solution.

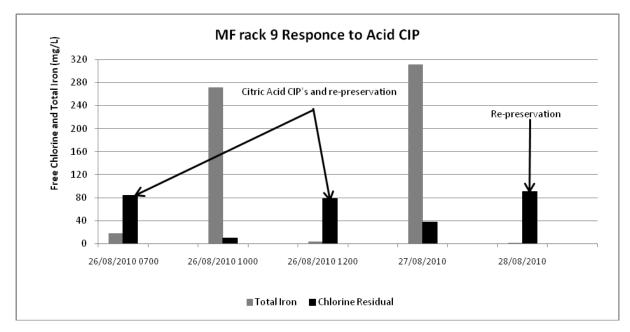
Figure 5: MF 9 Response to Citric Acid CIP

The results of the sampling period also indicated that three of the racks (MF racks one, four and nine) continued to display higher than expected chlorine degradation and total iron concentrations. To remove this excess iron, secondary CIP's were performed with citric acid. Post the CIP's, the racks were re-preserved. Figure 2.5 depicts the response of MF rack 9 to the citric acid CIP. In this example a citric acid CIP was performed twice on the same day. Immediately after the first citric acid CIP the racks was put back into preservation and sampled to ensure the concentration of the preservation solution were acceptable. As demonstrated in the figure the free chlorine concentration is approximately 80 mg/L following a re-preservation, with slightly elevated total iron levels. Subsequent sampling two hours later showed a dramatic increase in total iron (to approximately 250mg/L) and significant degradation of free chlorine concentration to 5 to 10mg/L. An additional citric acid CIP was performed and sampling of the preservation solution performed which showed similar results to those obtained after the first citric acid CIP and re-preservation. Generally total iron values after a preservation are quite low and slowly increase over days.

The introduction of a citric acid CIP had a significant effect in removing the iron into solution, where it was subsequently precipitated once the rack was preserved again. Similar responses were also observed in MF racks one and four after citric acid CIP's were performed. Once the excess iron was removed the racks returned to a normal represervation sequence requiring re-preservation every three to five days. Similar to that observed in the other MF racks.
