**BUNDABERG FLOODS NOW THE MUD HAS DRIED –
FLOOD RECOVERY AT MILLBANK WWTP**

Kym Kneebone, *Assistant Coastal Treatment Co-ordinator,*

Bundaberg Regional Council

*37th Annual Qld Water Industry Operations Workshop
Parklands, Gold Coast
5 June to 7 June, 2012*

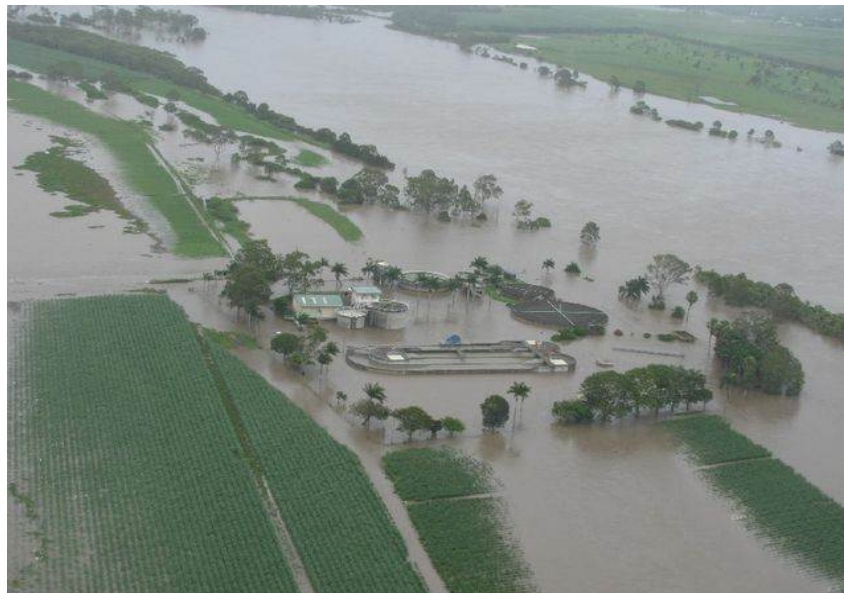
Figure 3: Millbank WWTP at Flood Peak

The Millbank WWTP catchment sewerage pumping stations were all experiencing large inflows with associated high inflow to the Millbank WWTP. It was considered that there was capacity to catch gross solids at the Millbank WWTP as well as to limit sewerage overflows in Bundaberg suburbs. On 30/12/2010, the Parks & Gardens boat was used to undertake visual inspections and take photos where possible of the Millbank WWTP. During the floods the approximate flows were around 37ML per day. By this time the river had peaked at 7.92 metres. The Millbank WWTP during this flood peak is shown in Figure 3.
