CORROSION OF AN ASBESTOS CEMENT SEWER RISING MAIN DUE TO HYDROGEN SULPHIDE

Colin Bowker, *Senior Engineer – Projects,*

Westernport Water

*75th Annual Water Industry Engineers and Operators' Conference
Bendigo Exhibition Centre
4 to 6 September, 2012*

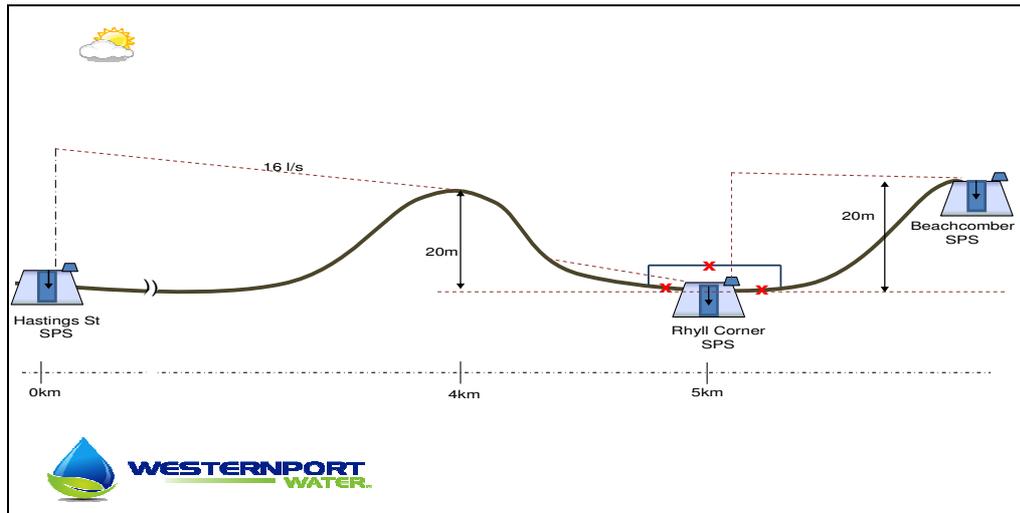
In summary it is a 5 km long main, rising to a crest at the 4 km mark then falling to the Rhyll Corner SPS. At the design pumping rate of 16 l/s, the pipe runs only part full at the crest with the sewage free draining over the last 1km of its length.

Figure 1: *Longitudinal Section with HGL at 16l/s*

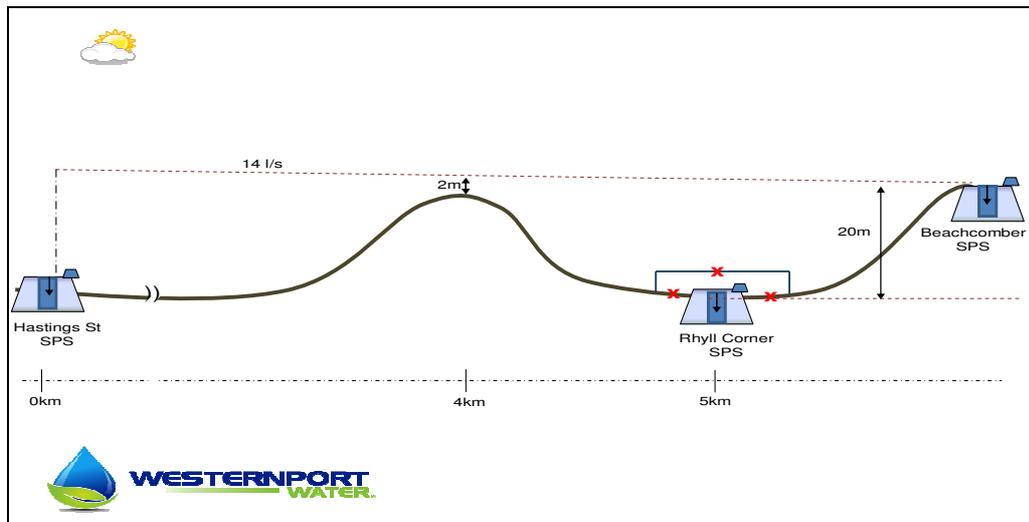
It is possible to bypass the Rhyll Corner SPS and when bypassed, the static head at the Rhyll Corner SPS increases by 20 metres, with only minor impact on the Hastings St SPS rising main. The pumped flow decreases to 14 l/s, reducing pressures along the first 4km of its length, and the crest experiences full pipe conditions. The final 1 km of the pipeline is subject to minor pressures of up to 20 metres, as shown in Figure 2.

Figure 2: *ByPass Mode with HGL at 14l/s*

The first burst on the rising main was reported within a few hours of operating in bypass mode, at chainage 4400 m, approximately 600 metres from the end. The burst occurred in a section of main that had not operated full and under pressure for the past 17 years.

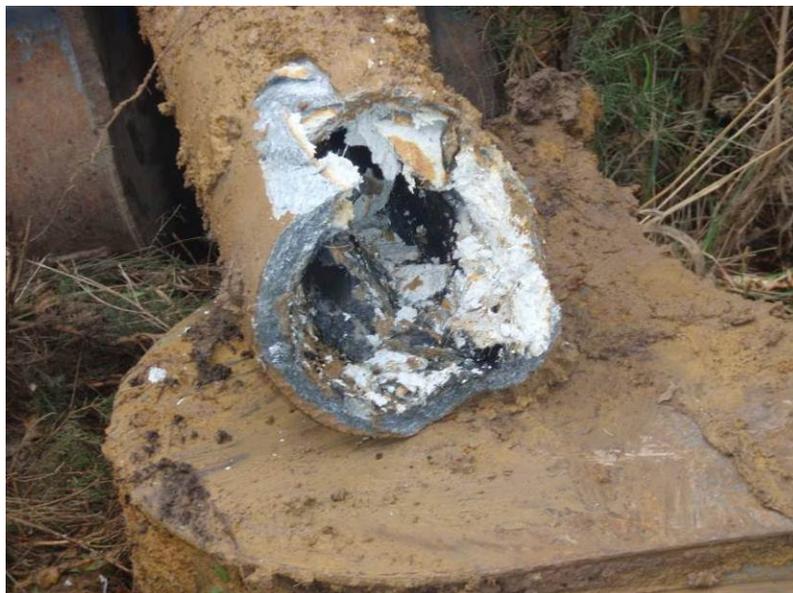
The broken AC pipe was inspected more closely. Once the top and bottom of the pipe were identified, it became clear that the bottom of the main was very hard and dark, and the top of the main was a softer white material as shown in Figure 3.

Figure 3: ***Section of removed AC Pipe, clearly showing a corroded pipe wall***

Our mechanical engineer who was investigating odour and concrete corrosion in sewage pump stations at this time, suggested that the problem could be due to hydrogen sulphide corrosion.

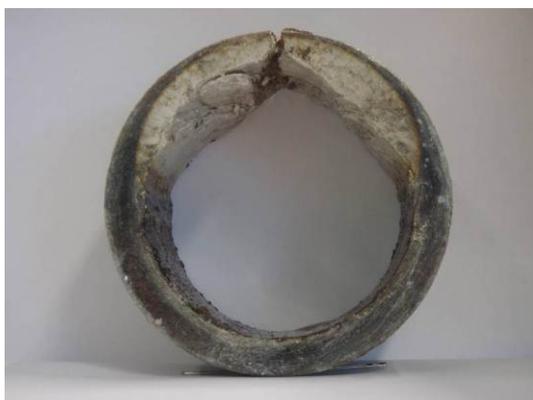
Broken pipe from the second burst was better preserved and it was neatly cut then immersed in clear epoxy paint, and is shown in Figures 4 and 5. This section shows the lower half of the pipe being unaffected, then gradually corroding more and more from the half pipe until the 19 mm wall thickness is reduced to 3 mm at the top of the pipe. The corrosion is clearly occurring from inside the pipe.

Figure 4: *Section of AC Pipe, showing gradual corrosion of pipe wall*

The mechanism of sulphide corrosion in sewers is complex however in simple terms, bacteria in the sewage converts sulphite to sulphide which creates hydrogen sulphide gas in the presence of air. The hydrogen sulphide then reacts with moisture to form sulphuric acid on the concrete surface/pipe wall which breaks down the bonding capability of the cement by leaching its calcium, causing softening and loss of mechanical strength. This causes the collapse of whatever aggregates the cement is binding together.

Figure 4 shows the lower half of the pipe in perfect condition because it was flushed every time the pump operated and the pipe ran half full. The top half of the pipe however, never ran full and the obvert was always damp due to the moist nature of part full sewers with insufficient ventilation.

The final 1 km of the Hastings St SPS rising main was replaced by pipe cracking the 150mm AC main with a new 180 mm HDPE pipe. The testing of the various sections gave us confidence that the first 4 km was in excellent condition and not in need of replacement at this time. Even though the final 400 metres was in relatively good condition, it was decided to replace the entire section of the main from 100 metres before the crest to the very end. This was considered to be a better solution than only replacing to the point where the main actually stopped corroding by conducting further pipe sampling which involved the cutting of more AC pipe. Simply exposing the top of the main and observing the outside of the pipe would not have detected this type of corrosion because it occurs from the inside.

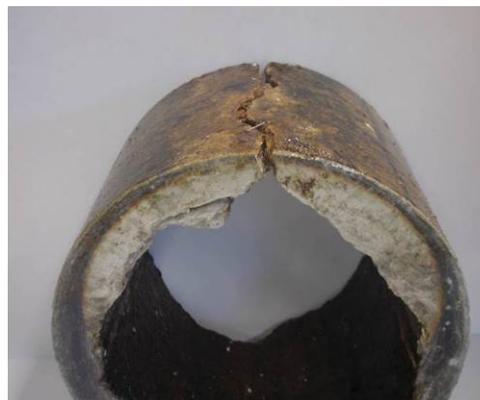
Figure 5: *Section of AC Pipe, showing a crack along the top of the pipe*

Taking the Rhyll Corner SPS offline for an extended period was dependent on this rising main withstanding the minor pressure increase resulting from the bypass. This did not eventuate as shown in Figure 5. This gap in asset knowledge resulted in two sewage spills and the delay of essential repair works on the Rhyll Corner SPS.

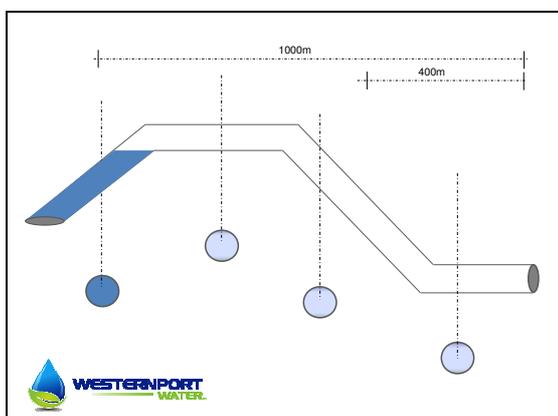
Figure 6: *NO FLOW in the final 1 km of the rising main*

Figure 6 shows the final 1 km of the rising main, a few minutes after pumping has stopped. The pipe is full up to the crest and is therefore rarely exposed to hydrogen sulphide. The section from the crest to the end is empty and always subject to hydrogen sulphide.

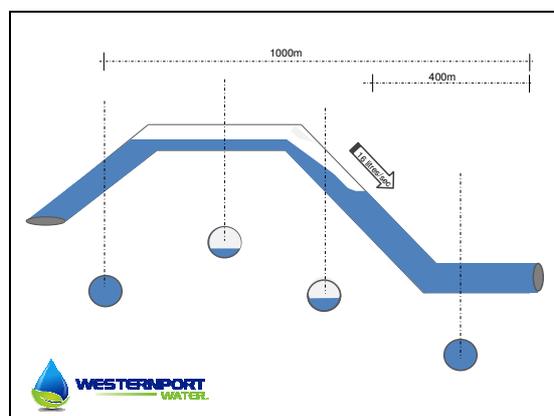
Figure 7: *PART FULL FLOW in the final 1 km of the rising main*

Figure 7 explains why the sample taken at 300 metres from the end of the rising main showed a pipe in good condition. When the pump is operating, the pipe only runs part full to a point approximately 400 metres from the end, washing recently formed acids from the invert of the pipe only. After this point, the main runs full due to the small amount of head required to drive 16 l/s along the remainder of the pipeline, regularly washing both the bottom and the top of the pipe in the final 400 metres of main.
