**AFTER THE VICTORIAN FLOODS:  
IMPACTS OF RAW WATER QUALITY CHANGES ON  
MICROFILTRATION PLANTS**

**Dr Kathy Northcott, *Process Operations Engineer,***

*75<sup>th</sup> Annual Water Industry Engineers and Operators' Conference  
Bendigo Exhibition Centre  
4 to 6 September, 2012*

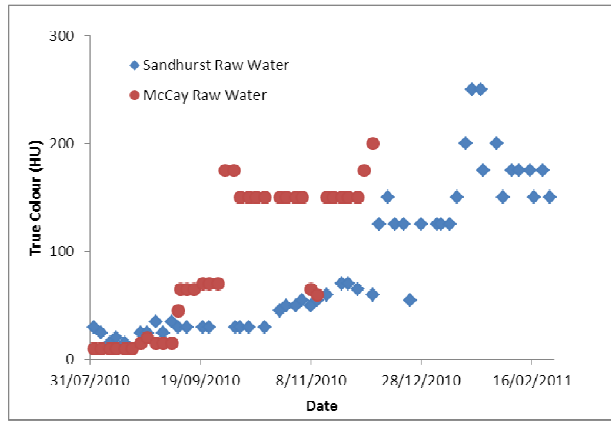
True colour results over this period increased from around 10-30 HU to over 200 HU at Bendigo WTP. DOC results in raw water increased from around 4 mg/L to over 11 mg/L at Castlemaine WTP and over 10 mg/L at Bendigo WTP. Iron and manganese results also trended upwards, iron concentrations increasing from around 0.2 mg/L to approximately 0.6 mg/L and manganese results increasing at both WTPs from around 0.01mg/L to 0.02-0.03 mg/L.

**Figure 1:** *True Colour in Raw Water at Sandhurst and McCay Reservoirs (Aug 2010 to Feb 2011)*

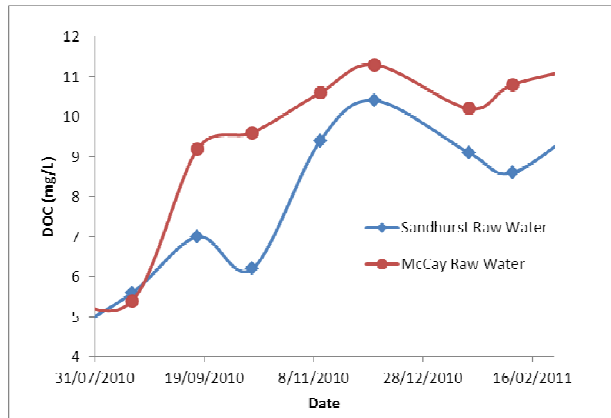
**Figure 2:** *DOC in Raw Water at Sandhurst and McCay Reservoirs (Aug 2010 to Feb 2011)*

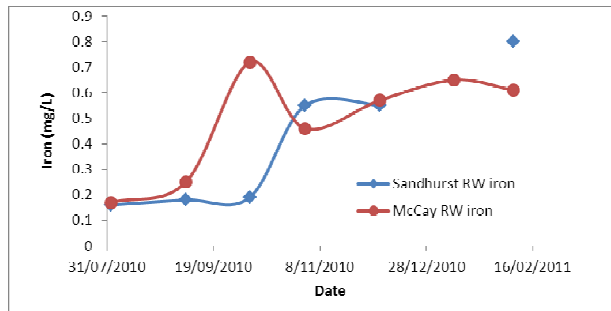
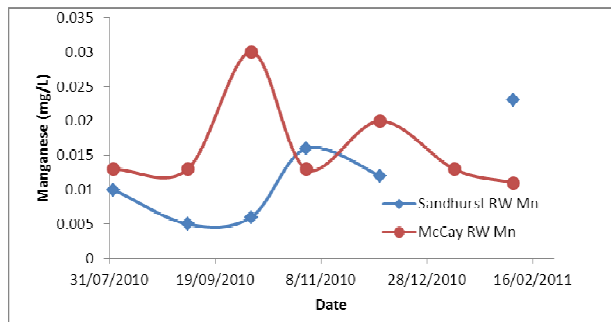
**Figure 3a & 3b:** *Iron and Manganese (mg/l) results in raw water for Bendigo (Sandhurst) and Castlemaine (McCay) WTPs*

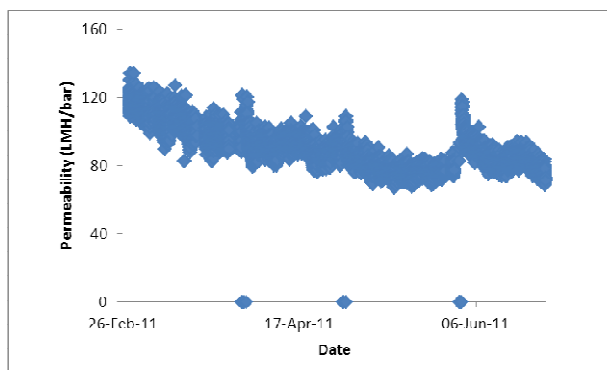
The impact has been particularly significant at Castlemaine WTP. Figure 4 and 5 shows the membrane permeability and resistance for one of the Castlemaine WTP membrane skids in the months after the January 2011 floods. Typically, due to the presence of significant levels of fouling compounds in the raw water, permeability decreased and membrane resistance increased with time.

**Figure 4:** *Membrane permeability for Castlemaine WTP skid 2*

- Increased backwash frequencies.
- Changes to backwashing set points.
- Review CIP effectiveness of CIP cleans, adjust chemical dose and chemicals used accordingly.
- Implement extended chemical soaks to assist in removal of foulants.

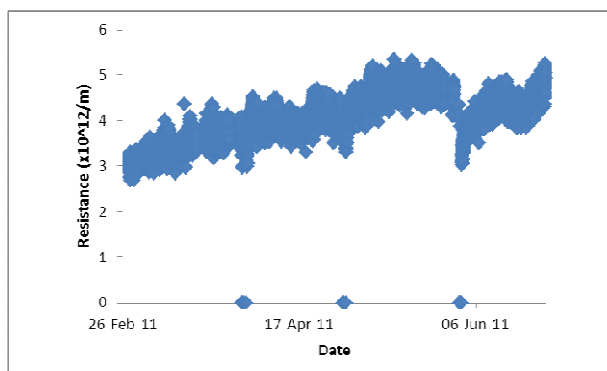
**Figure 5:** *Membrane resistance for Castlemaine WTP skid 2*
