DIAGNOSIS AND RECTIFICATION OF CLASS A PLANT PERFORMANCE ISSUES

Clint Vandeeper, *Process Engineer,*

Yarra Valley Water

*76th Annual WIOA Victorian Water Industry Operations
Conference and Exhibition
Bendigo Exhibition Centre
3 to 5 September, 2013*

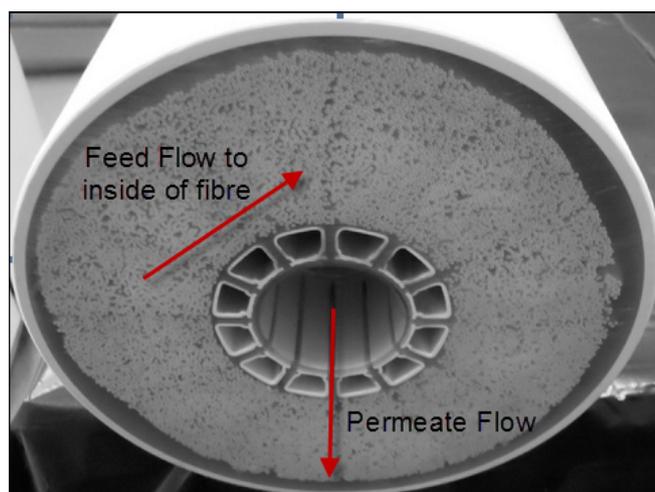
Figure 2: *Potted end of Membrane Module.*

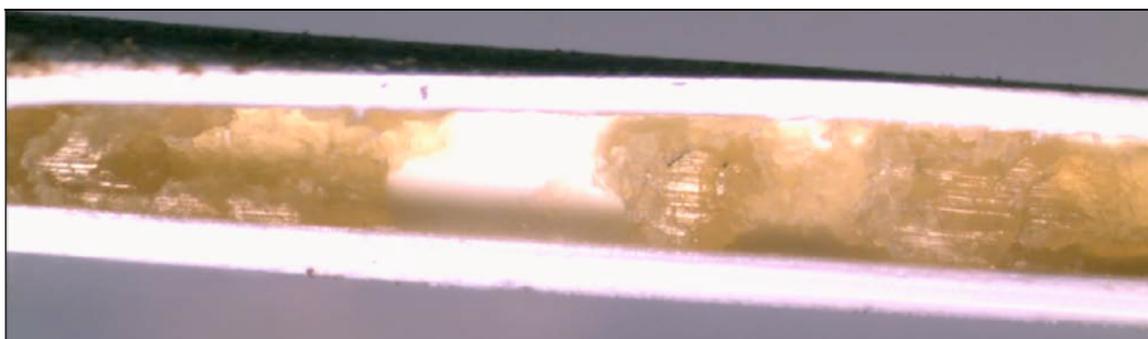
1. Fouling was present on both the shell and lumen side of the membrane but the nature of fouling on the lumen side was likely responsible for high TMPs.
2. The nature of the fouling was largely inorganic and highest in aluminium and silica content.
3. The fouling on the lumen side could be dissolved in nitric acid.

This suggested that fouling may have been attributable to overdosing with coagulant (Aluminium Chloro Hydrate) and that at some stage clay particles may have been present in the feed and backwash water.

Figure 3: *Stereomicroscope image of fibre cross-section.*

With the fouling identified as aluminium and silicate deposit and removal possible with acid soaks, the next step was to achieve some dedicated long acid soaks. This would determine whether membrane recovery was possible or whether new membranes would be required to be purchased and installed. Regardless, the issues identified with the PLC programming in Phase 1 of the troubleshooting were of priority concern. If these were not rectified, this would only promote further fouling and improper cleaning.

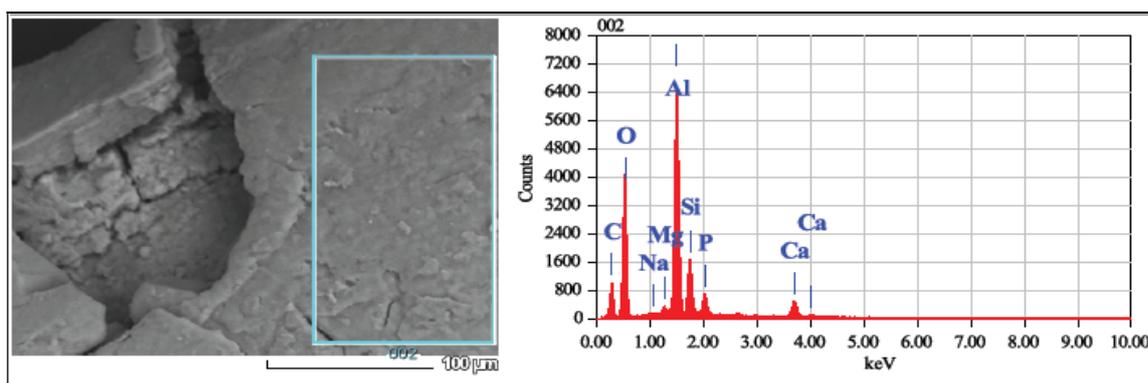
Figure 4: *Scanning Electron Microscopy image and Energy Dispersive X-Ray Spectroscopy spectrum identifying Aluminium as major content.*
