SEVENTY SEVEN NOT OUT OR HOW TO PROLONG THE LIFE OF A VERY OLD WATER TREATMENT PLANT

Doug Moorby, Manager Engineering Operations,

Narromine Shire Council

*8th Annual WIOA
NSW Water Industry Operations Conference and Exhibition
PCYC in Orange,
1 to 3 April, 2014*

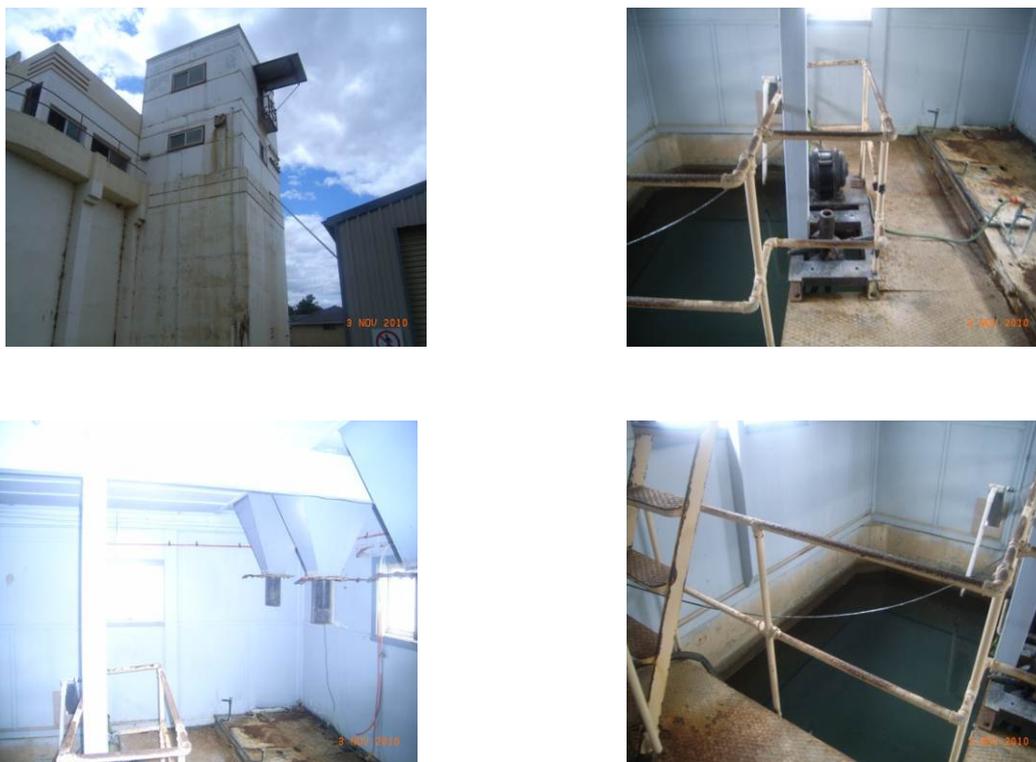
- Major Work Health and Safety issues including damaged bonded asbestos.
- Substandard chemical dosing and no mixing systems leading to poor clarification.
- Gravity sand filters with poor water quality results and extended backwash times.
- No air scour system, which is essential in dealing with polymer created mud balls.
- Aged and depreciated backwash water pumping system.
- No information available on filter flume and underdrain system.
- Depreciated electrical and SCADA Diagram Control Systems.

Figure 1: *External and internal images of the Raw Water Mixing Well*

- Prepare specification for demolition of old structure over raw water mixing well and removal of broken AC sheet ceiling above filter gallery.
- Prepare drawings plans and specifications for new structure and platform over raw water mixing well, including weir structure. New raw water delivery lines, chemical dosing, injection systems and flocculation mixers.

- Demolition of existing mixing well structure, disused dosing system and flocculator removal of asbestos including filter deck ceiling.
- Installation of new raw water feed line relocation of raw water flow meters and flash mixer including dosing quills and systems.

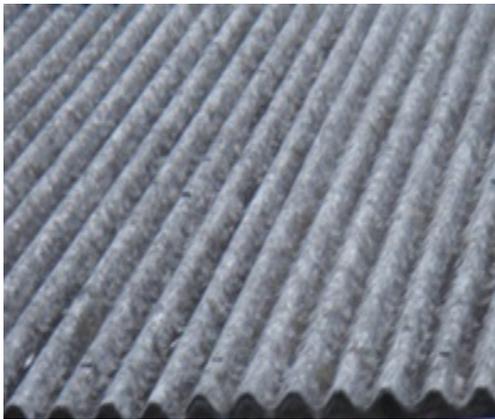
The project plan called for an exploration dig within one of the four gravity sand filters to determine the structure of the underdrains and assist in the redesign of the backwash pumps and design of an air scour system. This dig led to a discovery and incident that meant that the redevelopment of the filters had to be accelerated and quick decisions needed to be made in relation to the systems to be used. The dig was conducted in the first week of March 2013, and revealed that the underdrain filter flume was constructed from asbestos super six sheeting on a hardwood support structure.

Figure 2: Example of AC Super Six

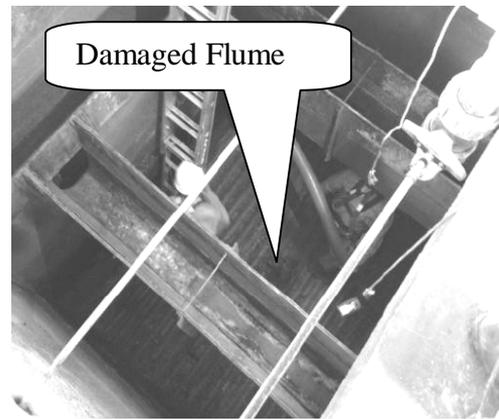
This discovery occurred when the operator who was carrying out the dig, had his foot disappear through the then unknown surface. This somewhat dramatic discovery meant the immediate and permanent shutdown of filter number 2 and a reduction of treatment capacity by 25%.

Figure 3: View of damaged filter

As Council's Water and Sewer Engineer, I had undertaken some initial research into underdrain systems suggested by Mr Kamal Fernando of the NSW PWD and had reviewed projects carried out in both Australia and overseas. This research led to quotations and proposals being sought from two companies. The final selection saw orders placed with Xylem Leopold for their SL® Underdrain System and I.M.S® 200 Media Retainer and Underdrain Accessories including Air Header Tanks.

- Removal of filter media and asbestos filter flume from the damaged No 2 Filter.
- Off-site construction of the new mixing well structure by contractors.

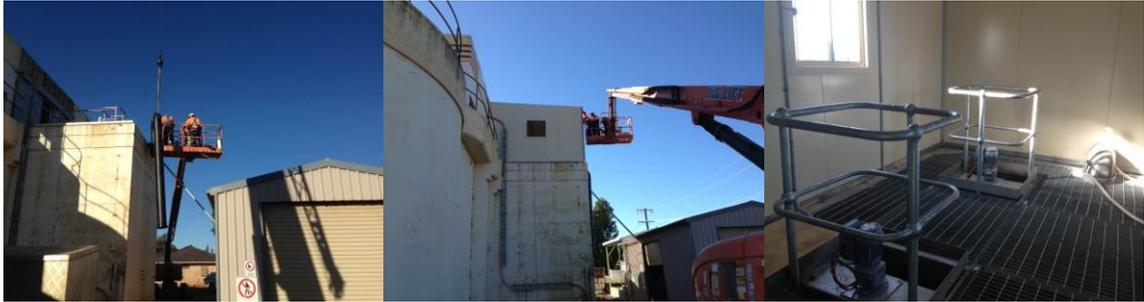
Figure 6: *Raw water delivery line mixing well structure and flocculation mixers*

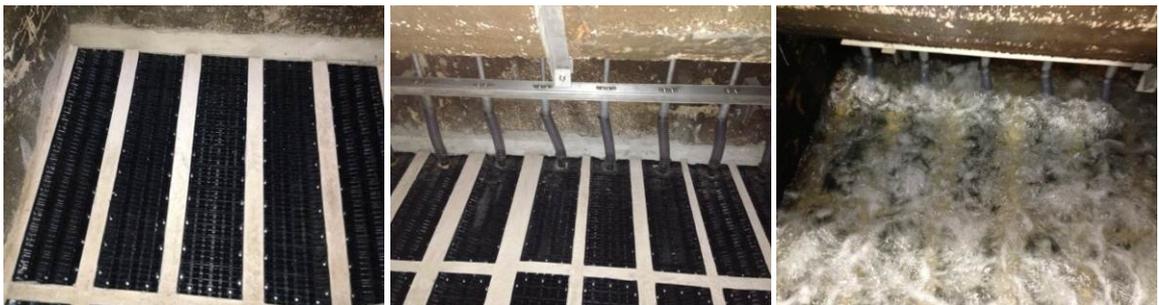
Figure 7: *Completed block installation air induction manifold and water air scour test*

- Installation of new high lift pumps and associated switch board.
- Installation of air scour blower and associated switch board.
- Installation of Xylem Leopold underdrains by Council Staff and Xylem Staff from the Los Angeles Office.

- Connection of air scour system to new underdrains and conduct commissioning clean water test.
- Load filter media consisting of 450mm of Quartz Filter Sand topped by 450mm of Filter Coal (Anthracite).
