THERE'S A HOLE IN MY BIOREACTOR WALL

Adrian Harper, *Senior Engineer Wastewater Treatment,*

Gippsland Water

*77th Annual WIOA Victorian Water Industry Operations
Conference and Exhibition
Bendigo Exhibition Centre
2 to 4 September, 2014*

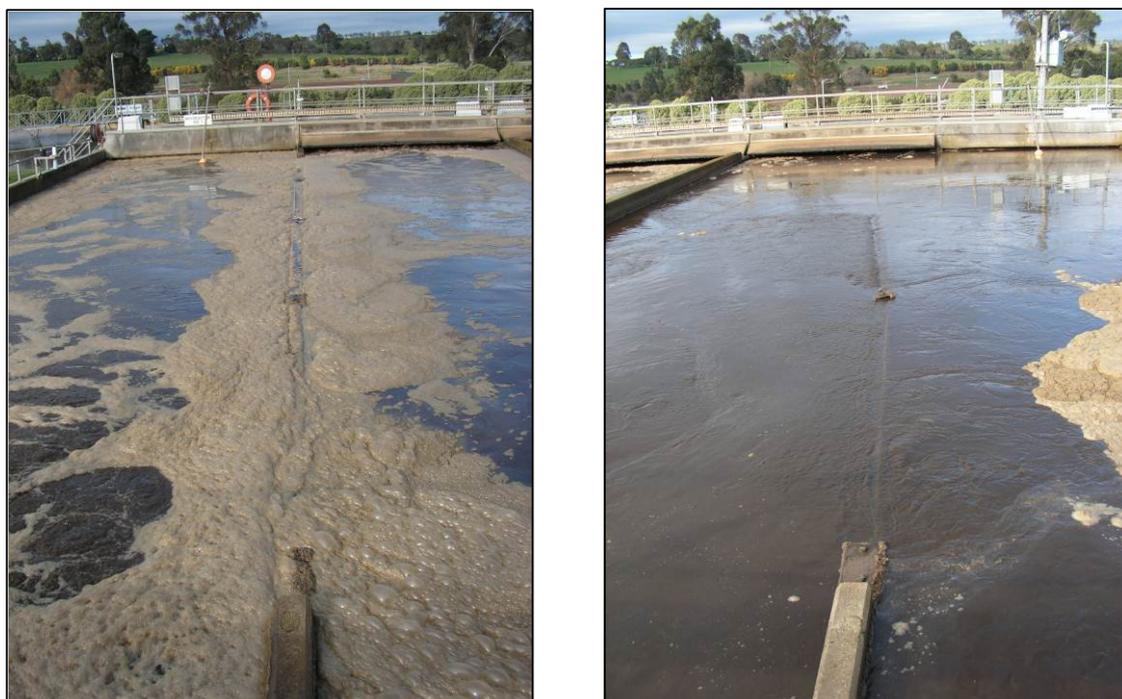
During a routine inspection on the morning of 3 August 2012, the Warragul WWTP operator discovered that a section of the internal wall in bioreactor 2 had disappeared, see Figure 1 and 2 below. Technical and management staff were notified immediately and an emergency onsite meeting was held to assess the situation.

Figure 1: *A comparison of the internal walls in bioreactor 1 (left) and bioreactor 2 (right)*

In the months leading up to January 2013, there had been various options discussed and debated as to how to reinstate the collapsed internal wall. It was agreed that the six precast panels that made up the whole section of wall between the two aerator bridges needed to be replaced.

The new design comprised of six identical precast panels, mounted on stainless steel pins embedded in the bioreactor floor and braced back to the external wall above the water line.

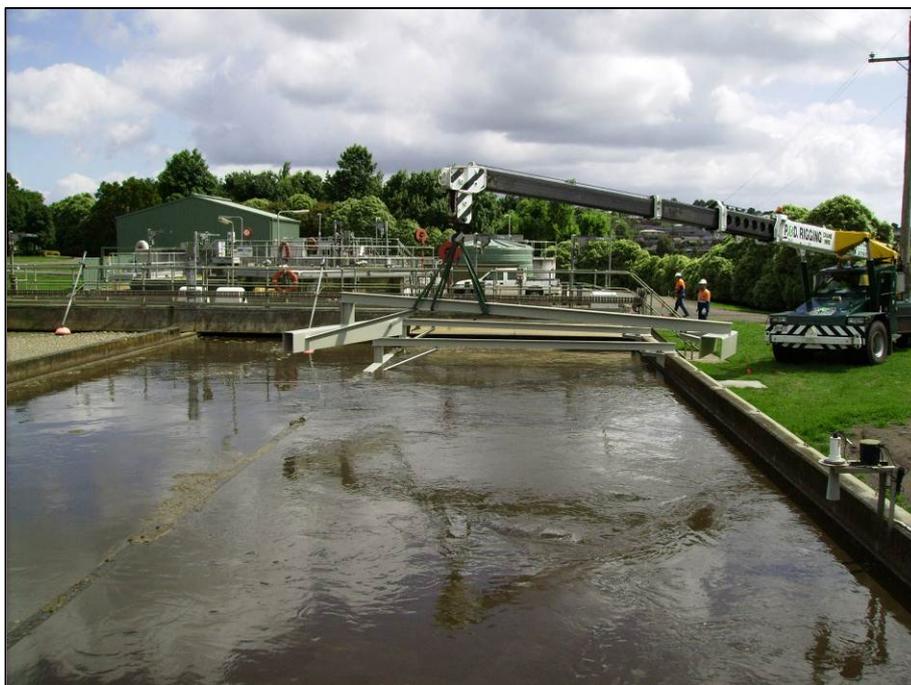
There was concern that the equivalent wall in bioreactor 1 could suffer the same fate as that in bioreactor 2. Further inspection revealed that the internal wall in bioreactor 1 was swaying slightly due to the constant flow path in the bioreactor. Steps were taken to mitigate this risk; braces were designed and installed to support the wall from above, eliminating the immediate need to drain this bioreactor as well. See Figure 3.

Figure 3: *Installation of internal wall bracing in bioreactor 1*

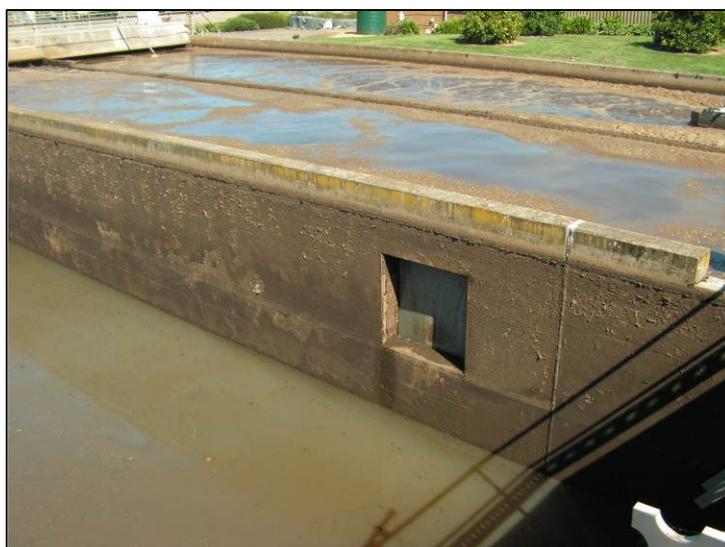
The bioreactor system includes a transfer point between the two reactors as seen in Figures 2 and 4. Being below the normal operating level of the bioreactors, any isolation of this point required a diving crew to guide a steel plate, suspended from a crane, into a frame in bioreactor 2. This was an expensive exercise and posed a number of risks, including the extent of isolation achieved when the water forces in the bioreactor 1 would act outwards on the plate. It was decided to install a penstock valve and this was achieved by a diving crew while the bioreactors were full. A gear box and spindle were also installed to allow the valve to be safely operated from the aerator bridge.

Figure 4: *Photo of transfer point between bioreactors, taken during the attempted inspection on bioreactor 1 in March 2012*

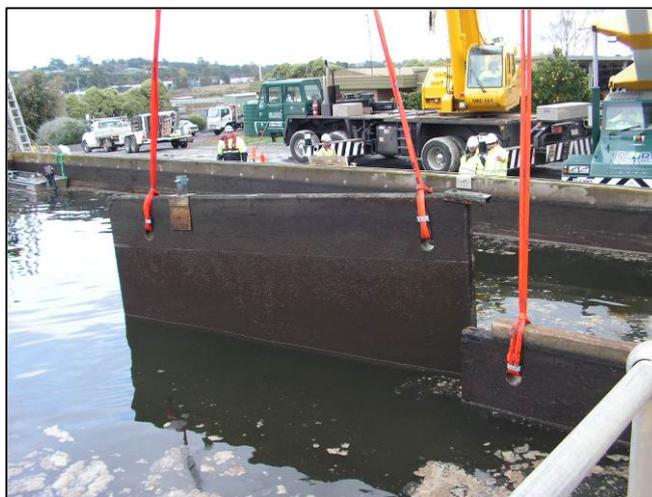
Figure 5: *Photo of removal of existing precast panels*

- Install three rental jet aerators into bioreactor 1
- Isolate bioreactor 2 and send all inflow through bioreactor 1. The final effluent was monitored frequently to ensure compliance with EPA licence limits
- Pump down bioreactor 2 by around 500mm to allow access to precast panels
- Lift out existing precast panels that were accessible from the surface (see Figure 5). Two cranes were used for this process.
- Pump down bioreactor 2 to 90% empty and lift out remaining precast panels
- Educt out and clean remainder of liquid and sludge in bioreactor 2
- Core holes in bioreactor floor and install pressure relief valves
- Embed stainless steel pins into bioreactor floor
- Lift in new precast panels and install top bracing to external wall
