VALVE CONDITION ASSESSMENT USING NEW TECHNOLOGY

Sagar Khadka, Asset Maintenance Engineer,

ACTEW Water

*77th Annual WIOA Victorian Water Industry Operations
Conference and Exhibition
Bendigo Exhibition Centre
2 to 4 September, 2014*

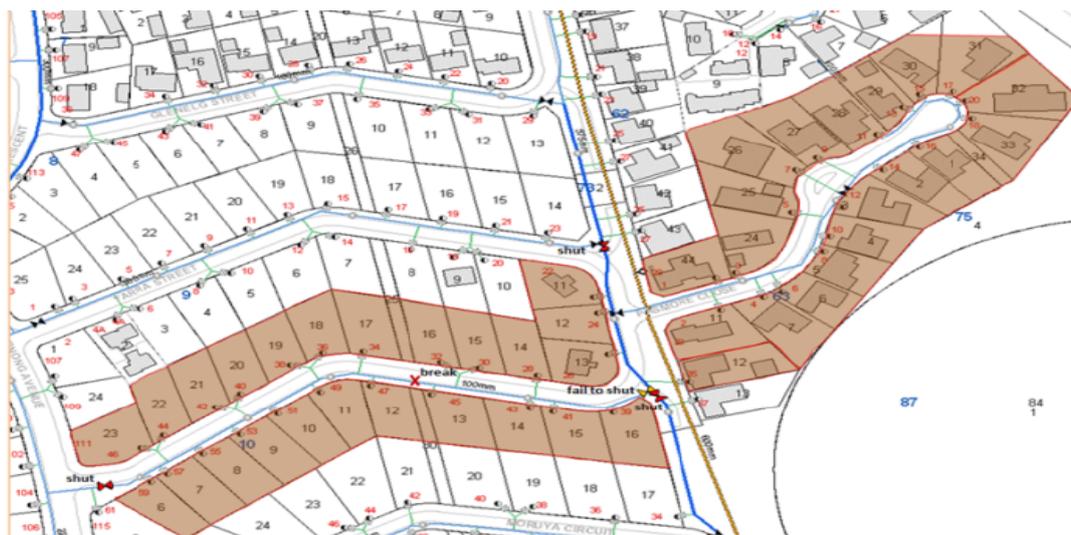
Figure 4: *Consequences if DN100 valve failed to shut, 41 houses affected instead of 20*

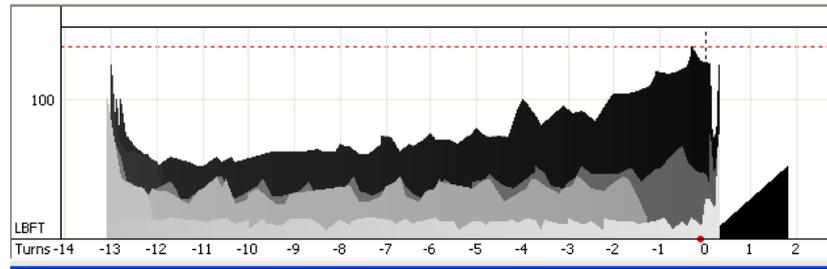
- 223 (9.02%) valves were very stiff. These valves were operated from fully open to closed and then back to fully open a few times until the torque required to operate the valve is minimal. They can now be safely operated manually. In fig 2, the number of turns is shown on the X axis and torque (LBFT) on the Y axis. Different colours in the graph show the number of times the valve was operated. The valve shown in Fig 2 was operated four times where the initial torque required to operate valve was around 90 LBFT but after operating four times, it required only 20 LBFT. This valve will be very easy to operate manually in the future.

Figure 5: *Stiff valve but smooth after operation*

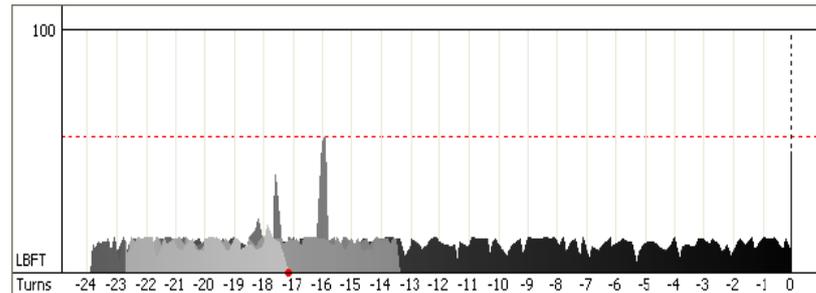
- Identified 15 broken valves (1%) which couldn't be used for isolation. All the broken valves were replaced immediately.

Figure 6: *Broken valve*

Broken valves will spin indefinitely with less torque and need to stop it manually.

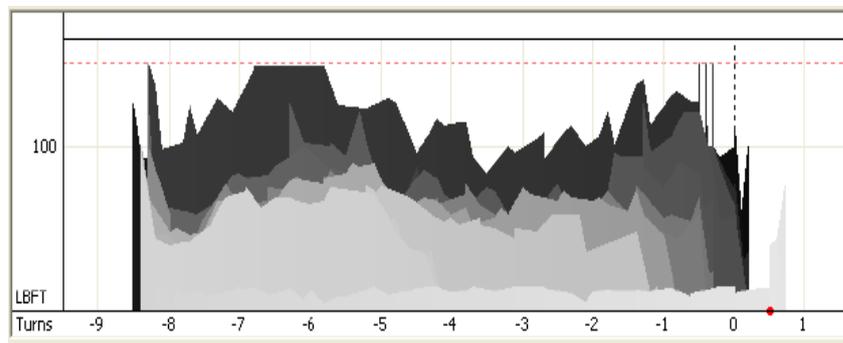
- 30 (1.2%) valves were very stiff and are still stiff after operating a few times. The torque required to operate those valves is still significantly high and they cannot be operated manually. These valves are listed for replacement.

Figure 7: *Valve considered for replacement*

In the above figure, the valve was operated five times to see if the valve could be operated with minimal torque after operating few times. There was no sign of improvement and this valve will be very difficult to operate manually. Replacement of this valve is required.

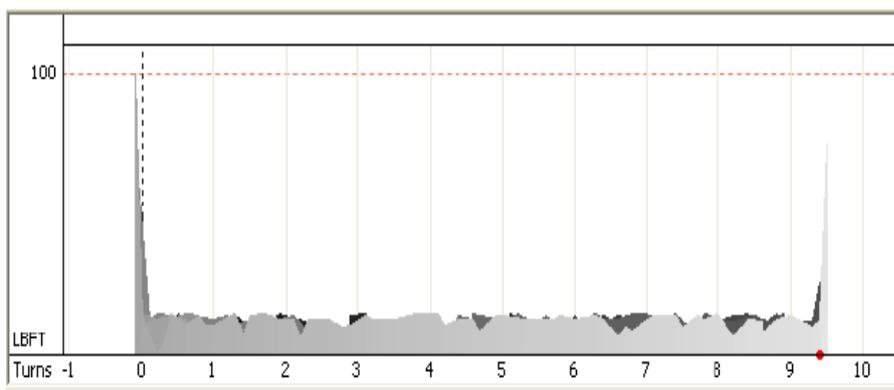
It was interesting to see that 4% (99) of the valves were left closed or partially closed after maintenance. If the valves are left shut, it creates dead ends and there may be stagnant water that will create water quality issues. All these closed valves were left open after exercising. One critical valve and a few big valves (above DN300) were also found shut and this information was also used to calibrate the water reticulation model.

Figure 8: *Closed valve and left open after exercise*

The position of “0” indicates the initial status of the valve. If the “0” is in the LHS and is spinning towards the RHS, then the valve is closing.

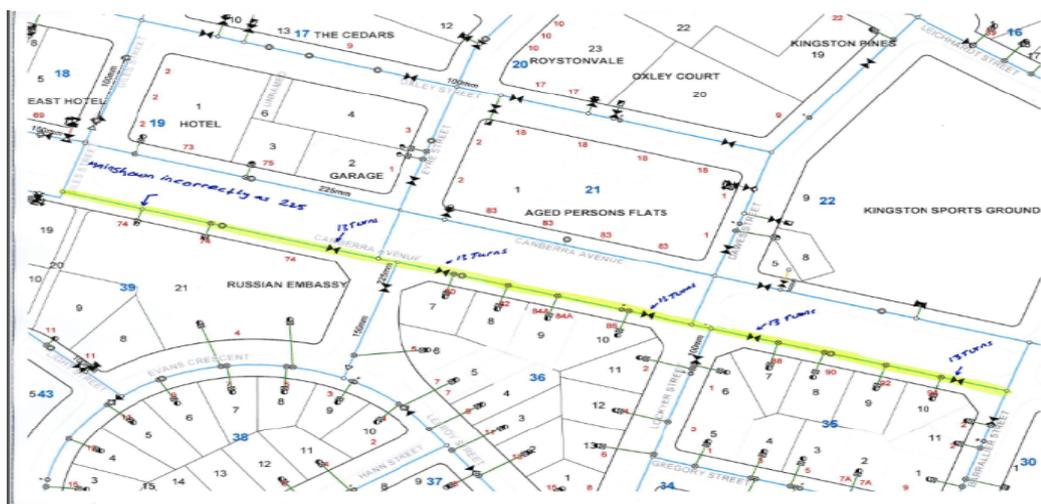
- 7% of new valves that had been replaced reactively within last five years had not been updated in the GIS.
- 85 valves and the corresponding water mains were incorrectly sized in the GIS and thus in the water reticulation model. Incorrectly sized mains can be critical for fire flow analysis. The number of turns is used to verify the size of water main and valve information within the GIS has been updated accordingly.

Figure 9: *Mains and valves incorrectly shown as DN225 for DN150 main and valves*
