# STROMLO WATER TREATMENT PLANT UV LAMP BREAKAGE INCIDENT

**Kate Smith**, *Senior Water Treatment Engineer,*

ACTEW Water

*9<sup>th</sup> Annual WIOA  
NSW Water Industry Operations Conference and Exhibition  
Orange PCYC,  
24 to 26 March, 2015*

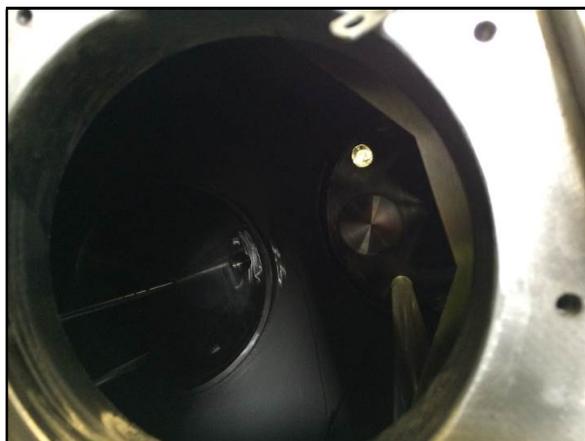
**Figure 3:** *View through Lamp Sleeve Mounting*

Figure 3 shows the view through the sleeve mounting with the broken sleeve end removed. The other end of the broken sleeve is visible through the pipe. The unbroken lower sleeve and lamp on the same bank are also visible. There were no signs of any pieces of the actual mercury lamp, which had been carried away in the drinking water flow.

The logic fault caused the valve to open very fast, resulting in a very high rate of flow increase into the plant, and subsequently, a very high rate of flow through the single online UV train. This caused two quartz sleeves and UV lamps to break from the force of the fast flowing water.

1. Repair of the control logic error (including other identified instances).

2. Configuration of an upper limit on the raw water set point which is a function the number of UV trains available.
3. Configuration of an alarm on the rate of change of flow feeding the plant.
