## **FINDING THE SOURCE OF HYDROCARBONS IN DRINKING WATER – A CUSTOMER COMPLAINT**

**Steven Newham,** *Process & Water Quality Specialist,*

Goulburn Valley Water

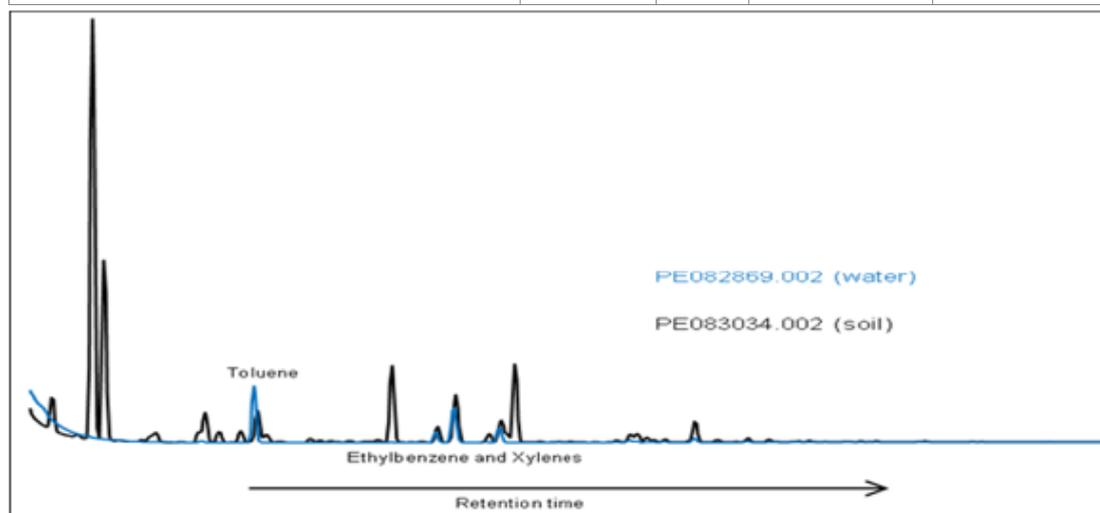
**Figure 2:** *GC-FID chromatogram comparison for Water and Soil samples*

The chromatogram comparison, Figure 2, between the water and soil samples had close matches for Toluene, Ethyl benzene and Xylene, confirming the contaminated soil was the source of the drinking water contamination. A hydrocarbon fingerprint of the samples was unable to identify a unique match, rather it appeared to be cocktail of contaminants; *similar to mineral turpentine, degreaser, high octane petrol, WD40, light distillates & possibly two stroke engine oil* which indicate that the area could have been a dumping ground for petroleum products for quite some time.

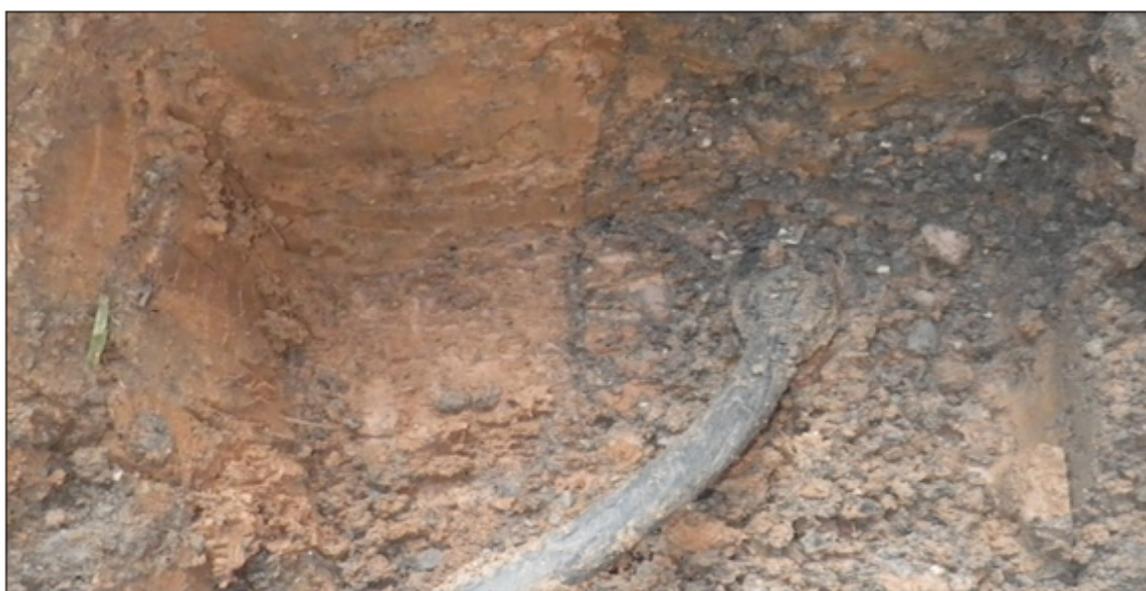
**Figure 4:**     *Original Repair - Rural Grade Poly Pipe*

The site was attended once again and this time the toilet cistern was dye marked with Fluorescein confirming no siphoning. It was found that the customers sink still had a strong solvent smell and it was during this inspection that a small amount of oil was noticed between the buildings which was in line with the internal plumbing and almost directly above the old repair identified by the tenant.

The issuing of the formal letter advising both the owner and the tenant that the water contamination originated within the property and that the water was not suitable for consumption eventually led to the owner relocating the internal pipework to by-pass the contaminated soil. After the owner relocated the pipe, the area of contamination was excavated to identify the pipe material and it was found to be *Rural Grade Poly Pipe*. This is significant as it confirms the contamination is via permeation of plastic piping.
