UV LAMP BREAKAGE AT MELBOURNE WATER DISINFECTION PLANT

Mary Daaboul, *Water Quality Engineer,*
Brendon Murphy, *Water Supply Lead Operator,*

Melbourne Water

*78th Annual WIOA Victorian Water Industry Operations
Conference and Exhibition
Bendigo Exhibition Centre
1 to 3 September, 2015*

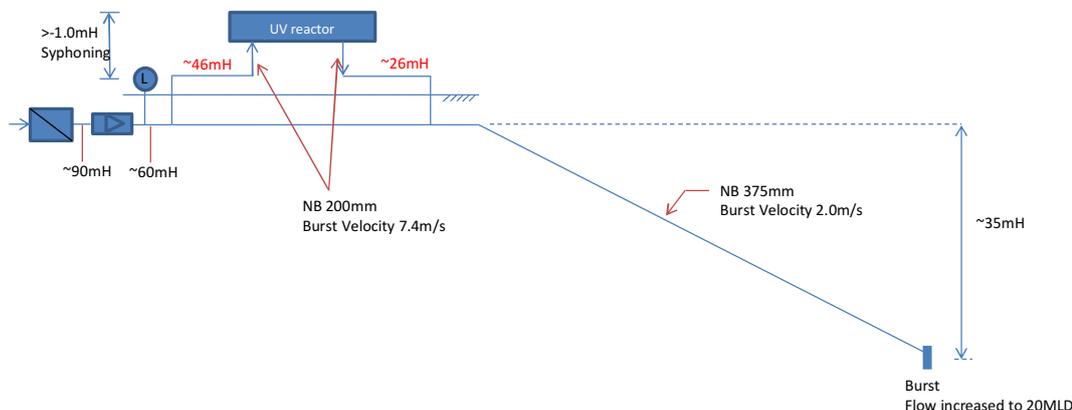
Dewatering of the UV reactor has been known to cause negative pressures which can lead to breaking of the UV quartz sleeves. The plant's UV system elevation is such that the reactor's inlet and outlet streams are both lower than the UV reactor (see Figure 1). This is not a favourable arrangement as it makes the reactor susceptible to dewatering. A reduced dewatering option would be to either have both reactor inlet and outlet above the reactor, or the inlet lower and outlet above the reactor.

Figure 1: *The Current UV System Elevation at this Treatment Plant: To the left is the raw water entering the treatment plant from the main conduit, and to the right is the treated water going into water supply. The diagram shows the elevation from the main burst location.*
