FAILURE OF UF MEMBRANES AT COWES CLASS A TREATMENT PLANT

Colin Bowker, *Senior Engineer - Projects,*

Westernport Water

*78th Annual WIOA Victorian Water Industry Operations
Conference and Exhibition
Bendigo Exhibition Centre
1 to 3 September, 2015*

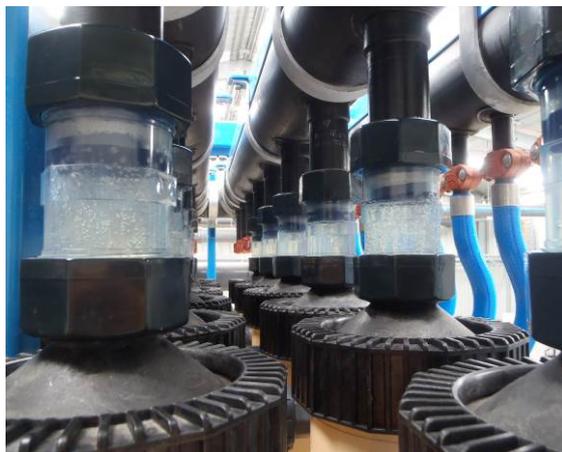
When the Cowes RWTP is operating, a daily integrity test is performed on the UF membranes, which entails pressurising the membrane modules with compressed air, monitoring pressure loss and visually inspecting the transparent tops of the membranes for evidence of air bubbles as depicted in Photograph 1. UF membranes have properties that allow water but not air to pass through the pores in the membrane wall. Evidence of air bubbles, therefore indicates that there is a hole in the membrane wall larger than the pore size of the membrane. Each pore is smaller than the smallest expected virus, therefore evidence of air bubbles is a warning that viruses may be able to pass through the filtration process.

Figure 1: *Integrity Testing*

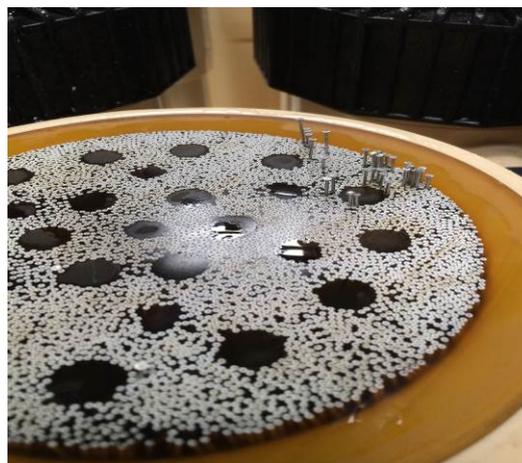
If air is observed during an integrity test, the top of the membrane module is removed and the suspect membrane fibre is located visually and pinned, which entails pressing a small nail into the fibre, as shown in Photograph 2. This fibre is then permanently isolated from the filtration process. There are approximately 6000 fibres per module and the Cowes RWTP has 24 modules.

In 2014 however, 10-30 pins were required each day. Aside from the labour involved in finding and pinning 30 failed fibres across 24 modules, this rate of failure indicated that there was a serious problem with the membranes with respect to water quality and public health.

Figure 2: *Membrane Pinning*

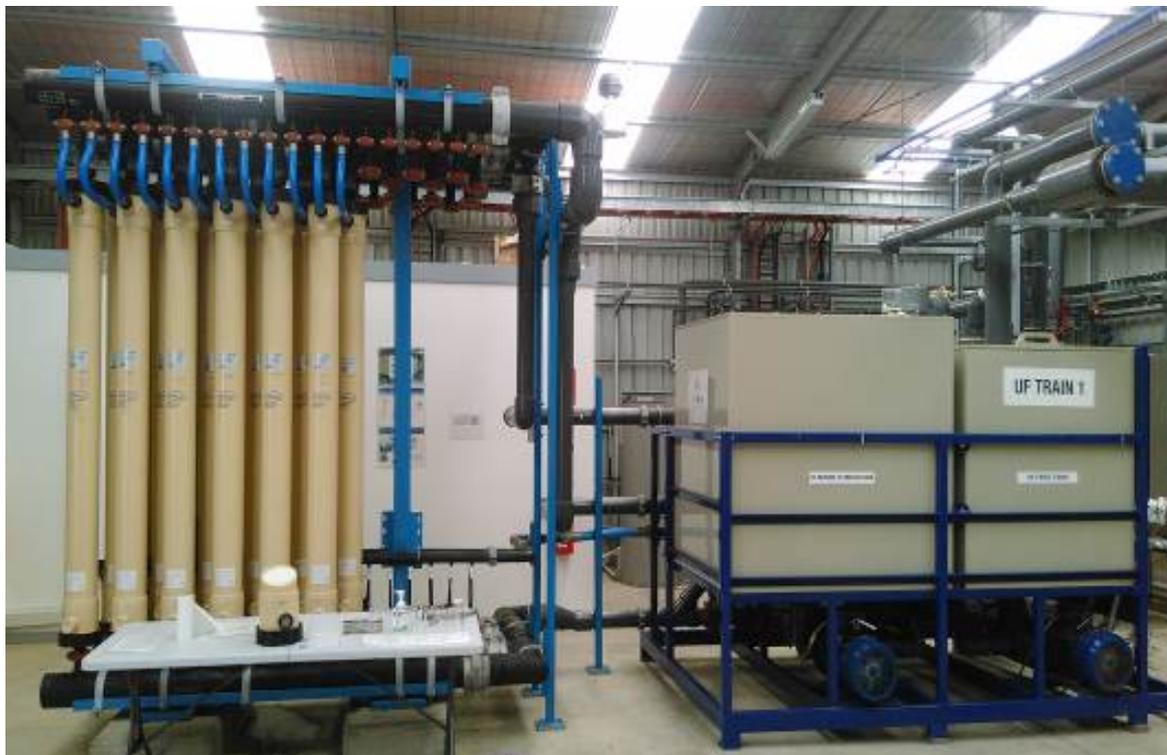
After recirculation through the membranes, the pump was turned OFF and it was discovered that the membranes did not remain flooded. Over an hour or so, the water level in the membranes fell, leaving the upper portion of the membranes dry. The reason for this was either a leaking check valve or a leaking drain valve. Closer inspection revealed that the O Ring seal on the check valve after the recirculation pump was missing, suspected to have been torn away by the pumped flow.

Figure 3 shows an elevation of the UF membrane modules with respect to the UF feed water tank. Due to the leaking check valve, the water in the vertical modules (in the left of the photo) drained down to the level of the water in the feed tank (in the right of the photo). This backflow continued for an hour or so, leaving the upper 1/3 of the membrane modules without water for the following 23 hours. Membranes can be damaged if they are allowed to dry out, and there is still some debate whether 23 hours is long enough for the membrane fibres to dry out fully enough to cause damage.

Figure 3: *Side View of Membrane Modules and Feed Water Tank*

The consequences of drying out of membrane fibres was not a consideration, therefore a basic check valve arrangement was deemed to be adequate. A testable check valve arrangement will soon be installed between the pump and the membrane modules enabling a routine confirmation that the check valve is sealing fully.

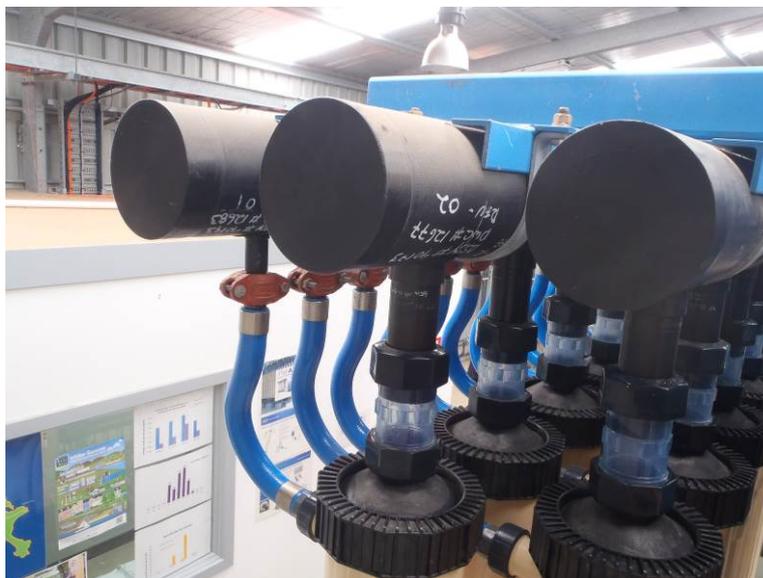
Figure 4: *Upper Membrane Manifold where Level Switch will be Located*

A point level switch is to be installed on the upper manifold of the membrane pipework as shown in Figure 4. This will alert if water is not detected above the membrane modules.
