RESPONDING TO INCIDENTS IS NOT ALWAYS ABOUT INCIDENT RESPONSE

Allan Hooper, *Environment and Wastewater Coordinator,*

North East Water

*79th Annual WIOA Victorian Water Industry Operations
Conference and Exhibition
Bendigo Exhibition Centre
31 August to 1 September, 2016*

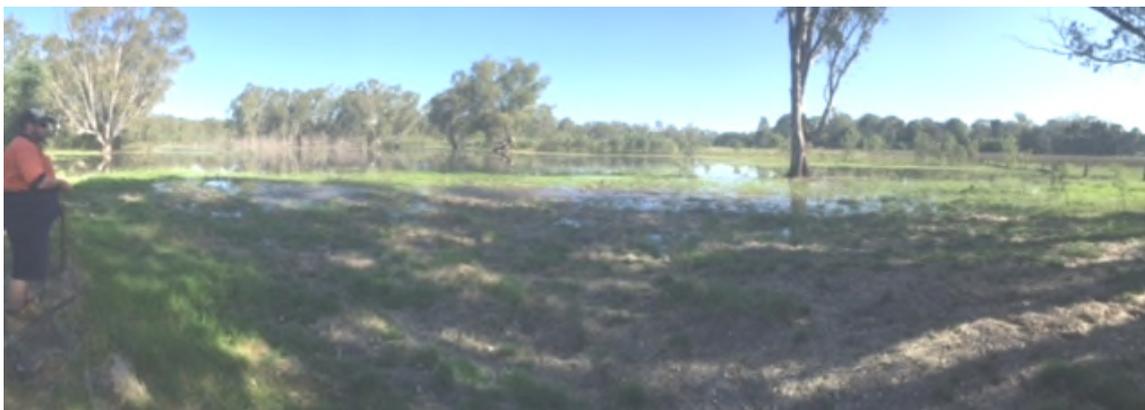
NEW was notified of a potential sewer spill near Wangaratta at 3:30pm. By 3:45pm the local Operations staff confirmed a sewer spill occurring in the flood plains of the Ovens River near Wangaratta and by 4:15pm an IMT was set up and starting to coordinate the response. It was clear early on that this wasn't a typical spill and the initial response was trying to understand the issue and ensuring services.

Figure 1: *First pictures of the incident*

The Liaison Officer coordinated the investigation to confirm if the spill was contained. This determined that the spill occurred within a wetland located on both crown land and private property, was contained and was not discharging to the nearby creek.

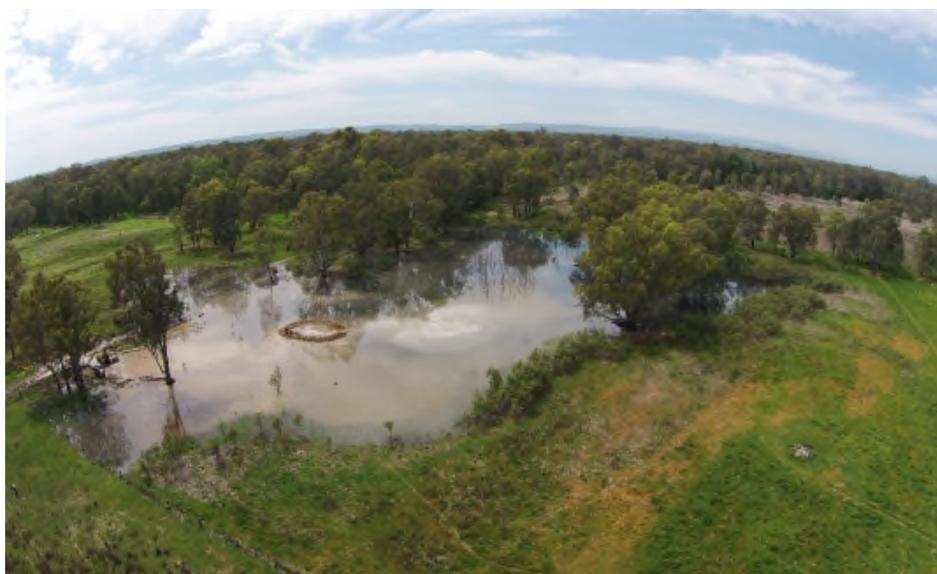
Figure 2: *Aerial photo of spill site on 20 October 2015*

Figure 2 highlights the impact of the spill including the repair works being coordinated in the coffer dam in the centre of the spill. This aerial footage was able to tell a powerful story for the IMT and more broadly used to communicate the incident to the Board of North East Water. The estimated spill volume was 5.5 ML which is significant from NEW's perspective.

A recovery and remediation plan was developed both onsite and within the IMT to ensure the site was returned to a state that meets landowner, stakeholders and North East Water's satisfaction. The primary objective was how to deal with the volume of wastewater. It was agreed that pumping of wastewater from the spill site back into the sewer reticulation was the achievable and appropriate action in the recovery of the site. The pumping commenced after the sewer rising main had been repaired.

This pumping occurred for two weeks and additional pumping was conducted after several rainfall events. This ensured that as much of the spill was removed from site as practicable.
