# INCIDENT AT YERING GORGE PUMPING STATION. HOW WHAT YOU DON'T KNOW CAN HURT YOU

**John deBoer**, *Operations Specialist, Water Supply Operations,*

*79<sup>th</sup> Annual WIOA Victorian Water Industry Operations  
Conference and Exhibition  
Bendigo Exhibition Centre  
31 August to 1 September, 2016*

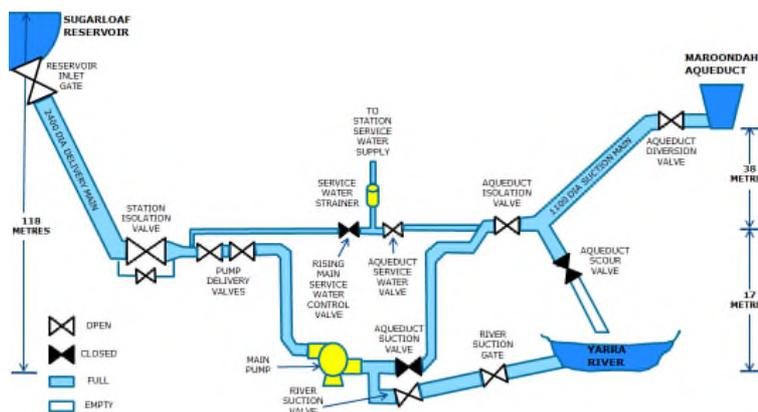
The station draws water from the aqueduct suction main to supply critical station services such as motor cooling, bearing cooling and seal ring flushing systems. Whenever the aqueduct is taken out of service, the station services supply is re-valved to be supplied from the pump delivery main via a pressure reducing, service water control valve (see Figure 1).

**Figure 1:** *Pump Station normal configuration (River Duty)*

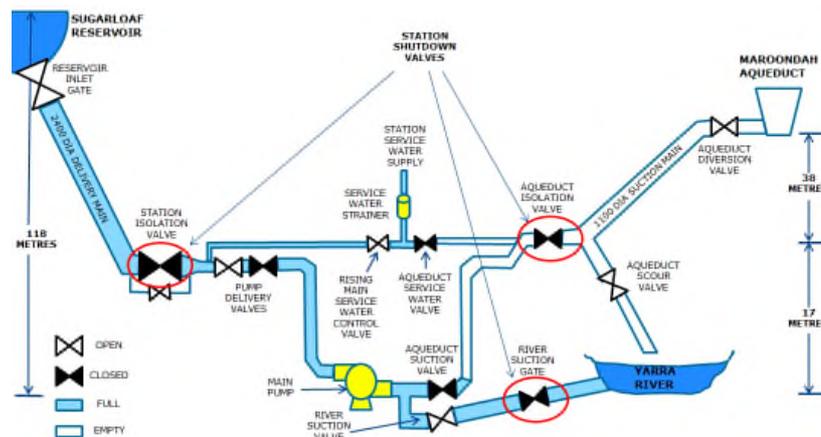
In the afternoon of May 19, operators shutdown the pump station as river flows had once again declined to below minimum environmental levels. During the pump stopping sequence a minor “*reverse flow*” was detected in the rising main. This alarm initiated a “*Station Shutdown*” sequence which automatically closed the Station Isolation Valve, River Suction Gate and Aqueduct Isolation Valve. The reverse flow alarm during a pump stop sequence was not uncommon and was known to occur periodically.

As the pumping station was no longer required to operate it was left offline in “Shutdown” mode with the major isolation valves remaining closed (see Figure 2).

**Figure 2:** Station in “Emergency Shutdown” Mode with Aqueduct suction main dewatered

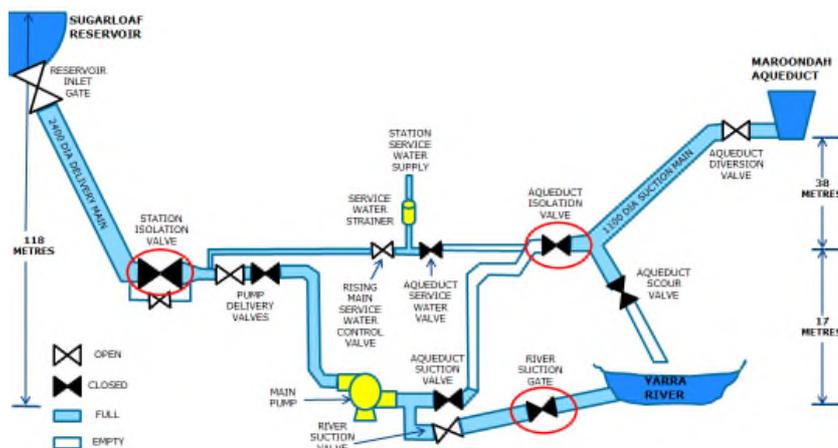
With the Aqueduct maintenance works now complete, the aqueduct is slowly recharged but only filled as far as the, now closed, aqueduct isolation valve leaving approximately 17 meters of empty 1100mm diameter suction main beneath it (see Figure 3).

**Figure 3:** Aqueduct main recharged

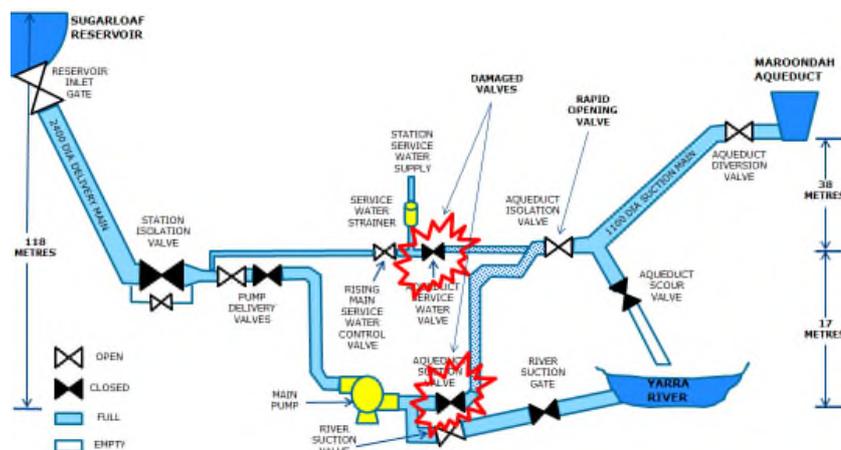
The Operator attends site to prepare the station to resume pumping from the, now recharged, aqueduct supply. He initiates a “*Station Reset*” command. This control function returns the Aqueduct Isolation Valve to its pre-shutdown condition, immediately opening the valve. The opening travel time of the 1100mm diameter butterfly valve is less than three seconds and the rapid opening of this valve allowed the 40 tonnes of stored water above the valve to drop rapidly into the empty void below. The resulting pressure shock split the housing of the 250mm service water valve causing water to flood from the ground floor into the station below showering the high voltage pump drives with water and causing an electrical fault which turned off all the station lighting.

The shock also hits the two closed, 1100mm diameter, aqueduct pump suction valves tearing the butterfly's from their cast housings and punching a 300mm hole in the side of one of the valves (Figure 4 & 5). Water flowing from these valves knocked down a blockwork wall and flooded into the pump well at a much greater rate than the sump pumps could manage.

**Figure 4:** Location of damaged valves

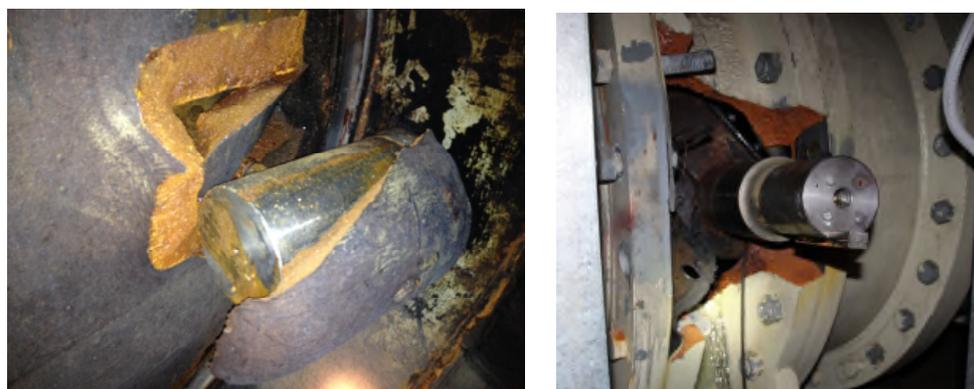
**Figure 5:** Damaged butterfly valves

Whilst there were many key factors associated with this incident the root cause was ultimately determined as to be: *“The hazard of the aqueduct suction pipe becoming dewatered was not identified in the design and subsequent operation of the pump station.”*

Orders were immediately placed for replacement valves. Meanwhile detailed isolation risk assessments and implementation plans were developed to allow the safe removal of the damaged valves and installation of blank flanges to enable the station to harvest from the Yarra River until the new valves arrived. A second shutdown was then conducted to remove the blank flanges and install the new valves returning the station to its full operating capacity. These restoration works were conducted over a period of eight months at a cost in excess of \$1.2 million.

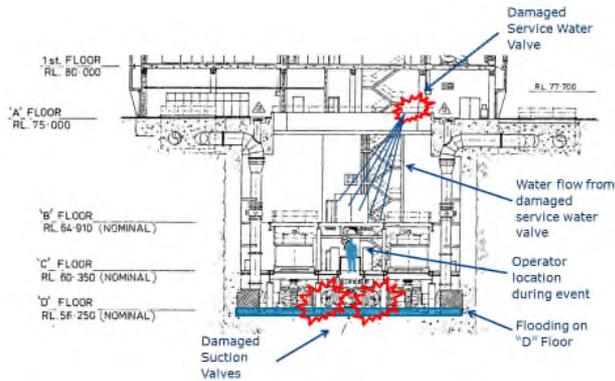
The Operator Interface Unit used for station control is situated on “C” floor at the bottom of the pump well, one level above the main pumps. With water flooding over high voltage equipment from above, the pump well flooding from below and the station in total darkness, the operator was trapped in a precarious position. To add to the operator’s predicament, an emergency escape ladder adjacent to the operator interface had been recently deemed non-compliant and was barricaded pending further investigation. This left the operator with no choice but to remain in this location (Figure 6) until help arrived to safely isolate the electrical supply.

**Figure 6:** *Operator location during the incident*

- Proactively reviewing local operations that may expose people to “line of fire” hazards in the event of an asset/technical integrity failure, including evaluating egress from these locations in the event of an emergency; and
