# THE CURLY CASE OF THE CORRODING CHLORINE PIGTAILS

**Sylvia Campbell**, *Process Engineer-Water Supply Northern  
Operations,*

Melbourne Water

*79<sup>th</sup> Annual WIOA Victorian Water Industry Operations  
Conference and Exhibition  
Bendigo Exhibition Centre  
31 August to 1 September, 2016*

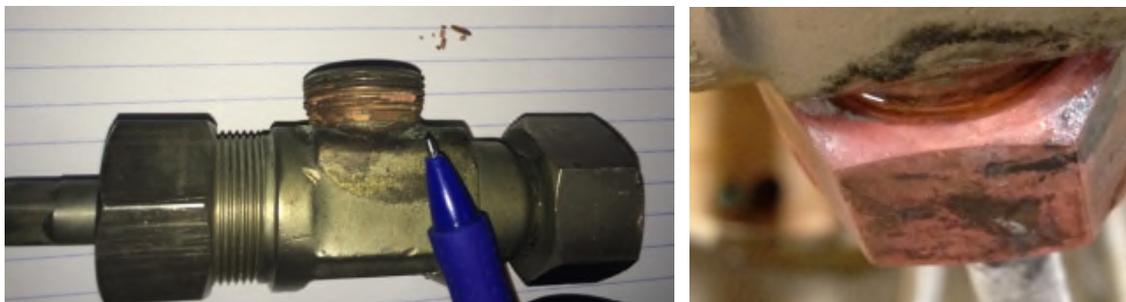
An incident response team was formed with the objectives to maintain safety of all Melbourne Water staff, contractors and the general public, to maintain supply of safe drinking water and recycled water, and to identify the root cause. An inspection at Greenvale found some valves with threads partly eaten away but external plating was intact. Missing or brittle threads presented a risk of loss of containment of chlorine. The incident response team arranged for an urgent inspection of valves at all chlorine drum sites.

**Figure 2:** *Brittle threads on valve (left), moisture in pigtail nut at Greenvale (right)*

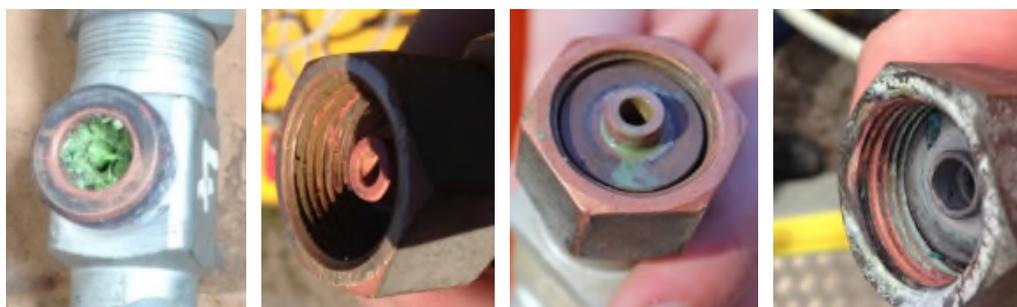
Inspection of disconnected valves and pigtails at WTP, Greenvale, Cardinia, Silvan and Tarago treatment plants found a range of internal and external corrosion symptoms including plating discolouration or removal, coloured corrosion products, moisture, brittle or removed threads and pink colouring indicating dezincification of valve surfaces and even internal threads and brass packing components in some cases.

**Figure 3:** *Observed corrosion symptoms (L to R): 1 green precipitate, 2 pink dezincified surfaces, 3 green moisture, 4 white/brown corrosion/plating removal*

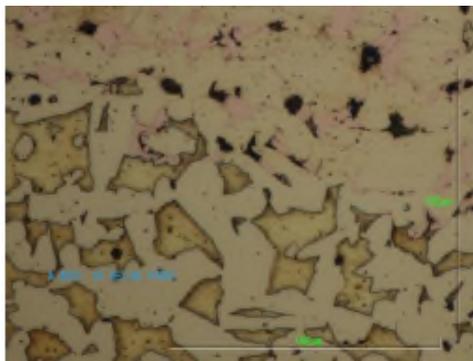
Brass can be a single phase structure (alpha phase) or two phase/duplex structure (alpha-beta phase). Dezincification is more likely in the latter. Laboratory analysis showed that the brass had an alpha-beta microstructure and hence was susceptible to dezincification.

**Figure 4:** *Microstructure analysis of a Greenvale valve showing alpha-beta structure: beta phase (darker patches) in alpha phase (lighter coloured background)*

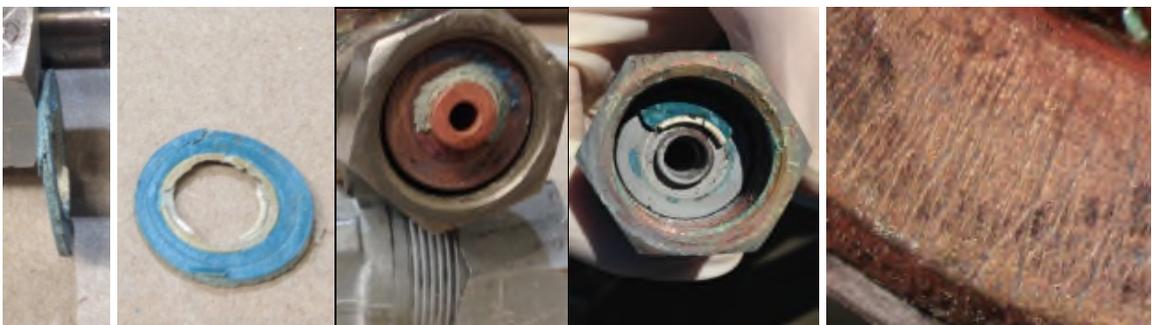
Discussions with the valve supplier suggested that discolouration of pigtail nuts indicated a very low level chlorine leak below detection limits indicating that these connections had poor seals. Gaskets are used to seal the pigtail/auxiliary connection and the auxiliary/drum valve connection. Gaskets used were 1.5mm thick Tesnit (aramide fibre). Operators reported that the gaskets currently used had a larger inner diameter than older gaskets from years ago and the new ones were more prone to slip when installed. Inspection of valves found that some gaskets were worn, torn, unevenly compressed or in some cases broken into pieces when the pigtail nut was disconnected which suggested overtightening. The gaskets commonly stuck to the sealing surfaces and had to be removed with scrapers or wire brushes to clean the valve sealing face before applying a new gasket. Optical assessment of valve sealing faces showed track marks from wire brushing which may have allowed chlorine to pass around the gasket in older valves. There was no common tightening method or understanding of how tight a connection was needed to achieve the correct compression of the gasket to create a seal. Torque wrenches had been trialled unsuccessfully in the past and were not used for connections.

**Figure 3:** 1. Unevenly compressed gasket, 2. Torn gasket, 3. Gasket stuck to sealing face, 4. Broken gasket, 5. Scratches on valve sealing face

Affected equipment will be engineered out or substituted. Valves will be replaced with bronze valves, airtight caps and different flexible connections where feasible. PTFE gaskets with a smaller inner diameter are currently being trialled. The following administrative controls will also be implemented or updated to mitigate the likelihood of future corrosion. A single standard operating procedure will be developed which incorporates drum changeovers, nitrogen purging, pressure testing and leak testing, and tightening of connections to achieve a seal. Guidance for valve condition assessments in maintenance instructions and improved asset information records will also assist with data collection to monitor corrosion trends. These actions were adopted based on the incident analysis report from July 2016 and will be implemented throughout the remainder of 2016. While the corrosion issues have not been resolved at the time of writing, it is anticipated that the implementation of these actions will remove the incidence of valve and pigtail corrosion.
