# a PASS

Problem Accepted - Solution Supplied

An award providing opportunity for water industry operational staff to share their in the field innovations & fixes to problems so that others in the water industry can benefit.

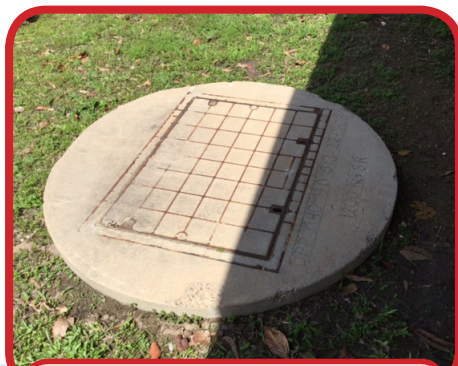
Example of a concrete gatic lid, typically used by Power and Water Corporation

Gatic lids that have been in service for several years without being opened or are in a high traffic area, are often stuck so tightly that they cannot be opened using the standard method.

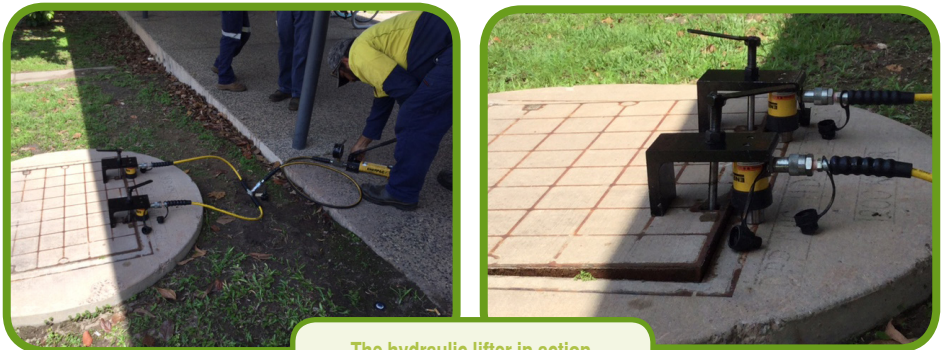
The solution was to fit two hydraulic cylinders to a hand cylinder pump via a three way splitter and isolating valve. Angle brackets and Tee bolts were fabricated and fitted to the cylinders. All this allows for the lids to be hydraulically lifted with the ability to pump on one lifting point or both at once, this is especially helpful if the lid is not lifting evenly.

The hydraulic lifter in action

The photo's below do not show the isolation valves, as they were fitted after the construction of the prototype.

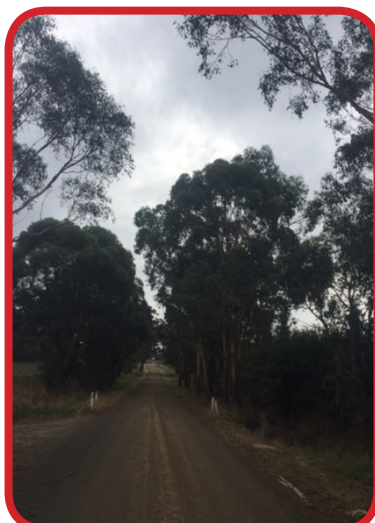
Remote water main with one customer  
at end of 7-8km 100mm main

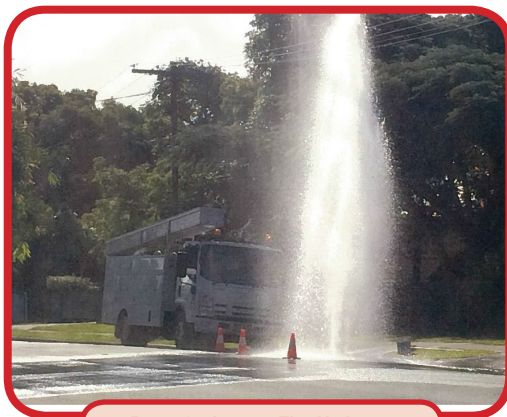
**Burst Spring-top Fire Hydrant.  
Example of an incident causing  
water outages**

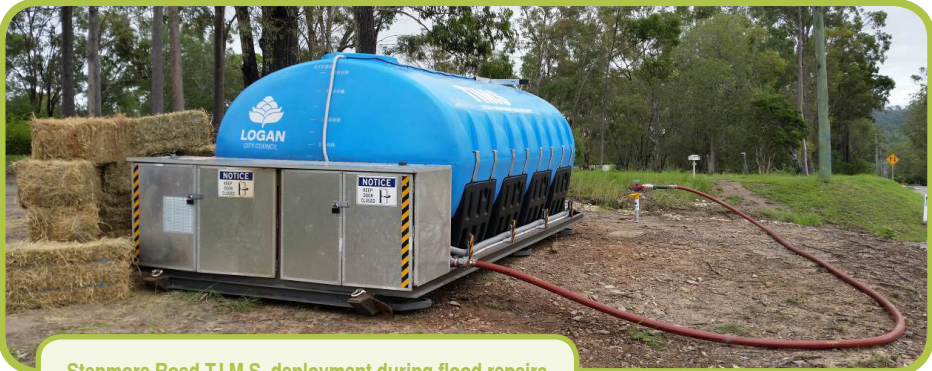
The T.I.M.S. unit is a self-contained and supported temporary water supply that can be hooked up to existing isolated infrastructure via a hydrant standpipe connected to an existing spring top fire hydrant within the isolated network. The unit consists of a 13,000 litre poly water tank which is connected to a 2 stage Variable Speed Drive (VSD) pump which is powered by a 9kva diesel electrical generator. The entire unit is currently mounted on a steel cradle with skids.

Stanmore Road T.I.M.S. deployment during flood repairs

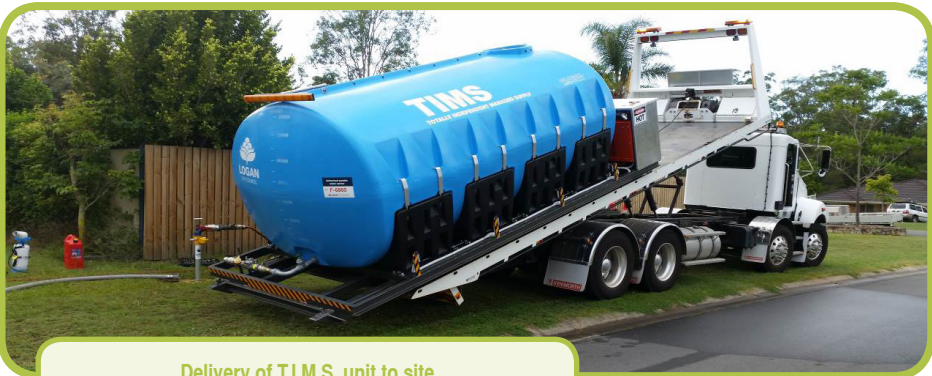
Delivery of T.I.M.S. unit to site

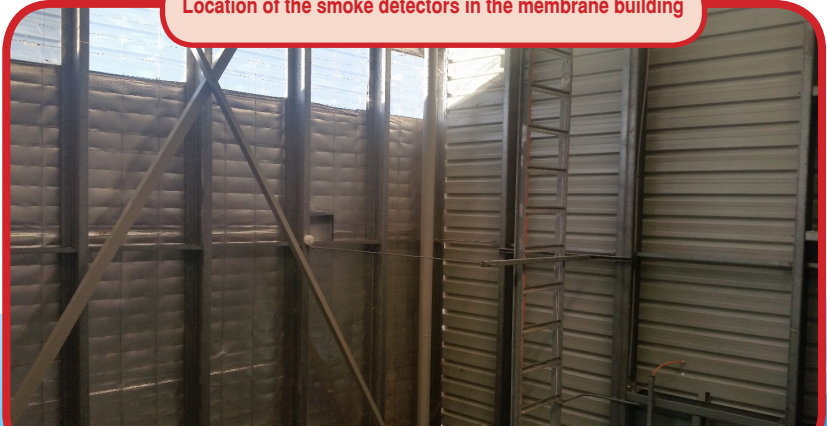
The problem was solved by one of our Operators, Andrew Naughton, who also happens to be an electrician. He devised a plan to install inspection hatches on the building roof so that the maintenance staff could reach down, unclip the detector and bring it onto the roof for maintenance or replacement.

Location of the smoke detectors in the membrane building

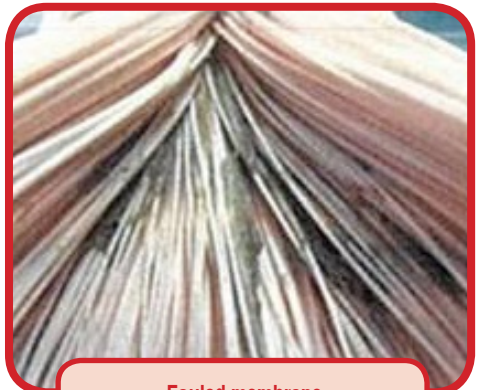
Fouled membrane

A full scale trial was undertaken from December 2016 to mid-March 2017 (during the high reuse demand period) on the ultrafiltration membranes at the GAP. A test skid was operated with continuous dosing of ferric chloride, at a concentration of 1-2 ppm as pure  $\text{FeCl}_3$ , prior to the UF membranes in order to form pin flocs that provide a heterogeneous coating on the membranes, to protect them from fouling matter. For comparison, a reference skid was operated according to usual procedures and manufacturer recommendations, without ferric chloride dosing.

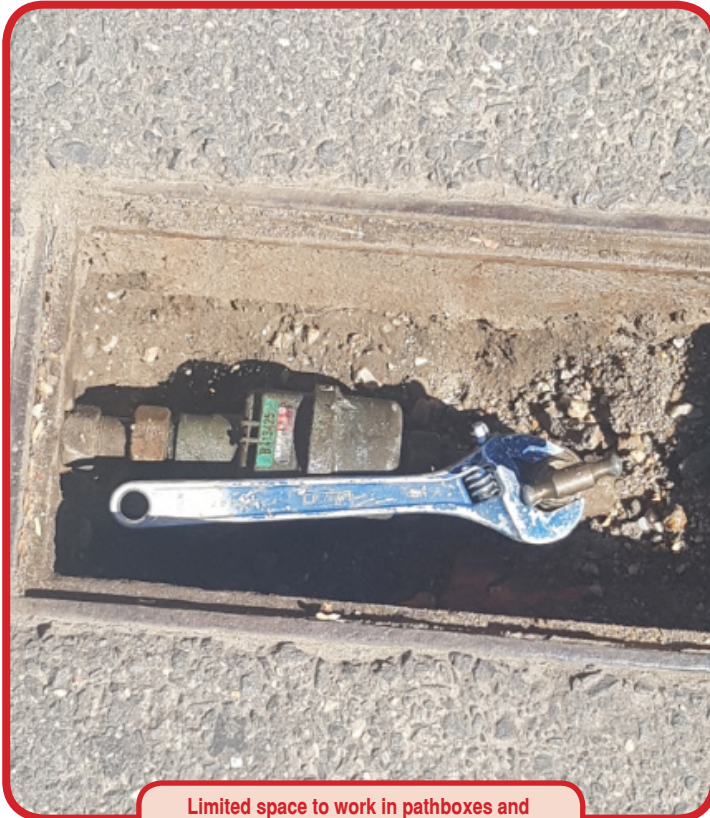
Limited space to work in pathboxes and potential cause of injury.

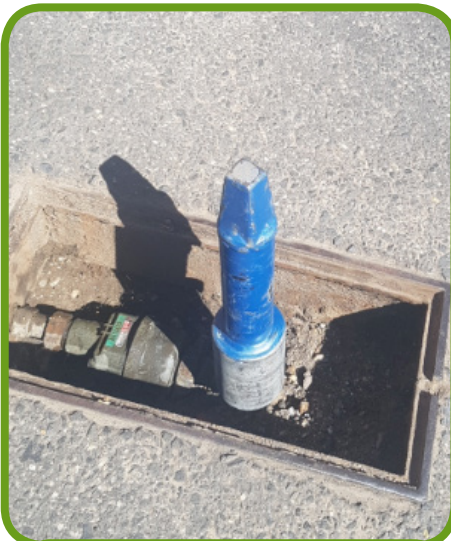
A compact tool that fits tightly over stop taps was created which utilises valve keys already found on Central Highlands Water maintenance vehicles.

The stoptap removal key fitted onto the stoptap.

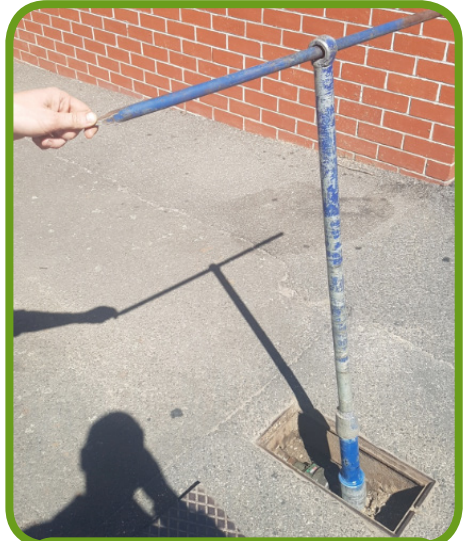
Valve key on top of the stoptap removal key

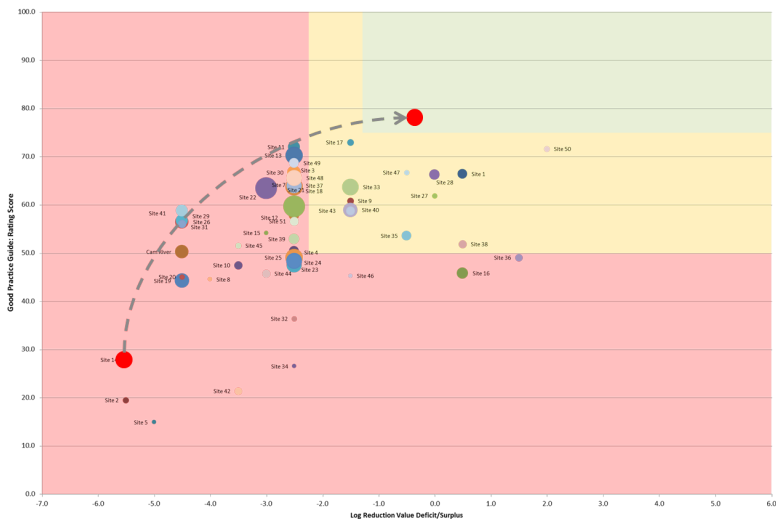
Graphic showing assessed treatment plants, the object is to move plants from the red section to the yellow and ultimately the green section.

The graphical example is showing that, with a combination of jar testing, sampling and instrument calibrations (vertical axis), together with optimisation activities (horizontal axis) that includes filter and clarifier performance activities and the installation of UV treatment, we can move a treatment plant from a very poor risk of water quality issues to a much safer one.

The solution is a visual representation of water quality risk on a chart. The closer to the bottom left of the chart, the more risk the greater chance of a water quality breach. The vertical axis represents the likelihood of risk (operational deficiencies) and the horizontal axis represents the impact of risk (the treatment deficiencies).

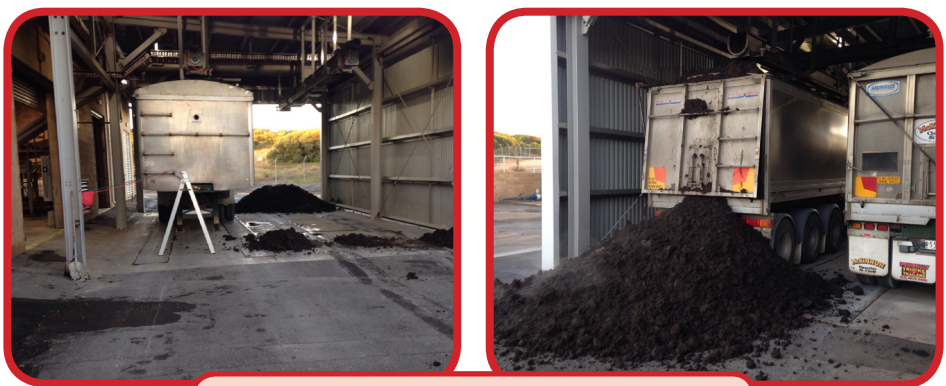
Examples of the OHS and spillage problems at the IDEA sewage treatment plant at Warrnambool

With many variables (MLSS, solids concentration, solids dryness, poly batching, wash water, etc) it was challenging to get a consistent load of biosolids into the trailer bins. On occasion it led to overfilling the trailers by several tonnes. This meant either unsafe loads being transported, overspill, or having to drop biosolids on the ground. There were significant costs in down time and contractor/equipment hire, and an increased risk to OHS and the environment.

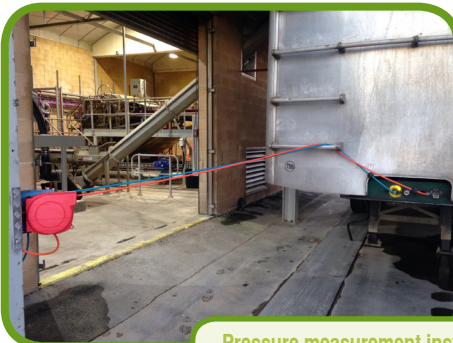
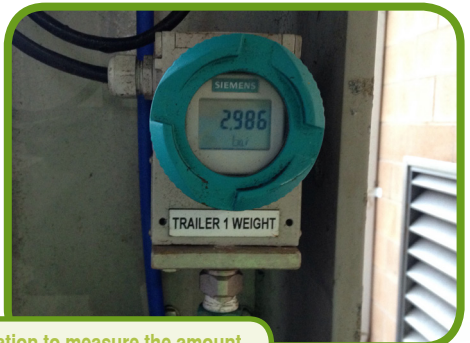
When connecting for the removal of the biosolids, the current contractor would typically hook up the truck's air supply for the trailer's airbag. The trailer had a pressure gauge on the side. We started checking the pressure gauge against the weigh docket and found that we could pretty closely guess when the bin was full, purely based on air pressure.

Pressure measurement installation to measure the amount of sludge loaded into trailers.

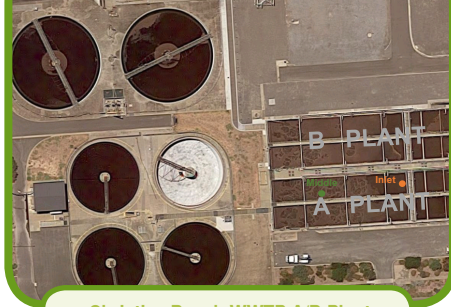
Christies Beach WWTP A/B Plant  
and Ammonia analyser location

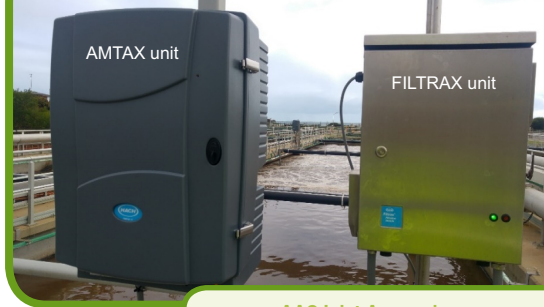
AAC Inlet Ammonia  
Analyser Installation
