CENTRAL HIGHLANDS MAINS CLEANING

70th Annual Water Industry Engineers and Operators' Conference
Bendigo Exhibition Centre
4 to 6 September, 2007

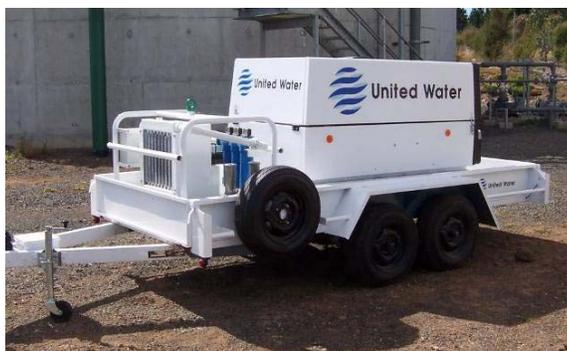
Figure 3: Trailer Mounted Air Scouring Unit

The major equipment used for air scouring is a compressor unit and air filters, filter bags, lay flat hose and standpipes. Figure 3 shows the trailer mounted air scouring unit Figure 4 shows the filter bag in use.

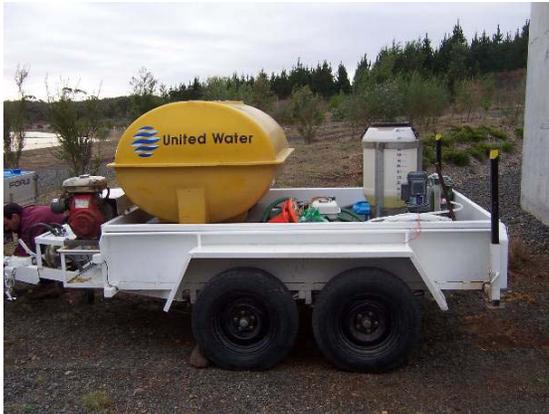
Figure 5: *Disinfection Trailer*

Following each air scouring run, the main requires disinfection. This is achieved using a 12.5% sodium hypochlorite solution injected into the main and left for 3 hours. A minimum of 10 mg/L free chlorine is to be measured at the end of 3 hours. Once the required dose is achieved the highly chlorinated water needs to be removed from the main. This water needs to be dechlorinated prior to discharge to the environment which is achieved using a sodium thiosulfate solution injected into the discharge stream. An alternative method of dechlorination is to pass the discharge water through a diffuser containing ascorbic acid tablets, however, care must be taken with this method as it is not as affective at reducing chlorine at very high concentrations and the level of chlorine in the discharge must be checked. Figure 5 shows the mains dosing trailer, Figure 6 the temporary supply trailer and Figures 7 and 8 the two dechlorinating methods.

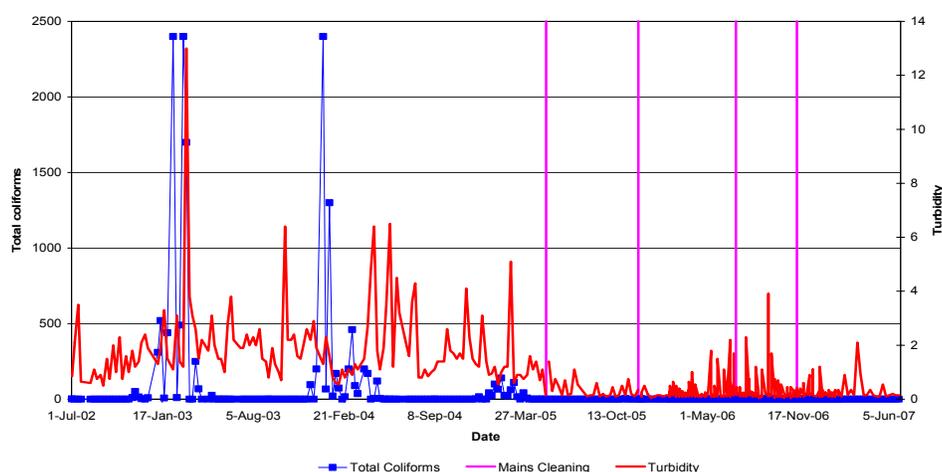
Figure 9: *Blackwood Network Total Coliforms and Turbidity*

Figure 9 shows the network turbidity and total coliforms before and after the treatment plant commissioning and mains cleaning program. It can be seen that the network turbidity has decreased since the introduction of the treatment plant and the mains cleaning program.

Water treatment together with mains cleaning and UV disinfection has been successful in maintaining adequate bacteriological water quality and the boil water notice was lifted in June 2006. Customers are inconvenienced by water outages for 2 nights and 2 days per year whilst mains cleaning is undertaken. Treated water is discharged to stormwater during mains cleaning and disinfection processes. It is important to remember that good maintenance practices, ie burst main repairs, are important to maintain a supply free from bacteriological contamination in a water network that has no disinfectant residual.

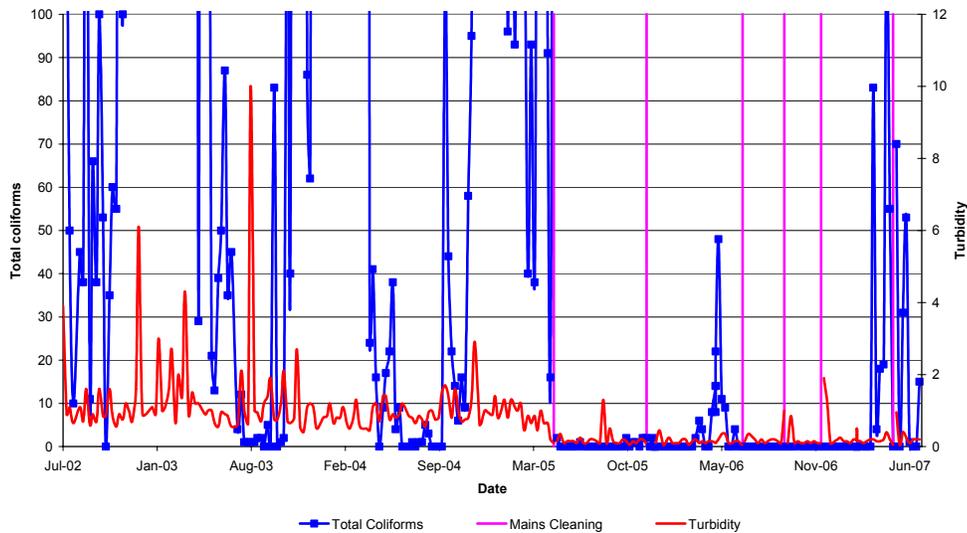
Figure 10: *Beaufort Network Coliforms & Turbidity*

Figure 10 shows the network turbidity and total coliforms detected from July 2002 to June 2007. It can be seen that the turbidity has improved since the treatment plant came on line in 2005. However total coliforms have been detected in the network between May 2005 and June 2006 which indicates that the mains disinfection trial had not been successful in maintaining adequate bacteriological water quality in the network.

The trial was extended for a further 12 months at an increased frequency twice that of the original program. It can be seen that total coliforms still persist in the Beaufort network and the results of this trial are currently being evaluated by Central Highlands Water. The boil water notice remains in place and customers are inconvenienced by water outages for 2 nights and 4 days per year with the upgraded mains cleaning program. Treated water is discharged to stormwater during mains cleaning and disinfection processes however it can be recycled back to the reservoir at significant cost/kL by utilising tankers. It must be stated that this is very impractical if it is expected to capture all of the discharged water as tankers can not keep up with the cleaning process. Beaufort has an old water supply network, with a high failure rate, compared to Blackwood, it consists of various pipe types which have, for the majority of their life, transported untreated water, it is not unexpected to see the results obtained.
