IMMEDIATE & LONG TERM IMPACT OF BUSHFIRE ON STORAGE OPERATIONS

John Cameron, *Headworks Supervisor,*

Southern Rural Water

*2nd Annual WIOA NSW Water Industry Engineers & Operators
Conference*

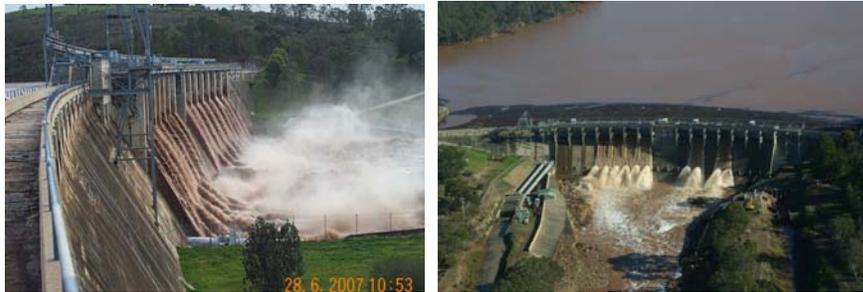
Figure 2: *Flood at Lake Glenmaggie June 2007*

The result was devastating with many dwellings and buildings being destroyed in both the upper and lower catchments. Much of the community infrastructure (roadways, bridges, parks etc) was destroyed and burnt debris and fallen trees arising from the bushfires entered the streams and were carried downstream to the storages.

Consequently Lake Glenmaggie and Cowwarr Weir created an artificial obstruction to the debris travelling downstream. SRW was obliged to employ mechanical means to remove the debris in order to ensure the dams would continue to function as designed. In addition the size, volume and intensity of the debris travelling downstream caused considerable damage to the structures. (Eg. Cowwarr Weir was later dewatered to remove debris from the pool to permit the floodgates to be fully closed without obstruction. The protective log boom was also destroyed by this event.)

Staff were also placed under duress and required to work long hours in order to guarantee that the integrity of both structures were not compromised. They were also confronted with public backlash about releases that impacted on downstream properties. The damage took many months and approximately \$3.5 mill. to repair. This severely tested SRW resources during the recovery period.
