A CREEPY SOLUTION TO SLUDGE THICKENING

Russell Mack

Russell Mack, *Water Treatment Technologist,*

*71st Annual Water Industry Engineers and Operators' Conference
Bendigo Exhibition Centre
2 to 4 September, 2008*

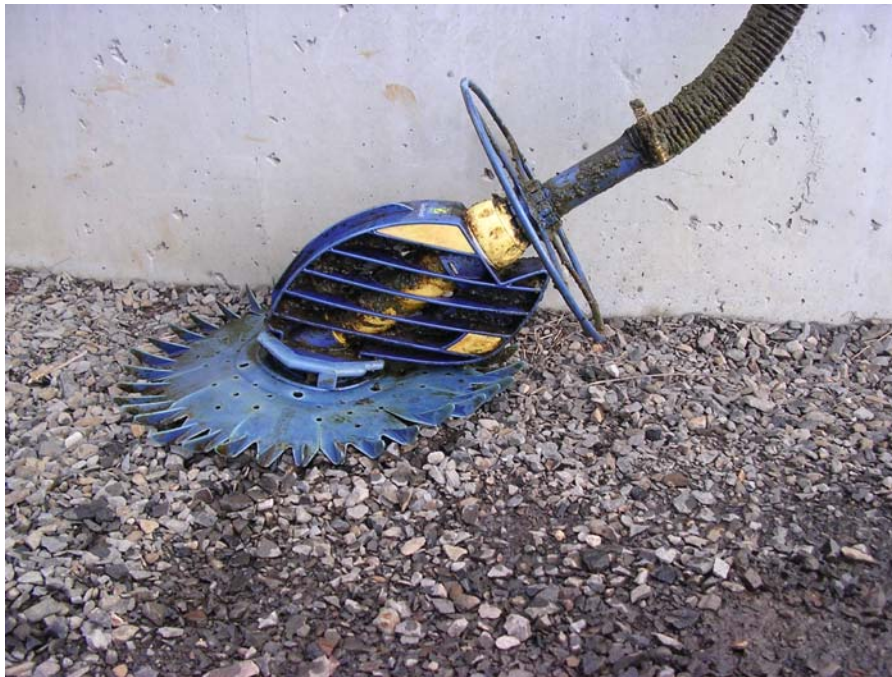
The idea of using a pool cleaner was raised and a “Genie Creepy Crawly” (Figure 2) was purchased from a local supplier. Adapters were made so the unit could be bolted onto the base of the submersible pumps that were originally in place. We found that that some of the existing pumps did not run at the required flow rate (40 l/min) to ensure correct operation.

Figure 2: *Genie Creepy Crawley*

Some trials were conducted to get the right length of hose to allow the cleaner to reach the whole area of the tank floor. The cleaner proved quite successful at removing the sludge but however there was another issue! The cleaner managed to find every obstacle in its way and get caught up. While this was frustrating it was no worse than original fixed pump suction. To overcome this we removed where possible those obstacles by shortening or removing pipes and smoothing off cast joints in the concrete tank. Where it was not possible to remove obstacles we installed deflectors, these were primarily plastic feed troughs bolted to the walls, bottom out. We ensured that the finish and quality any new sludge tanks that were aimed at reducing these issues.

Another problem for us has been the suction head blocking due to grass, leaves and other debris blowing into the primary sludge tanks. This requires the operating Technician to manually extract the cleaner and clear the blockage. This is an ongoing issue that we need to find an answer to.

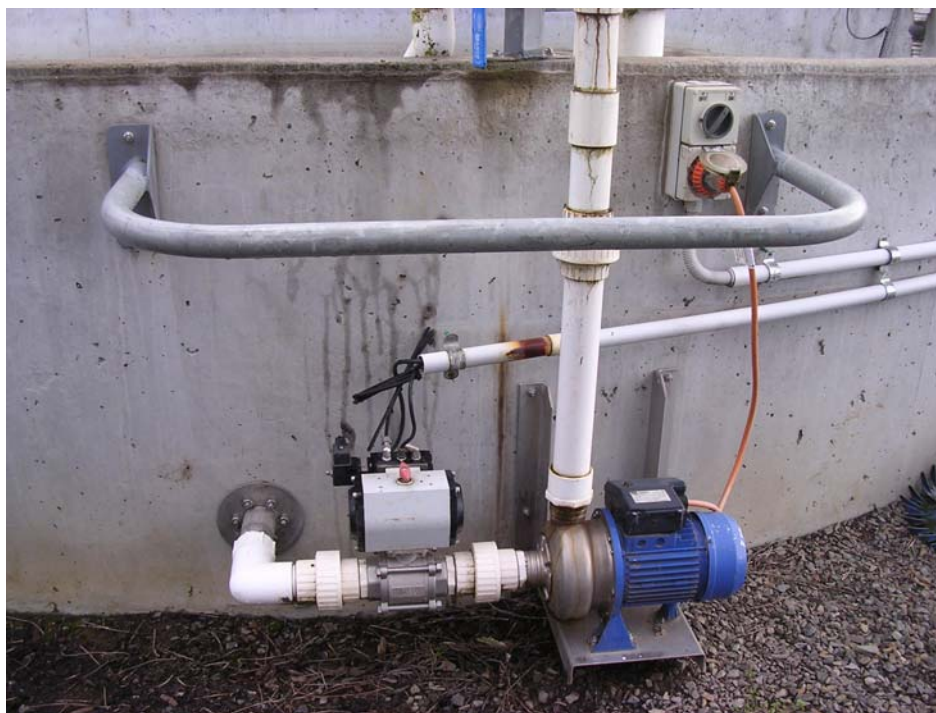
As we modified each plant we made improvements to the system we first installed. We tried different size pumps both submersible and externally mounted pumps (Figure 3) with solenoid valves to maintain prime. These pumps required modifications to suction pipe work which would allow easy access to the cleaner.

Figure 3: *External pump configuration*

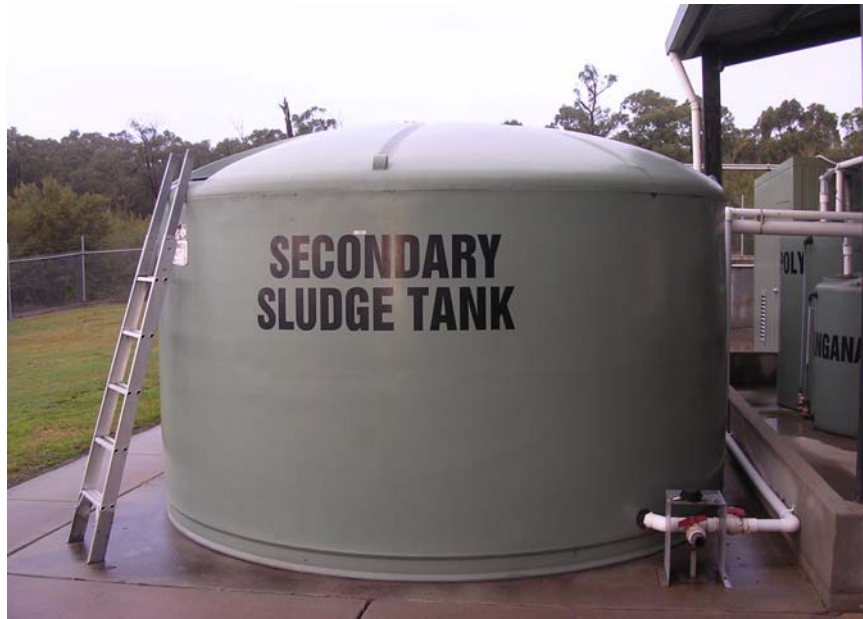
The provision of flat bottom 20kL plastic tanks as secondary sludge tanks for storage, created an issue when it was time to empty the tank, the contractor that we used had only centrifugal pumps to remove the sludge via a 50mm Cam-Lok fitting in the base of the tank. As the tank lowered it would rattle through the sludge and draw out all the water, this would then vortex and suck in air which would put an end to the pumping process.

This left us with 40% of the sludge left in the tank and us paying full price for half a load of sludge. We decided to use vacuum trucks to empty the sludge tanks we found this to be a more effective way to remove the sludge, but we were still left with quite a build up of sludge away from the outlet. Access into the tanks was very restricted, so trying to remove sludge from the top was hazardous and not cost effective.

Figure 4: *Secondary Sludge Tank*

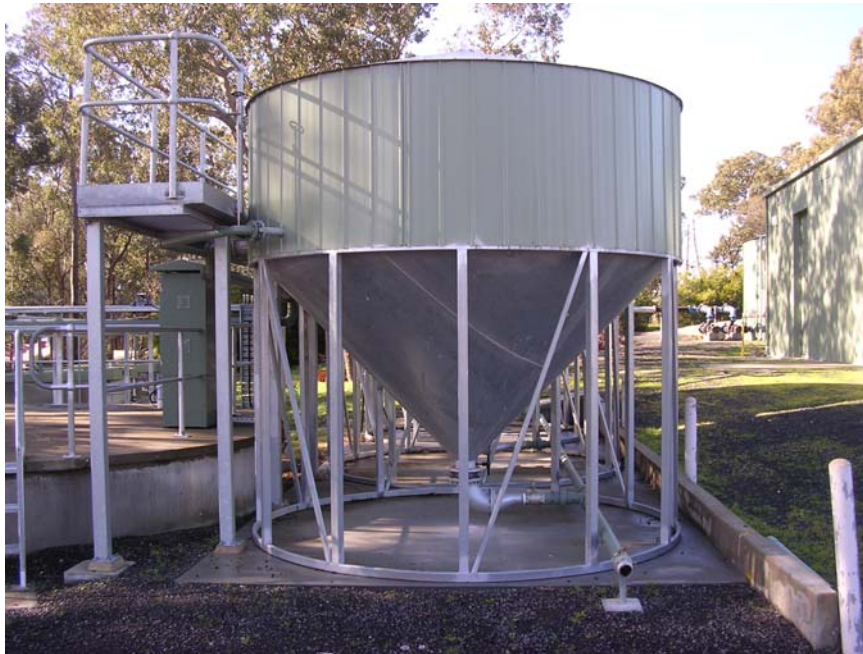
Figure 5: *Secondary Sludge Silo*

Again some thinking outside the box threw up the suggestion of using a silo as a secondary sludge tank was raised. We investigated the possibility of using an existing design of silo that was used for grain storage. We had to ensure that they would be water tight and had the capacity to hold 16 tonnes of sludge. We purchased an 18 kL silo with a steeply coned base (45°) and replaced the secondary sludge tank. The sludge from the primary sludge tank was pumped in from the bottom through the silo outlet and dosed with poly 1160 at this point. This provided some filtering through the sludge layer and with the help of gravity quicker settling of the sludge. The supernatant returns to the primary sludge tank via a fixed over flow. Visual inspections of the silo are carried out regularly to determine when emptying of the sludge is required.
