VERMIN PROOFING POTABLE WATER STORAGE TANKS

Jai Josey, *Supervisor*
Sunshine Coast Water

Peter Duzevich, *Project Manager*
Aqualift Potable Diving

34th Annual Qld Water Industry Operations Workshop
Indoor Sports Stadium, Caloundra
16 to 18 June, 2009

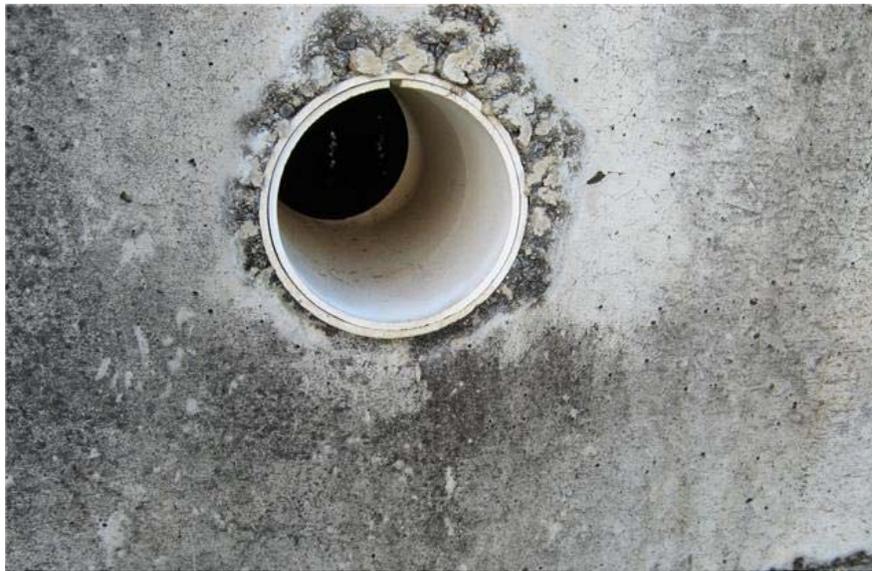
Figure 1: *An unsealed ventilation hole in the upper wall of a reservoir*

At the time of their construction, a fine wire mesh was used to cover the ventilation holes in many of the concrete reservoirs in South East Queensland. Due to the light weight nature of the material and its constant exposure to the elements, the mesh had completely deteriorated in the vast majority of cases. With this mesh no longer in place the reservoirs become exposed to potential water quality contamination issues from both wind born debris and more seriously, bird entry.

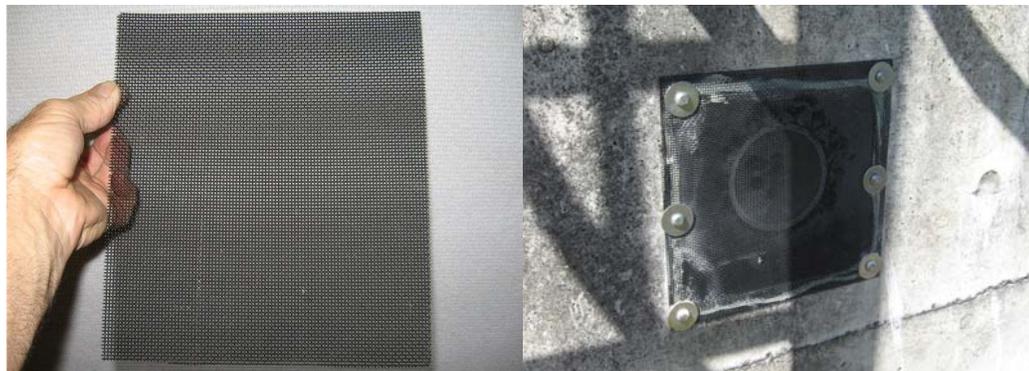
Stainless steel security mesh was selected for the replacement material, as it was rigid enough to cover the original vent holes with minimal fixing and it was also fine enough to keep out insects, birds and most wind born contaminants.

Figure 2: (a) A piece of Stainless Steel security mesh (b) the finished product.

Large stainless steel washers were used on each corner of the mesh panel (Figure 2b) and 8mm aluminium 'knock in' plugs with stainless steel drive pins were used to secure the panels.

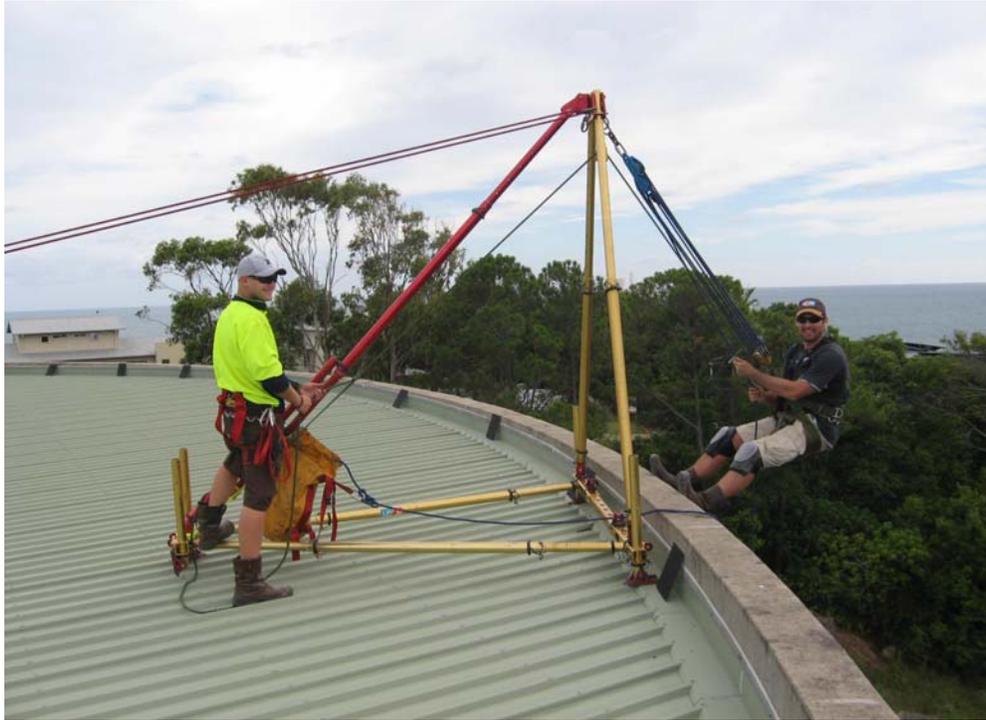
The operators used an SRT Oz Pod rescue frame (Figure 3) to lower themselves over the edge and carry out the drilling and pinning.

Figure 3: *Utilising the Oz Pod and advanced roping techniques to assess the upper walls of a reservoir*

This type of equipment is often used in cliff rescue scenarios and for high rise window cleaning, as it can be easily moved around when fully assembled and it only requires minimal back stay anchoring to maintain stability.

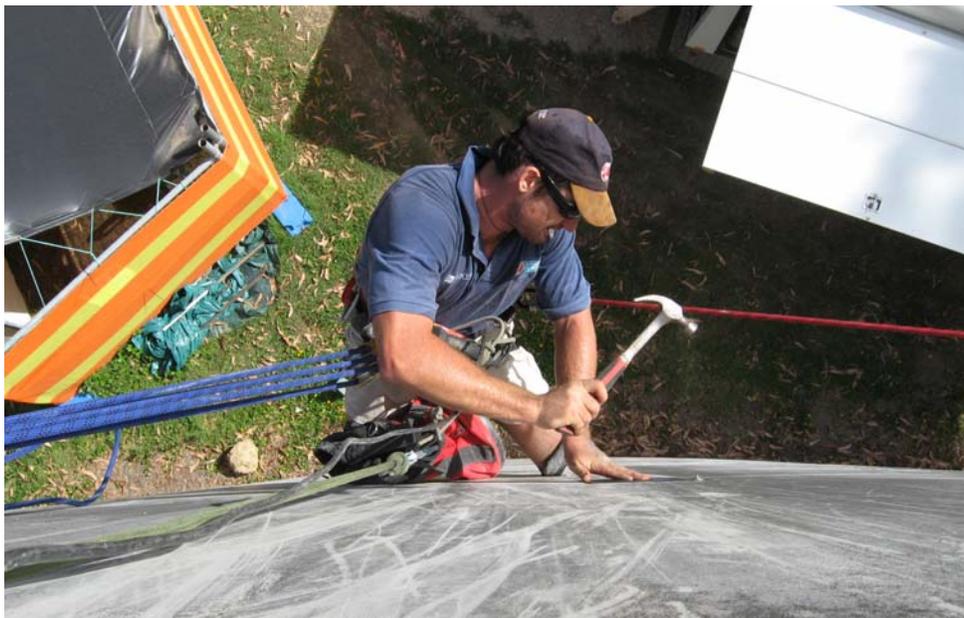
A six to one rescue pulley system was used to allow the operator to lower himself over the edge, adjust his height and then lock off (Figure 4). A secondary safety rope was employed as a back up, in case of a pulley system failure – this was operated by one of the topside support personnel, each time the operator was moving up or down.

Figure 4: *The operator is held in position by a side rope from his harness (on right near hammer) leaving his hands free to complete his works effectively*

By using a side rope the operator could be swung left and right by the top side assistants to enable two mesh panels to be fixed on each drop over the side. After the first day and the usual 'process improvements', the team were fixing up to thirty panels per day. Considering this was in fairly hot weather conditions (mid January in Qld), it was a pretty good effort. The Oz Pod was picked up by all three team members each time, shifted sideways and re-anchored as the team moved around the reservoir wall.

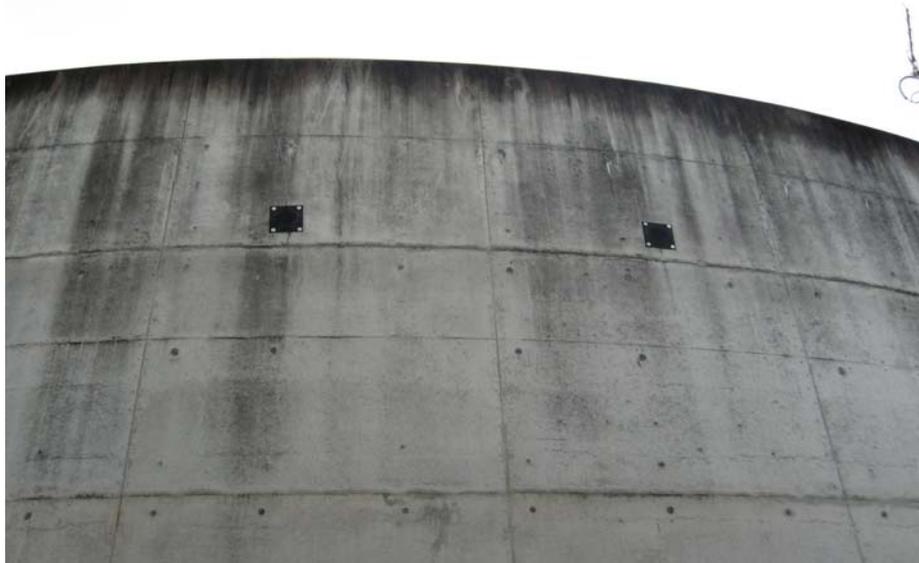
Figure 6: *The finished product; mesh screens secured externally over the ventilation holes*
