THE FIVE DAY CHALLENGE

Greg Comer, Technical Officer SCADA,

Goulburn Valley Water

*72nd Annual Water Industry Engineers and Operators' Conference
Bendigo Exhibition Centre
1 to 3 September, 2009*

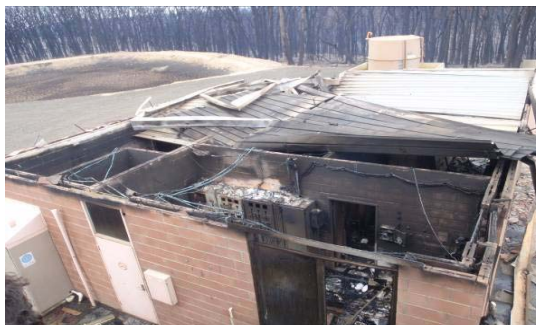
Following a more detailed investigation by an assessment team on Sunday afternoon it was found that while the control room at the Kilmore water treatment plant (WTP) was completely destroyed (see figure 1) the Dissolved Air Filtration (DAF) filters, motors, backwash pumps, dispersion system, raw water supply and most pipe work was still intact and serviceable.

Figure 1: *Burnt out dosing and control room*

A number of ideas were considered, from portable water systems to carting in water by truck, but none were thought to be viable or sustainable for any length of time. Considering that the DAF system itself was largely intact the only solution was to try and use it and rebuild the control room and start producing water in the shortest time possible.
