# THE FIVE DAY CHALLENGE

**Greg Comer, Technical Officer SCADA,**

Goulburn Valley Water

*72<sup>nd</sup> Annual Water Industry Engineers and Operators' Conference  
Bendigo Exhibition Centre  
1 to 3 September, 2009*

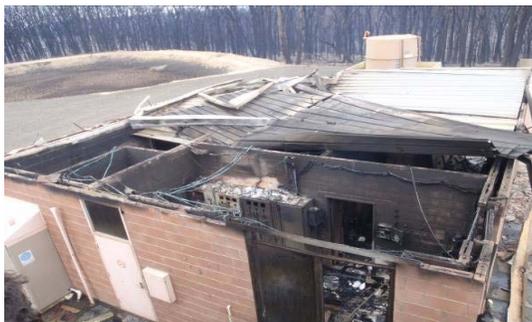
Following a more detailed investigation by an assessment team on Sunday afternoon it was found that while the control room at the Kilmore water treatment plant (WTP) was completely destroyed (see figure 1) the Dissolved Air Filtration (DAF) filters, motors, backwash pumps, dispersion system, raw water supply and most pipe work was still intact and serviceable.

All field wiring (415Vac, 240Vac, low voltage and instrumentation) cables were in good condition. Although the cabling was burnt at the cable entry point to the building, it had suitable length on it to be serviceable which later would become a very important aspect to the solution to this incident.

**Figure 1:** *Burnt out dosing and control room*

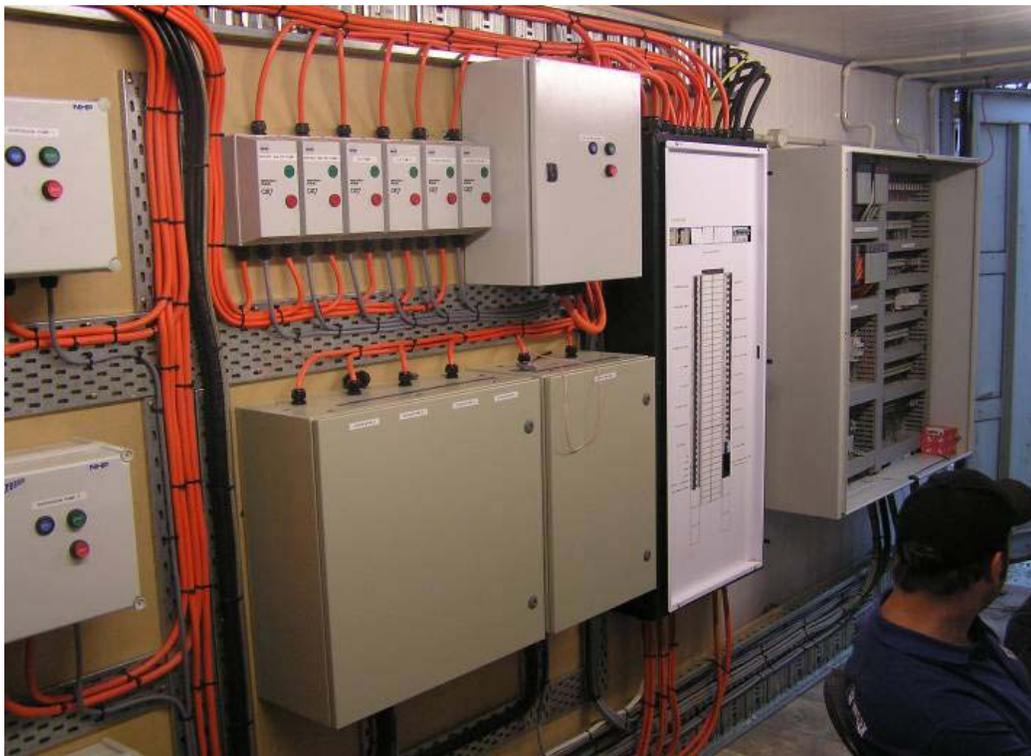
The objective of rebuilding the Kilmore Water Treatment’s Plant control room in five days was achieved. The control system allowed for full automation of the plant, and the operators claim that that it worked better than before. Figure 4 shows the finished control room.

**Figure 4:** *The finished control room*
