THE FIVE DAY CHALLENGE - REBUILDING THE KILMORE WTP AFTER THE BLACK SATURDAY BUSHFIRES

Greg Comer, Technical Officer SCADA,

Goulburn Valley Water

*35th Annual Qld Water Industry Operations Workshop
Community Sports Centre, CQ University, Rockhampton
22 to 24 June, 2010*

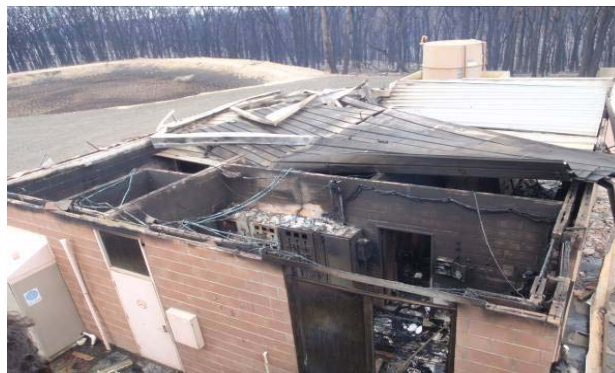
Following a more detailed investigation by an assessment team on Sunday afternoon it was found that while the control room at the Kilmore water treatment plant (WTP) was completely destroyed (see figure 1) the Dissolved Air Filtration (DAF) filters, motors, backwash pumps, dispersion system, raw water supply and most pipe work was still intact and serviceable.

All field wiring (415Vac, 240Vac, low voltage and instrumentation) cables were in good condition. Although the cabling was burnt at the cable entry point to the building, it had suitable length on it to be serviceable which later would become a very important aspect to the solution to this incident.

Figure 1: *Burnt out dosing and control room*

A number of ideas were considered, from portable water systems to carting in water by truck, but none were thought to be viable or sustainable for any length of time. Considering that the DAF system itself was largely intact the only solution was to try and use it and rebuild the control room and start producing water in the shortest time possible.

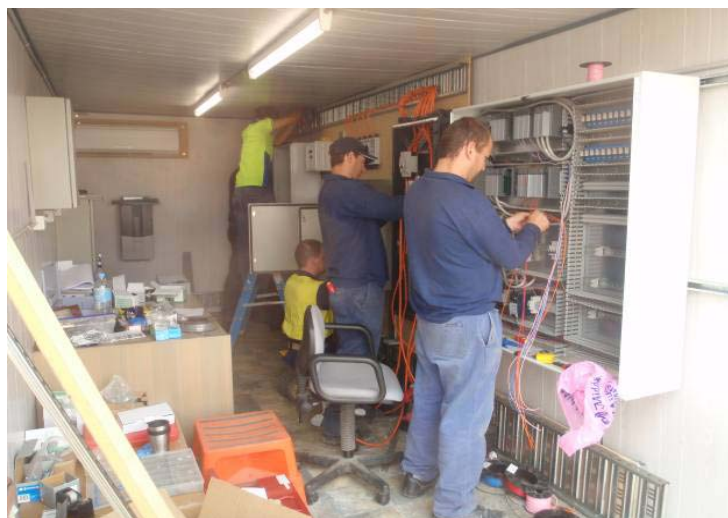
Figure 3: 5 team members working side by side

Tuesday saw the bulk of the construction take place. The main tasks carried out included continuing to mount the cabinets and motor starters, cabling, setting up the laptop for the HMI, air conditioning installation and cutting holes for the field wiring to enter the control room. The team followed the layout drawn on the white board at Sunday's planning meeting, improvising where required to appropriately install the cabinets, motor starters and cable tray for the large task of interfacing the field cabling.

The main item on the critical path for the construction phase in Shepparton was to adequately prepare the power and control junction cabinets ready for the field equipment to be wired. Connections between the motor starters, power junction box and the power distribution board were also carried out. The layout of the container continued to be very important with five team members working independently side by side (see figure 3). After a second planned progress meeting it was decided to gain the assistance of 2 extra electricians to aid in wiring duties. By the end of day 2, progress was still on track but the enormity of the task was becoming apparent.

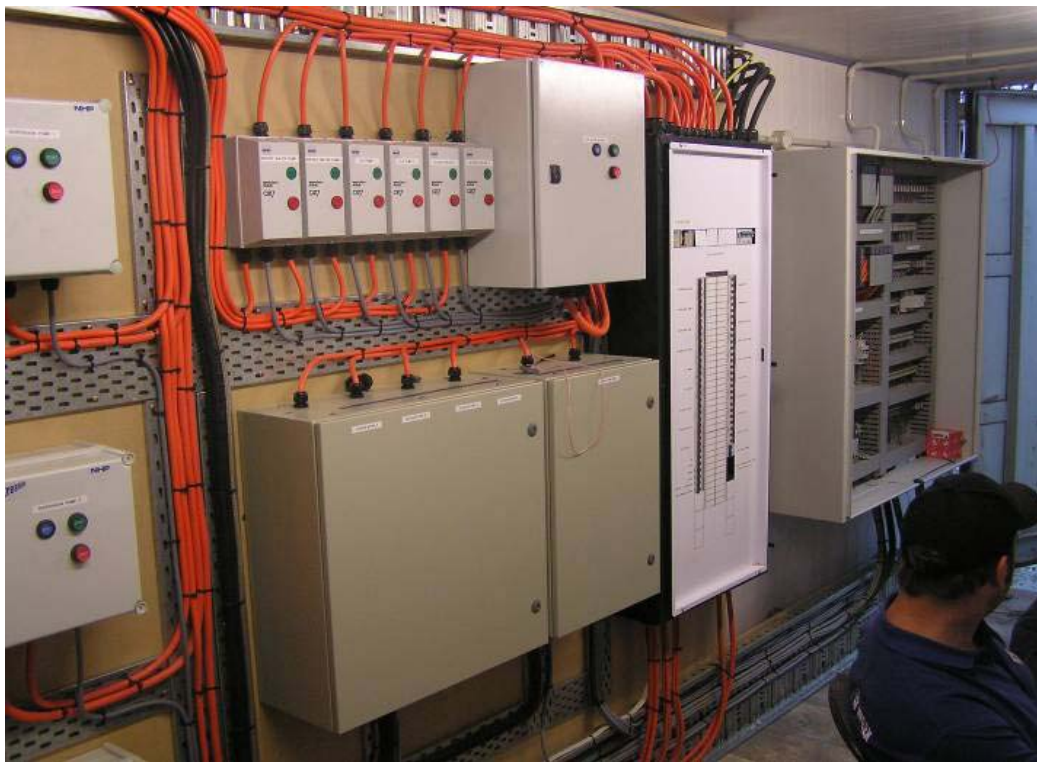
Figure 4: *The finished control room*

The objective of rebuilding the Kilmore Water Treatment’s Plant control room in five days was achieved. The control system allowed for full automation of the plant, and the operators claim that that it worked better than before. Figure 4 shows the finished control room.
