# WORKING AT THE PERFUME FARM FOR 28 YEARS

**Bob Banning, Supervisor,**

Bathurst Regional Council

*4<sup>th</sup> Annual WIOA NSW Water Industry Engineers & Operators  
Conference  
St Stanislaus' College, Bathurst  
20 to 22 April, 2010*

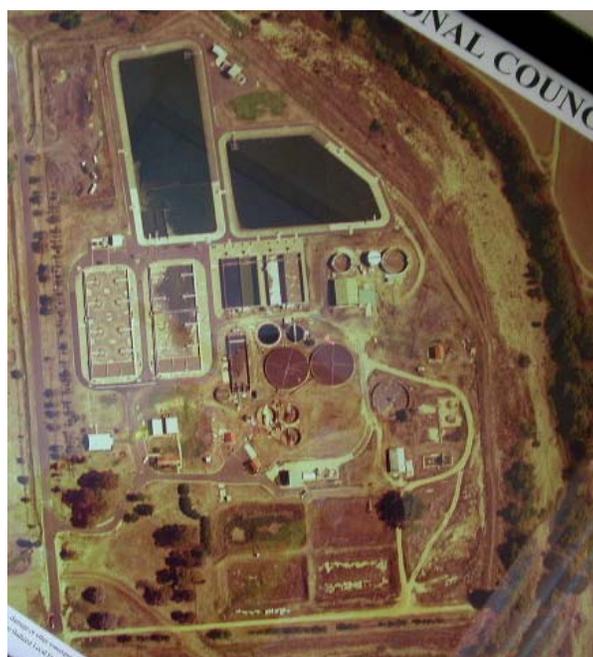
**Figure 1:** Bathurst Wastewater Plant in 2004

Bathurst has a population of about 35,000, has approximately 350 kilometres of sewer pipeline and 15 pumping stations which deliver the sewage to the plant. The flow into the plant is approximately 10 ML/day and of that 20% is recycled water. About one third of the inflow is from trade waste installations.
