RESERVOIR RENOVATIONS: BEST CHANCE OR LOST CHANCE

*4th Annual WIOA NSW Water Industry Engineers & Operators
Conference
St Stanislaus' College, Bathurst
20 to 22 April, 2010*

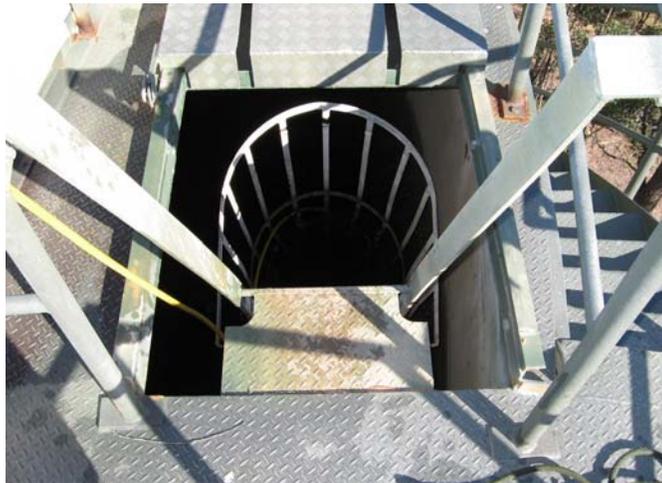
Figure 2: *Ladder stiles protruding from an unsealed entry hatch area.*

This entailed personnel climbing down into the tanks, often without the benefit of confined space knowledge or training. Ladder materials were also limited and galvanized steel was the preferred option, even though galvanizing had a limited protective life when immersed in water. Ladder and platform designs were based on the ability of personnel to climb them unassisted and rescue scenarios were often neglected or given low priorities. The AS 1657-1992 (fixed platforms, walkways, stairways and ladders) was used extensively, with little thought given to how it impacted on both confined space requirements (AS 2865- 2001 Safe Working in a Confined Space) or water quality. Consequently we have tanks fitted with sloping ladders and platform structures that prevent effective rescue from within the confined space environment. These same ladders generally have stiles protruding from out of the tank that makes it impossible to seal the entry hatch areas against natural or deliberate contamination.

Use longer lasting, non polluting ladder materials such as FRP, and configure the designs to assist in a rescue scenario if required. Vertical ladders are good for assisted climbing (using appropriate PPE) and they have benefits for rescue situations requiring several personnel at once to be lifted into or out of the tank. But these ladders should not continue out through the entry hatch area – there are better methods of providing hand contact for the climber that do not jeopardise stored water quality.

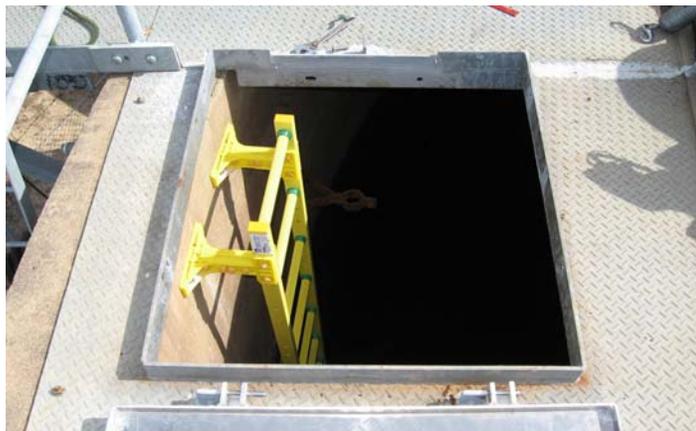
Figure 3: *The hatch frame sealed off and a new vertical ladder fitted.*

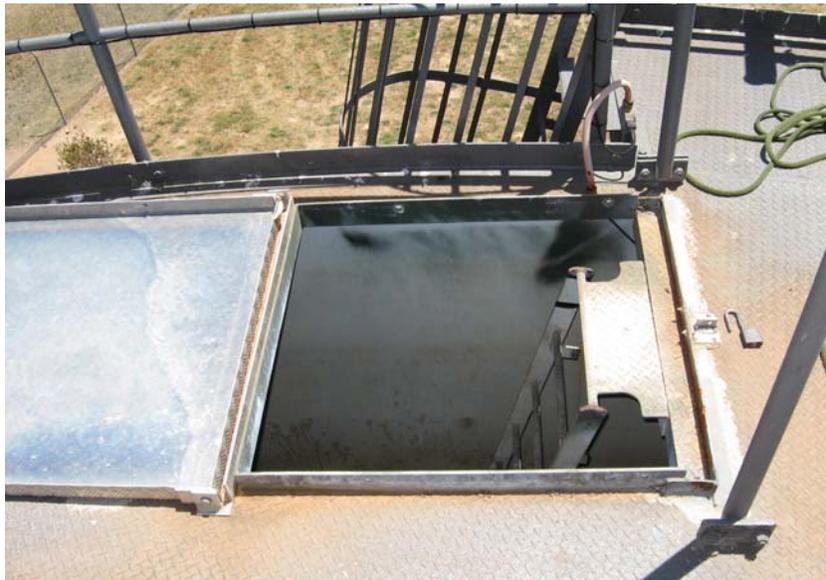
Figure 4: *The existing ladder stiles trimmed off, the front edge sealed and an overlapping cover fitted.*

Entry hatches need to be enlarged to at least 900mm by 900mm to allow easy access. The frame should be sealed onto the surrounding platform areas, the covers overlapped around the edges of the frame and having nothing protruding through them. Storm water and debris ponding needs to be eliminated from the immediate area to maintain a clean working environment when entering or exiting the tank.

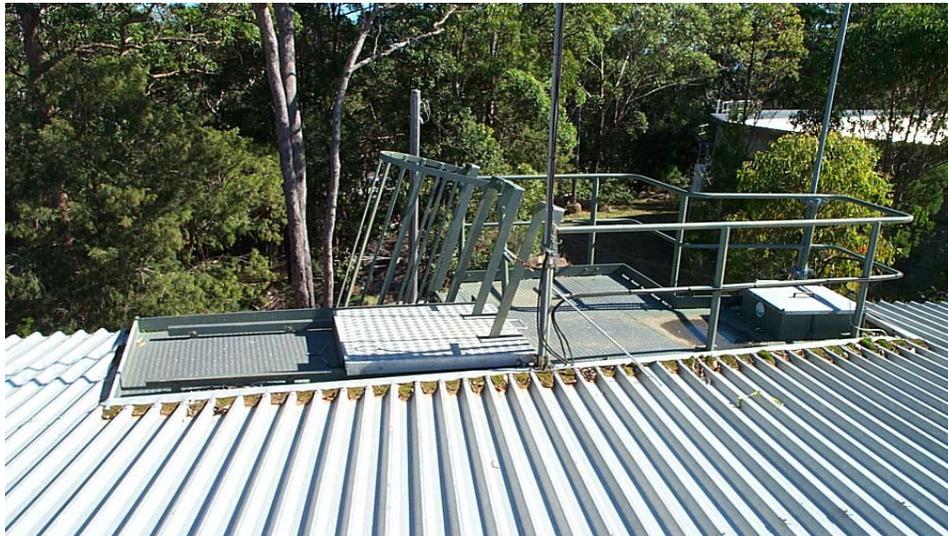
Figure 5: *Typical platform area – roof debris is ponding, unsealed hatch area and lack of effective guard rails.*

Platform areas need to be enlarged and sloped to encourage effective drainage, there needs to be adequate clearance to allow debris to be removed easily. Larger, uncluttered work areas assist in improving ergonomics and rescue systems need to be incorporated to assist confined space entry and exiting of the tank.

Guard rails need to be put in place to prevent personnel from falling off the immediate platform or roof area, but not to limit access to the safer areas of the roof, where regular maintenance needs to be carried out.

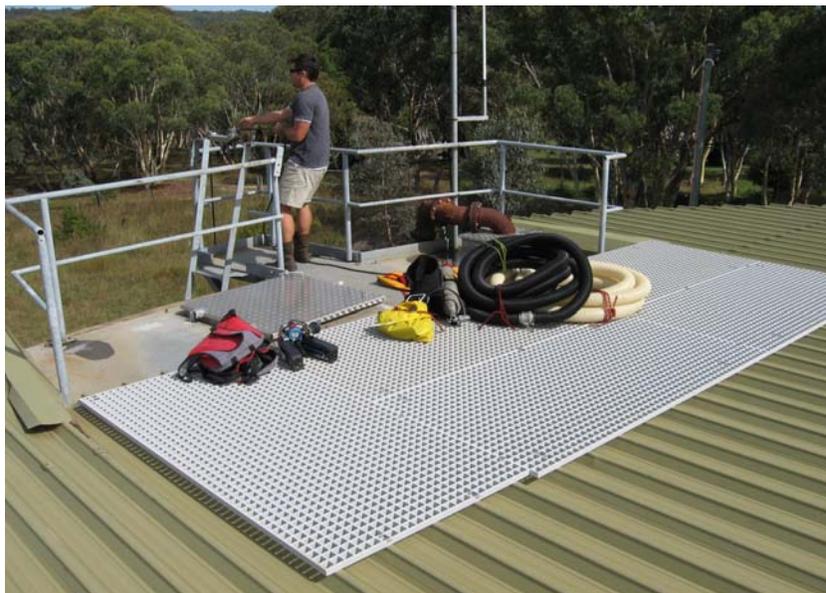
Figure 6: *An upgraded platform area including additional guard rails.*

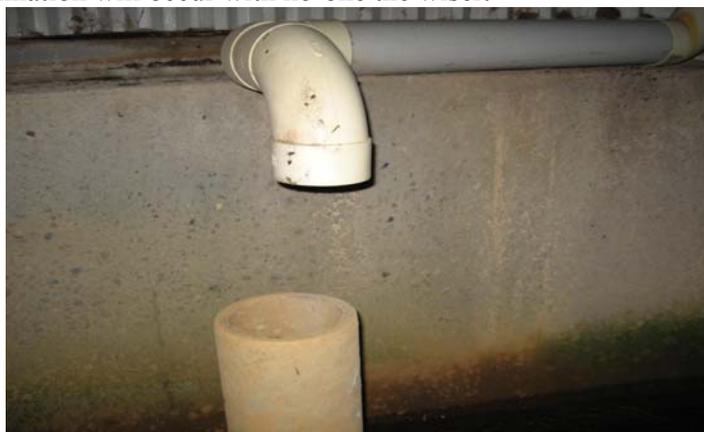
Figure 7: *A roof drain point not connected into the overflow.*

Any drainage system that is not obvious and external to the tank has a potential to fail. The platform areas were forgotten when it came to drainage issues – a bit of water draining back into the tank was probably looked on as being a bonus during dry times! The natural contamination present from leaf material, dust and bird faeces was not considered important and now our precious water is being polluted on a daily basis. Roof and walkway areas that drain internally often overflow and deposit waste materials directly into the stored water. This can be through poor alignment of the internal drain with the overflow bell mouth or under estimated volumes of water collected on the roof area during peak rain periods. Box type gutters can fail through blockage or corrosion and contamination will occur with no-one the wiser.

Change roof designs to avoid internal gutter systems, enlarge and re-align existing drainage points to cater for peak storm activity.

Install drainage points in ponded platform areas that exit out through the adjacent wall

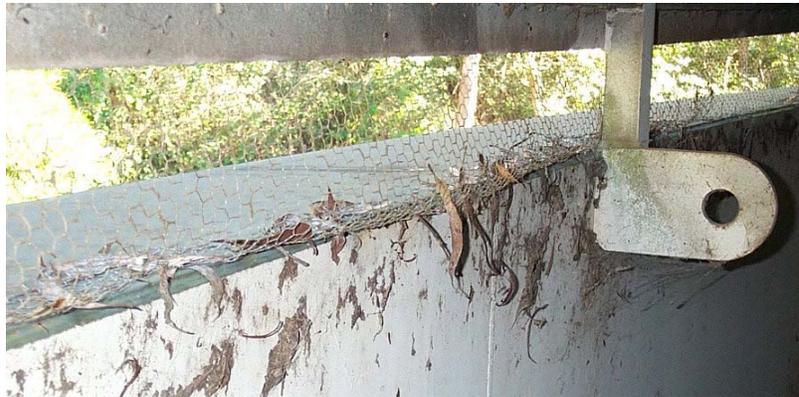
Figure 8: *Ventilation mesh not effective against leaf debris & wind born contamination.*

In some cases too much or poorly positioned ventilation areas can cause more contamination issues than they solve – there has to be a balance depending on the surrounding environment. Tanks surrounded by overhanging trees will be subject to excess leaf debris which can enter the tank through the vents. Also tanks in very dusty or industrial areas will need to have ventilation limited or re-positioned to avoid additional contamination from occurring.

Design ventilation systems to suit the local environment. Windy areas should not have turbine vents fitted as these will wear out quickly through over use – fixed vents are preferred.

Mesh panels should be positioned away from prevailing wind areas to avoid excessive wind born contamination, the materials used should be corrosion proof and be fine enough to keep out insects and larger leaf type contamination.

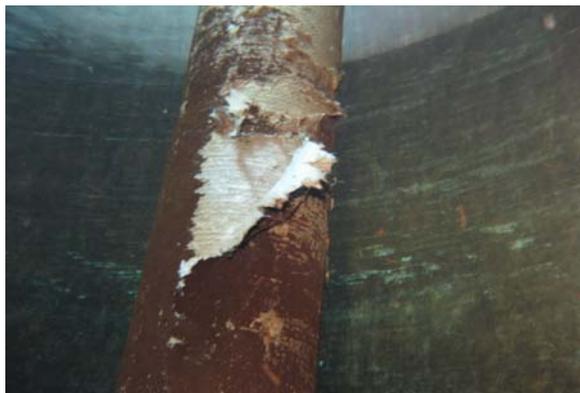
Figure 9: *An AC overflow riser pipe that is de-laminating.*

Removing or replacing any fitting that adversely affects water quality is important. Materials such as AC overflow risers, ductile iron pipes, galvanized metal items and any un-coated penetrations all need to be attended to during the renovation process. Fittings placed inside steel tanks are commonly coated with the same materials used on the wall and floor, but some items such as ladders and support brackets have been galvanized and these have deteriorated at a far quicker rate than the wall and floor areas.

Replace corroded or structurally deteriorated items with materials that are cathodically compatible and suitable for immersion.
