# CONTROL OF ALGAE IN POTABLE WATER SUPPLY – BEMM RIVER SHADECLOTH TRIAL

**Kristine Hunter**, *Technical Officer Water Quality,*  
East Gippsland Water

*65<sup>th</sup> Annual Water Industry Engineers and Operators' Conference*  
*Kardinia Heights Centre - Geelong*  
*4 and 5 September, 2002*

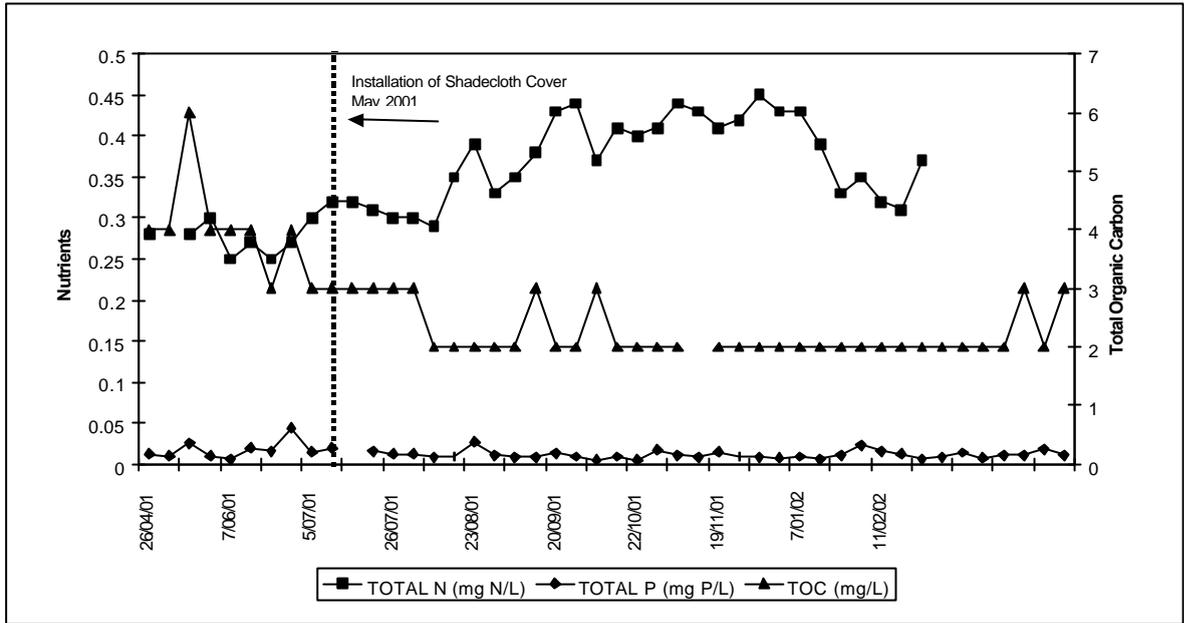
**Figure 1:** *Bemm River Storage Basin (Surface) – Nutrients and Total Organic Carbon*

In terms of the impact on nutrients and total organic carbon for both the surface and bottom samples taken, there appears to have been a decrease in the levels of total organic carbon since the installation of the shadecloth. This is assumed to be a reflection of the barrier to windblown dirt / debris into the storage basin. The total phosphorus levels appear to have been unaffected however the total nitrogen levels appear to be rising slightly.

Of the total nitrogen components analysed, the most significant increase was in oxidised nitrogen (NO<sub>x</sub> - nitrates and nitrites), sometimes referred to as 'available' nitrogen in terms of nitrogen required for plant growth.

As there is no historic nutrient data for this site it is not known whether this is a seasonal phenomena or whether it is in response to the decreased numbers of algae (see later discussion) – no algae / plant growth to remove available nutrients from the water column – or an increase in nitrogen levels as a result of decaying matter in the storage basin. However, a time series graph of total coliforms (refer Figure 3) as an indication of the bacterial load in the storage basin does support the theory that the dying algae did decompose and the consequent bacterial activity converted some of that biomass into available nitrogen which is now sitting there with very little biological activity present in the storage basin. With no further 'food' and minimal input into the storage as pumping from Bemm River occurs only 3 – 4 times per year, the bacterial load also decreased. Monitoring for both nutrients and total organic carbon is continuing on a monthly basis.

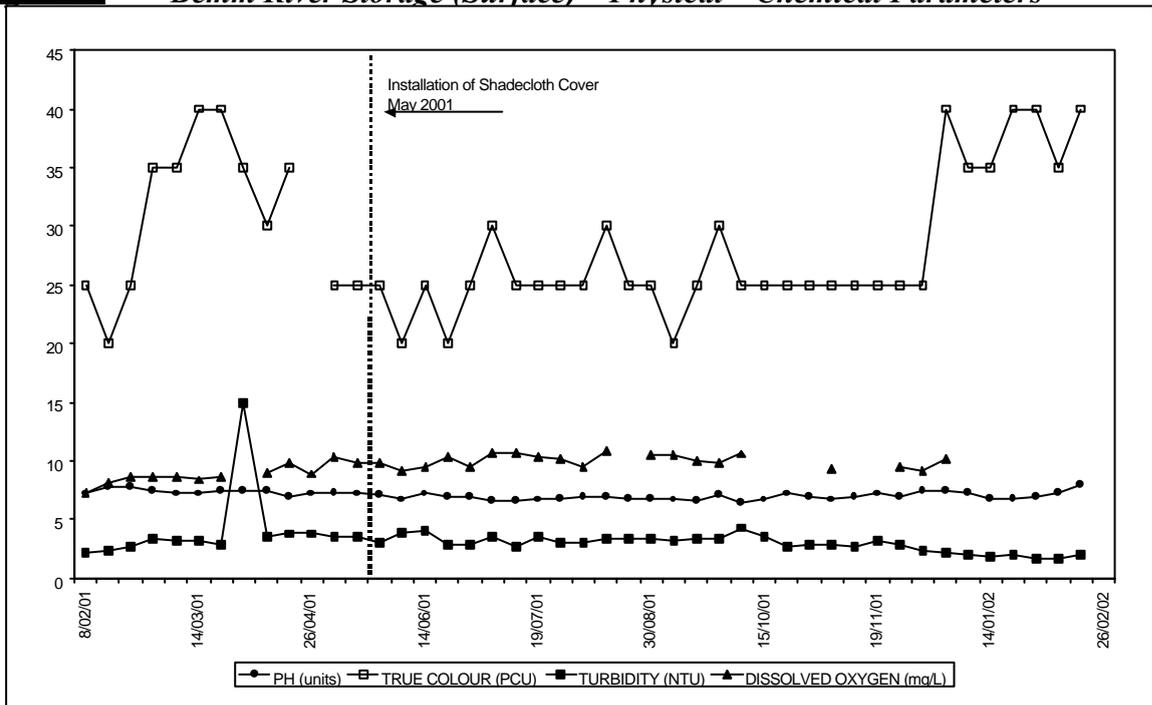
**Figure 2:** *Bemm River Storage (Surface) – Physical – Chemical Parameters*

From looking at the graphs presented below, it can be seen that there appears to have been minimal impact on the physical-chemical parameters by the installation of the shadecloth cover.

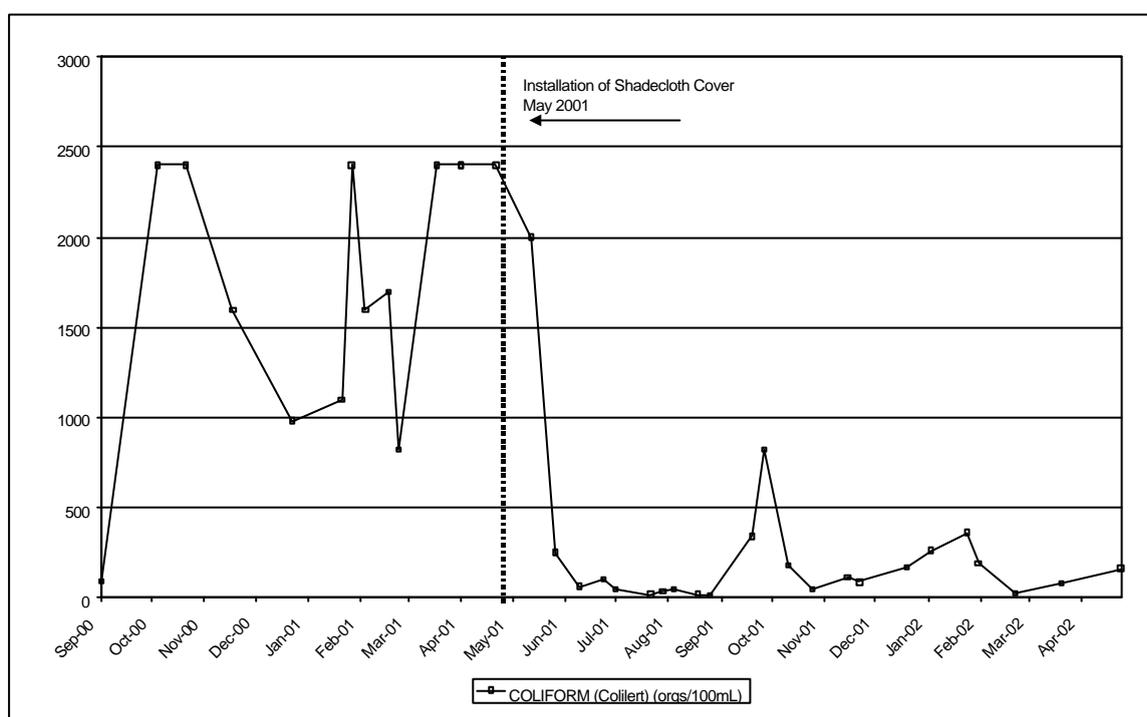
**Figure 3:** *Bemm River Storage – Total Coliforms*

Another positive aspect of the shade cloth cover is the potential increase in efficiency of disinfection – there is now little or no algae present in the water to provide a ‘mask’ for bacteria to avoid disinfection and, from the microbiological load (in terms of total coliform data), there are less bacteria to deal with.

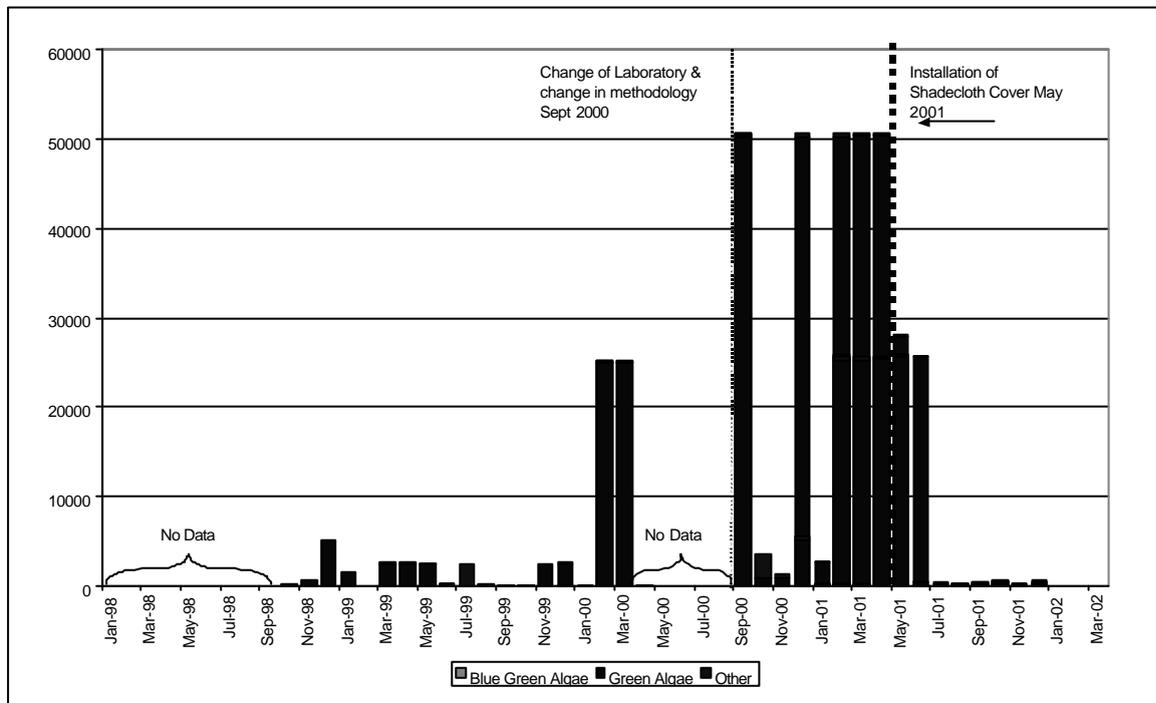
The values of the individual species were summed into their relevant categories for each month and then the three categories plotted as a stacked bar chart to present the overall abundance of algae in the storage basin. The figures shown on the Y axis are indicative of abundance only.

**Figure 4:** *Bemm River Storage – Algae Data*

From the available data it appears that the installation of the shadecloth cover resulted in a decrease in algae numbers and frequency of occurrence. This is also supported by the nutrient and bacterial levels as discussed earlier. Monthly monitoring is continuing to confirm that this decrease in algae numbers is real and permanent and not a reflection of a poor Summer season.

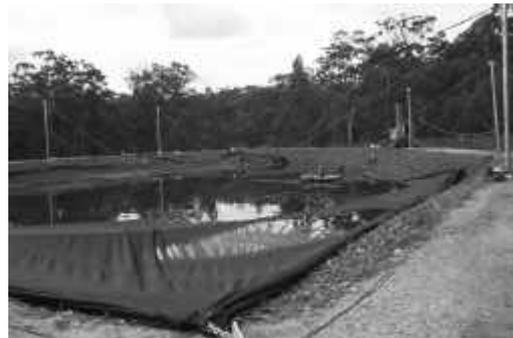
*Pulling the shadecloth across the basin*

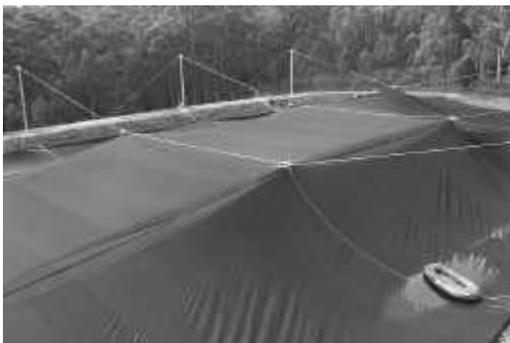
*Birds-eye view of tensioning the structure*

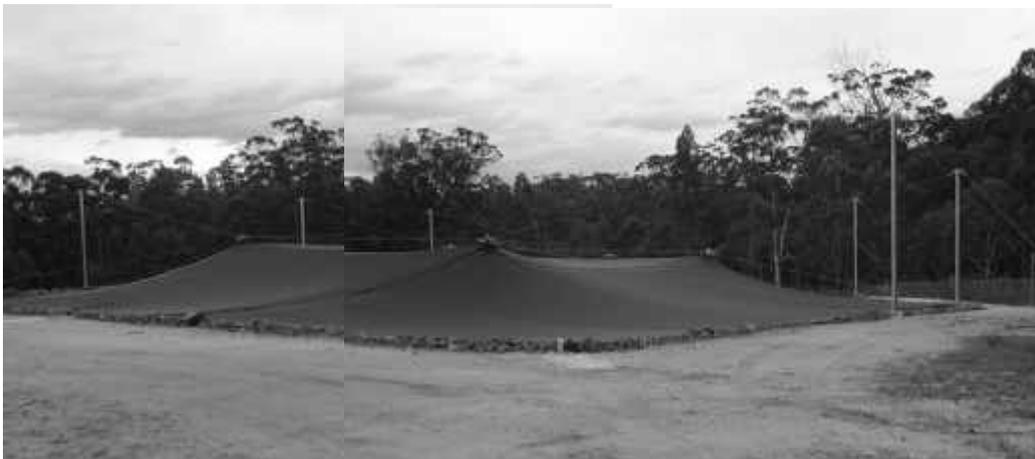
*Finished Structure!*
