# UPGRADING JET RODDING AT ACTEWAGL

**Graeme Whelan**, *Plant Co-ordinator,*  
**Paul Wheatley**, *Field Services Manager,*  
**Peter Burgess**, *Engineer,*

*66<sup>th</sup> Annual Water Industry Engineers and Operators' Conference*  
*Eastbank Centre - Shepparton*  
*3 and 4 September, 2003*

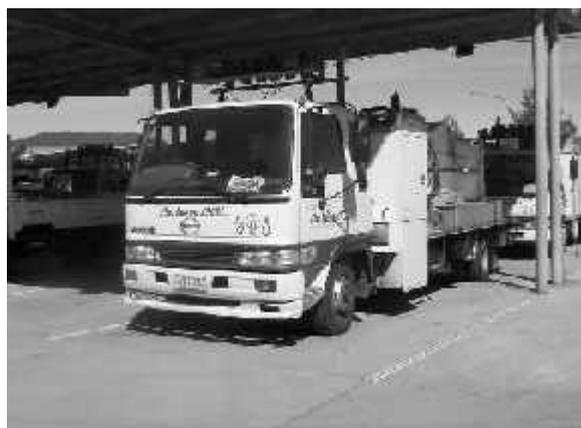
**Figure 1:** *Typical choke truck*

Four of the trucks are set up as choke trucks and are used on a shift rotation basis. The other truck has a high volume set up and is used in conjunction with CCTV for more specialised work.

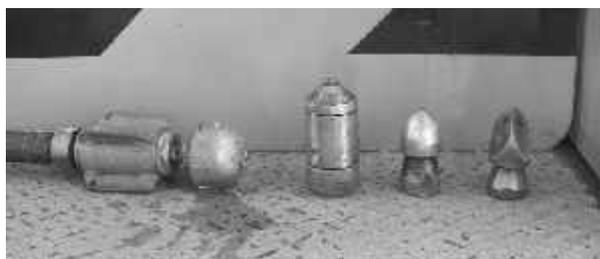
**Figure 2:** *Typical nozzles*

The basic nozzles used for jet rodding have two actions. Forward or sideway jets cut into the obstruction and the rear facing jets provide thrust. The effectiveness of the jet rodder is very dependant on the pressure and flow at the nozzle. If the jets are too big there will be high flow but little force and vice versa.

The in pipe tests were now repeated using the same nozzle for the different trucks and different nozzles for the same truck. These tests indicated that different nozzles were the problem and were too small or too large. It was suspected that they had been set up for the trucks when they were not operating properly and thus were now wrong

Tom Williams from DCS industries was called in to calibrate the existing nozzles and to fix up root cutters. All nozzles now became interchangeable between the trucks and thus we could reduce the inventory. Tom also pointed out a few other problems and issues with the pumping controls and trucks. All of these problems happened within the next three months as predicted.

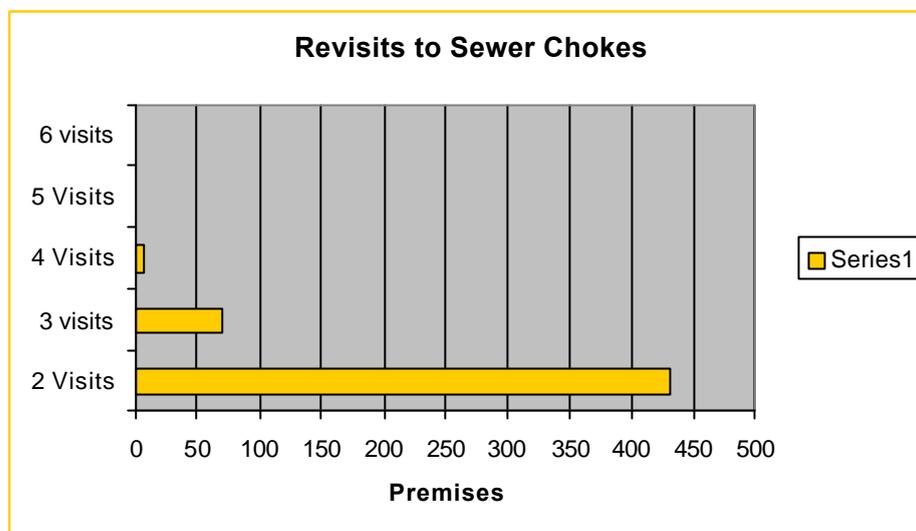
**Figure 3:** *Number of multiple visits to properties*

to the same site twice and sometimes up to six times (See figure 3). It was determined by the field service manager that we should look at the work practices and try to reduce this figure as based on a cost of \$165 per choke and some 680 revisits a saving of up to \$112,000 per annum was possible.

The main issue here was the difference between unblocking the pipe and removing the blockage. It is possible to punch a hole through the choke and to release the water backed up but this self seals and within two days the choke is back. Where there is some clearing of the roots the choke can take a bit more time to come back but this can be as short as three months.

It was decided that the work practice would change so that the crews removed the blockage so it would remain free for a longer period. The work method became to use a jetting nozzle to pierce the choke and then use a root cutter to remove the choke. This method was included in the training package and was to become the standard method. This became possible because when the choke trucks were brought up to specification they could easily run the root cutter.
