LEAKAGE – MORE THAN SMOKE AND MIRRORS

Malcolm Hill, *System Integrity Engineer*

South East Water Ltd

*66th Annual Water Industry Engineers and Operators' Conference
Eastbank Centre - Shepparton
3 and 4 September, 2003*

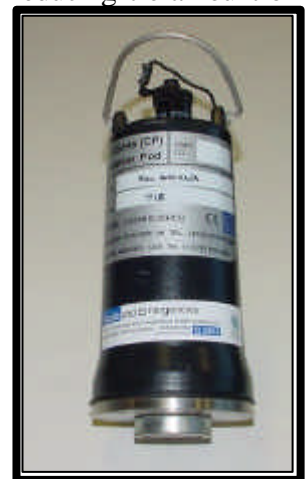
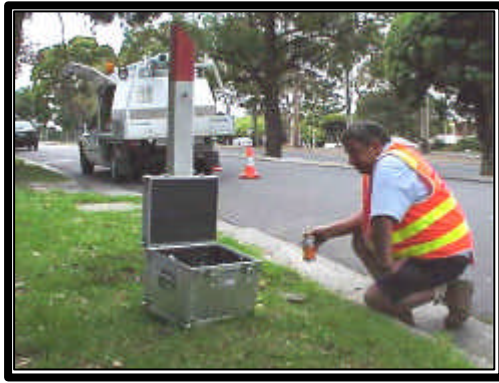
By placing the acoustic loggers on surface fittings such as fire hydrants and valves the loggers record the noise level of the water main over a series of short intervals.

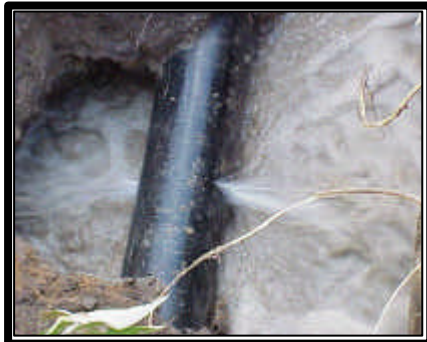
A distance between the acoustic loggers is calculated and the program produces a chart of the location of the water leak. The loggers are sensitive enough to identify leaks on the 20 mm

property service pipes as well as the water main in the street.

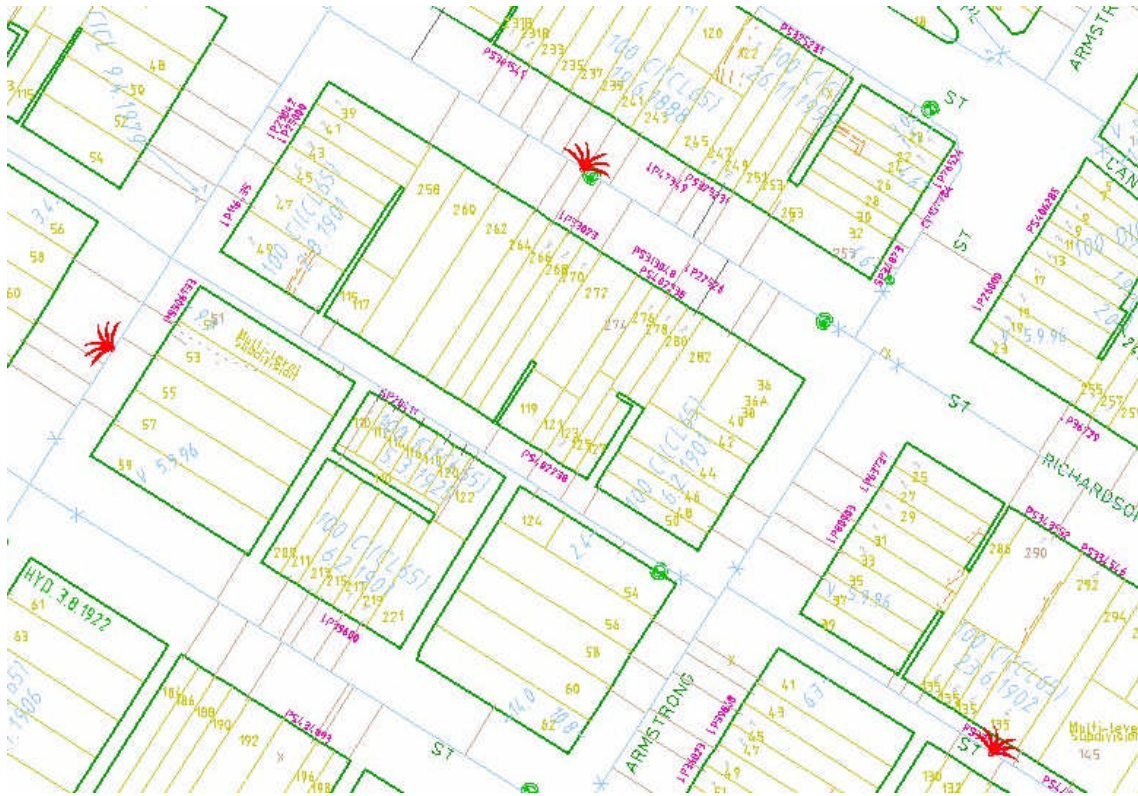
Figure 1: *Field View showing details of Water Mains*

The operator uses 1:2500 water reticulation plans to highlight the completed water mains and to locate the location of the water main surface fittings. Also a laptop is used in the field with our GIS data called Field View for addition details of mains location and distances between surface fittings.

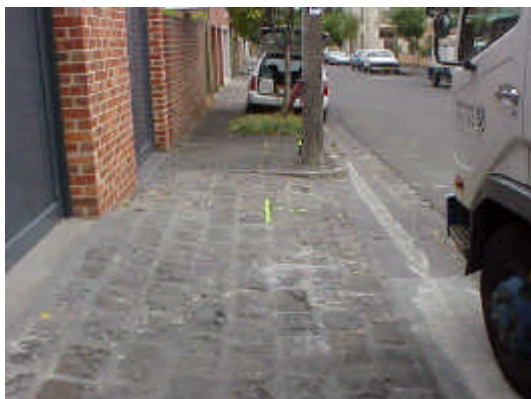
A typical leak in South Melbourne where there is no obvious signs of any surface leaks, however, the leak detection equipment identifies a leak under the blue stone driveway.

Addition exploratory drilling and listening using ground microphones identifies a high water level under the driveway.
