PIGGING OF THE LOBETHAL RISING MAIN

*68th Annual Water Industry Engineers and Operators' Conference
Schweppes Centre - Bendigo
7 and 8 September, 2005*

A 7.5 km long sewer rising main often burst at environmentally sensitive points. Although sections of the main were programmed to be replaced, pigging was a short term solution to relieve pressure in the main. There were numerous considerations during the planning of the pigging project.

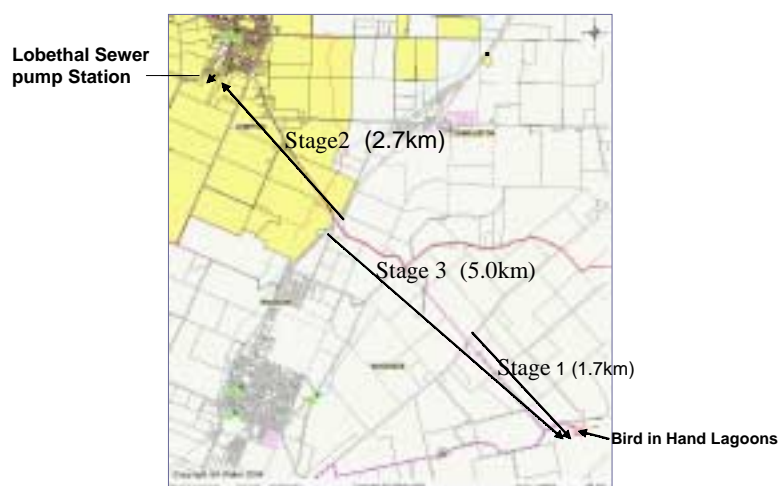
Figure 1: *Pigging Stages*

The lowest points of the main are at the creeks and drainage lines traversed by the main, the most significant being the Onkaparinga River, one of Adelaide's major catchment Rivers. The low points are where pipe failures occur. See attached map. Approximately seven bursts occurred annually.

Since we needed a considerable volume of water to push the pig through, we decided to break the whole job into stages, starting at the farthest third from the pump station then going back towards the pump station away from the Onkaparinga River.

Launch sites were chosen for ease of access and location of stop valves so not too much of the line had to be drained when we broke into it to install a pig launcher. Note stage 2 was back to the pump station from Onkaparinga Valley Road. This made it easier to retrieve the pigs.

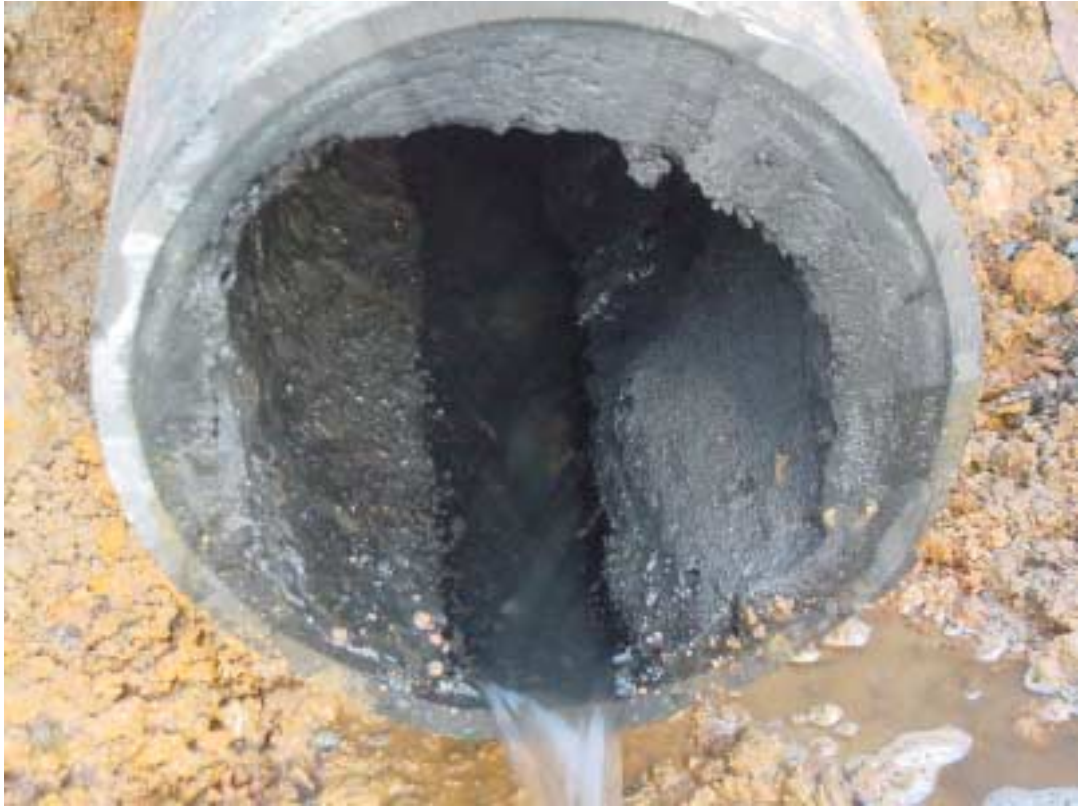
Figure 2: *Sludge Build-up in Sewer*

Sections removed during repair revealed the internal mortar of the cast/cement lined pipe a soft, sandy, with no residual alkalinity varying from 0 to 6 mm in thickness. The internal diameter of the pipe was also found to be severely restricted as a result of build up of sludge and corrosion products. The pipe failures were a result of local external corrosion and pressure surges which caused the pipe to crack longitudinally at its weakest point.

An extreme solution to the problem of bursts is replacement of sections of the main however due to the sludge build up it was decided to pig the main. Additionally we fitted a pressure sensor on the main so when a burst occurred the drop in pipe pressure would cause pump station shut down thus minimising environmental spillage.

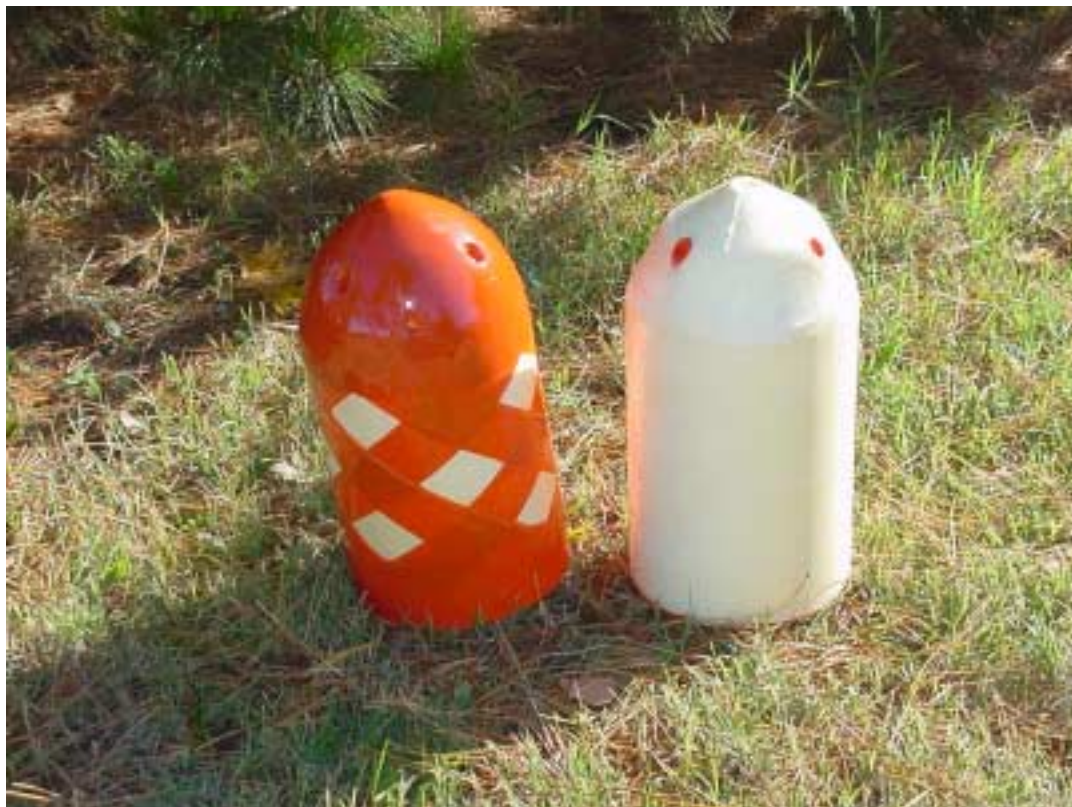
Figure 3 *Examples of the Pigs Used in the Project*

We undertook the pigging with pigging experts, a company based in Adelaide called Macro One.

The pumps in dry well configuration could not supply the pressure to push pigs through the network, so we used a fire truck pump.
