# TRAC(K)-ING DOWN YOUR PROBLEM - A ROPE ACCESS SOLUTION

**Heysen Dennis, Commercial Diver,**

**Aqualift Potable Diving Pty Ltd**

*6<sup>th</sup> Annual WIOA NSW Water Industry Engineers & Operators  
Conference*

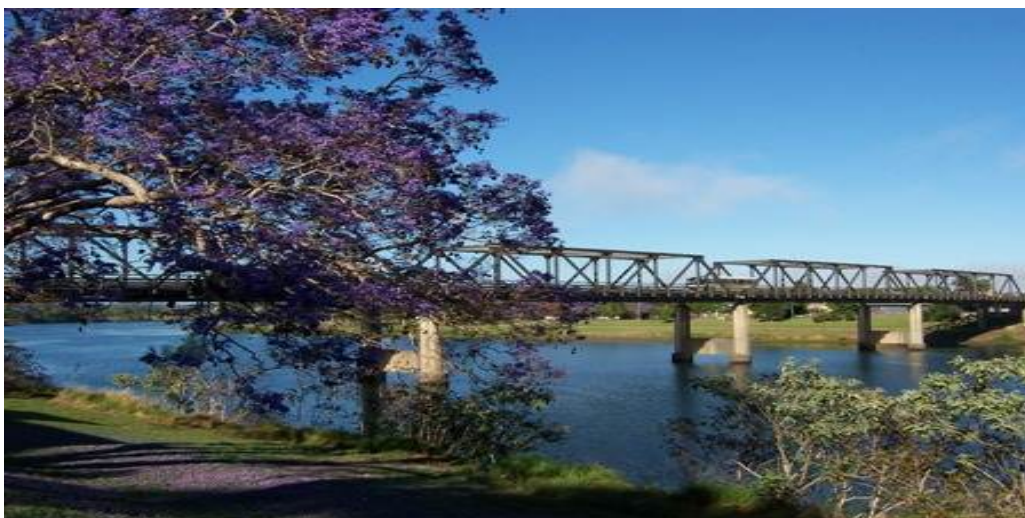
**Figure 1:** *Pacific Highway Bridge at Kempsey*

In June 2011, Kempsey Shire Council (KSC) staff identified a number of issues regarding a leaking pipeline that was suspended below the Pacific Highway bridge in the middle of the Macleay river at Kempsey. Due to increased traffic loadings, the bridge is subjected to a lot of flexing as large vehicles and machinery continuously pass over. While this does not affect the bridge structurally, it has an adverse effect on the services which pass underneath.

The 225mm ID pipe was constructed from fibre cement and is supported off the bridge through a series of clamps, which are slung back from the walkway. A blown or damaged pipe would have interrupted supply to the South Kempsey residents and due to the difficult location, any repair would not have been a quick or easy solution.

A closer inspection using binoculars showed that two separate gibault joints were failing to seal. On consultation between KSC and Aqualift, it was decided that a stainless steel repair sleeve system would be the best solution to rectify the leak. Replacing or rebuilding the gibaults would only have provided a temporary solution due to the ongoing movement that the pipe was being subjected to.

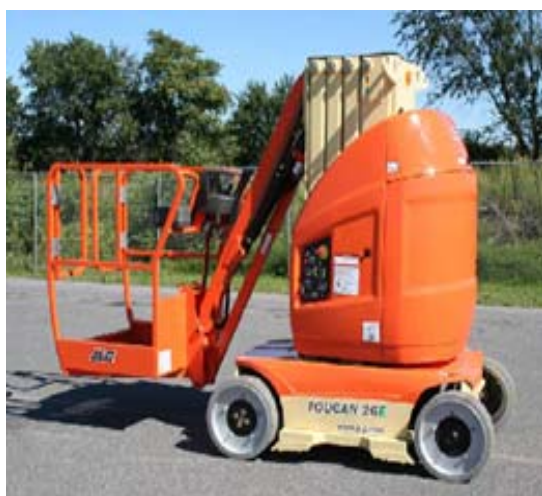
**Figure 2:** *Inverted knuckle boom*

An inverted knuckle boom (see Figure 2) would provide a stable work platform, however due to its size and the construction of the bridge, closure of the Pacific Highway would be required for the duration of the job. The knuckle boom also has limited inverted reach that may or may not have provided access to the site.

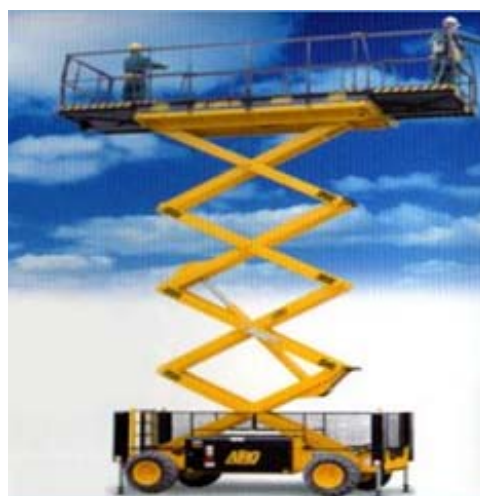
**Figure 3:** *Scissor lift*

A barge would have provided easy access to the site however due to the height required by the scissor lift (see Figure 3), the risk of pinching or entrapment to the operator from even the smallest boat wake or wind borne wave was a real possibility. An exclusion zone would have been required in the surrounding area and the cost of a scissor lift, a suitable barge and several safety boats, along with all the necessary crew was going to be expensive.

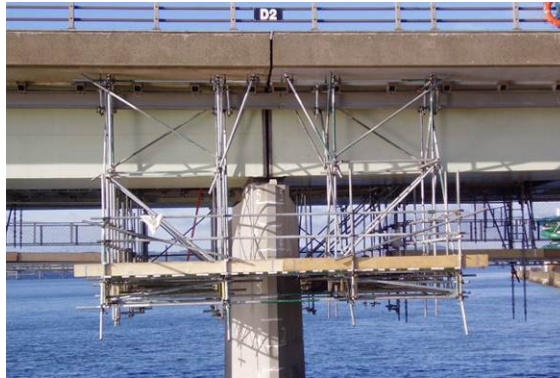
Scaffolding would have provided a safe, stable platform to work from, however due to limited mobility and the requirement to access multiple sites in a short time frame it would not have been a time or cost effective solution.

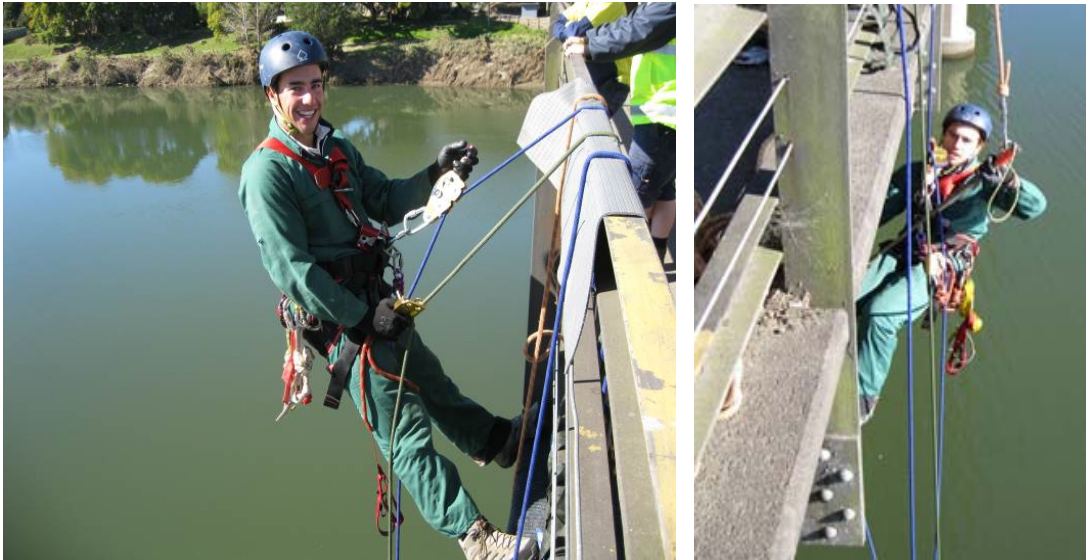
To access the work area the operator first clips on an ascender to the safety line. This piece of equipment will stop the operator falling in the event of rope breakage, an equipment malfunction or human error. The descender unit is then attached to the working line. Most TRAC type descenders are ‘fail safe’ and can only be operated by a conscience person – in the case of an incident, the unit will lock up and keep the operator safe until a rescue can be affected.

Before the operator begins to access the work area he is given an ABCDE (Anchors, Buckles, Carabiners, Descenders, & Everything else!) check by his ‘buddy’ to make sure ‘everything’ is in place.

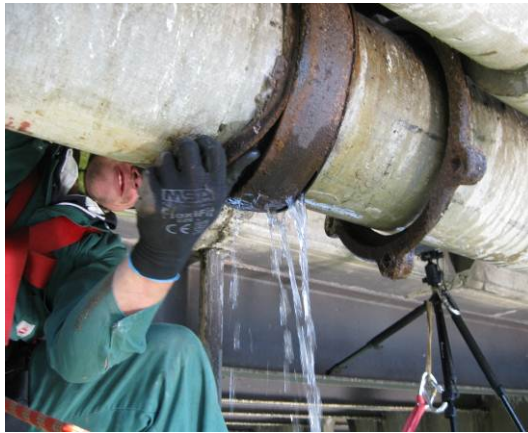
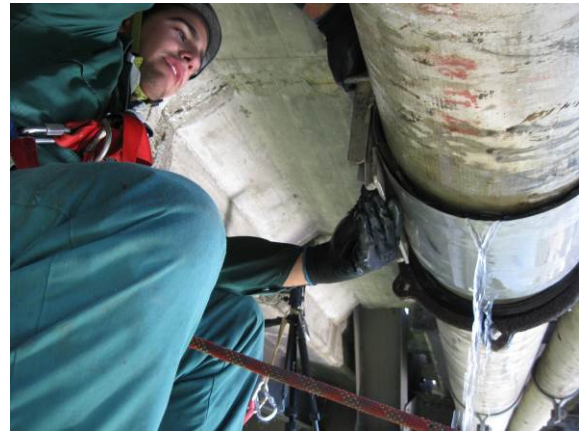
The task required was relatively simple, however due to the age of the gibbault, manual tools failed to loosen the retaining nuts. The solution was an air impact gun powered by a scuba tank - thirty odd years of resistance was quickly overcome!

The gibault was then slid out of the way and the pipe was assessed for any defects that would have affected a successful repair. Once the pipe had passed the inspection, the stainless steel repair clamp was attached and tightened up. The pipe was then pressurized and checked for leaks before the operators reversed the process, traversed out from under the bridge and climbed back up the working ropes to safety (and morning tea).

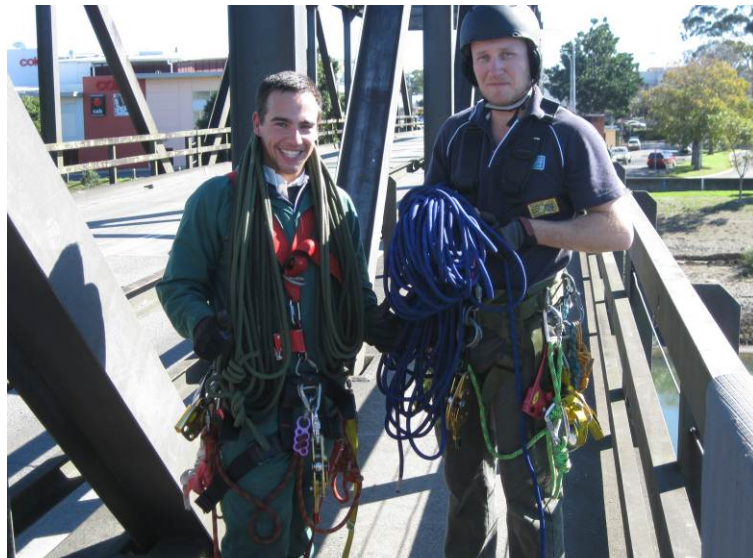
The process was repeated for a second repair and this took even less time, as the team was now ‘underneath things’ in a big way!

The entire task (removal of the gibaults and installation of repair sleeves) at two separate locations was completed in less than three hours (including morning tea!).
