MERRIJIG SEWAGE PUMP STATION REPLACEMENT DUE TO ODOUR PROBLEMS

*75th Annual Water Industry Engineers and Operators' Conference
Bendigo Exhibition Centre
4 to 6 September, 2012*

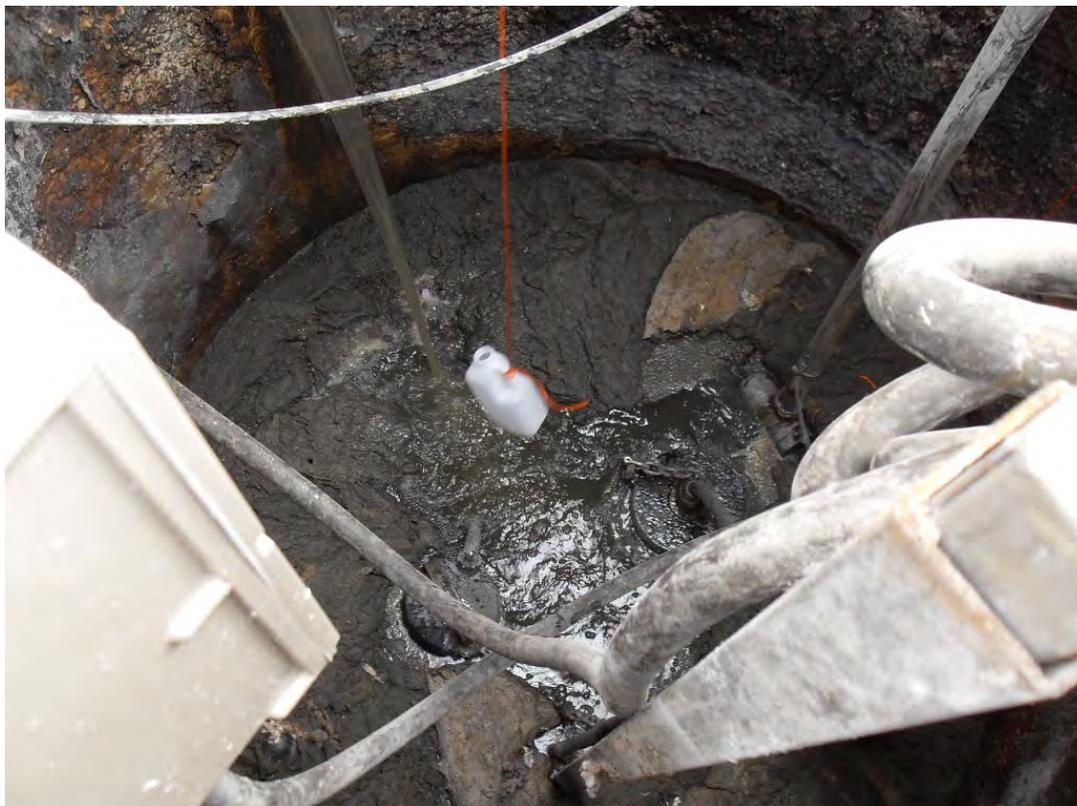
The Upper Delatite (Sawmill Settlement and Merrijig) is part of the South East operations district. In 1987, the Merrijig Sewage Pump Station 02 was installed for the Upper Delatite community to have access to a sewage reticulation system. In 2002, a report highlighted that the wet well was in need of replacement due to corrosion of the walls and thus its poor structural condition. The corrosion occurred due to the gaseous environment. As a result, a new concrete pump station with an epoxy grout seal was installed adjacent to the existing pump station. The existing wet well was retained and converted for additional emergency storage. The installation in 2002, of a new concrete pump station with the inclusion of the epoxy grout seal was thought to be the best option to stop the corrosion. It was found that in early 2011, the replacement sewer pump station installed in 2002 had severe H₂S gas corrosion and was in poor structural condition. Refer to Figure 1.

Figure 1: *Merrijig Sewage Pump Station – Note side walls of Wet Well*

Install a fibre glass pump station inside existing wet well. This option was adopted for the following reasons;

The contractor disconnected the existing rising main, gravity main from the wet well. Both the pumps, pump stools, guide rails, electrical cables and any other object attached to the wet well were taken out. The cleaning process of the wet well walls was done delicately due to the poor condition of the concrete. The concrete walls were in such poor condition, the pressure from the cleaning hose could blast a 50 mm hole into the concrete. After cleaning the well it was found that the floor was uneven and it needed to be level for the correct installation of the new tank. Levelling the floor with concrete helped with the installation of the tank. The concrete base held the tank in place when the concrete slurry was poured and ensured that the fiberglass pump station didn't float.

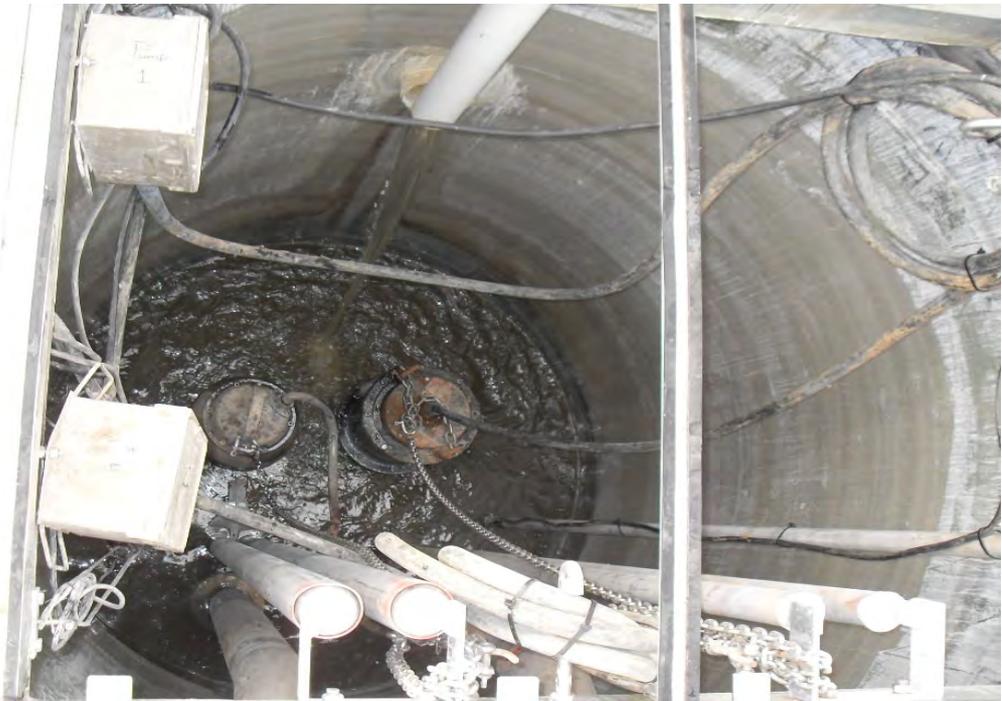
Figure 2: *Merrijig Sewage Pump Station – New fiberglass tank*

The slurry was required to fill the void between the existing and new pump station. Measurements were taken of the existing pipe work so the tank could be manufactured with these holes in the right position. The manufacturer was required to core the holes so that the structural condition of the tank and the warranty was not jeopardised.

To improve the atmospheric conditions inside the wet well and the surrounding area, a higher vent stack, ventilation fan and a variable speed drive (VSD) to run the fan was installed. The ventilation fan was installed to educt the odours from the wet well and emergency storage and was manufactured from 316 Stainless Steel to stop any corrosion. Due to the high H₂S readings and previous corrosive environment from this pump station, a fibreglass 12 high vent stack was installed. The height of this vent stack and fan ensured a high dispersion rate of odour, which will reduce any potential odour complaints. By using a fibreglass pump station and vent stack this eliminated the risk of corrosion. A VSD was installed to the ventilation fan so adjustments could be made to suit the environmental conditions. eg. higher flows during the summer period when odours are highly concentrated.
