NON-INVASIVE REHABILITATION TECHNOLOGIES

Ed Ahern, Director,

Nuflow Technologies 2000

*38th Annual WIOA Qld Water Industry Operations Conference
Parklands, Gold Coast
4 June to 6 June, 2013*

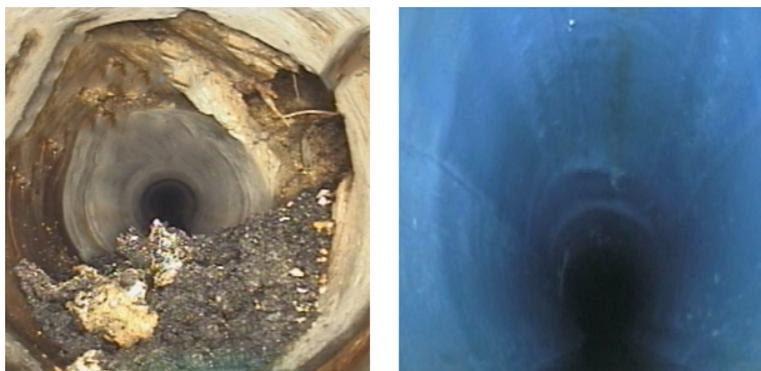
Figure 2: *Before and After Images of Mingaletta Street, Gold Coast Utilising Non-Invasive Rehabilitation Technologies.*

One example of the use of this new technology was Mingaletta Street in Ashmore on the Gold Coast. Due to the quantity of rain endured over several months a large sinkhole had developed in the road above the stormwater pipe. The road appeared to settle further down after every rain event and in order to address this problem, bitumen was poured into the hole in the road. This bitumen eventually found its way into the stormwater pipe (Figure 2). After viewing CCTV footage of the pipe under the sinkhole, it was apparent that there was a substantial hole 12m in from the manhole (Figure 2). In addition to the sinkhole in the middle of a road, there were also two large electrical conduits sitting directly over the top of the pipe.

There was also root intrusion from trees in the vicinity of the pipe. In order to use the new technology to repair the pipe, it was first cleaned using a high pressure water jet. It was then re-inspected before commencing the reline.

Fifteen meters of 300mm reinforced concrete stormwater line was rehabilitated utilising non-invasive rehabilitation technologies. This repair was carried out utilising a fast cure resin resulting in the job being completed within 10 hours with minimal disruption to local residents and traffic. A catalyst is added to the resin, forming a fast cure resin, accelerating the curing process.

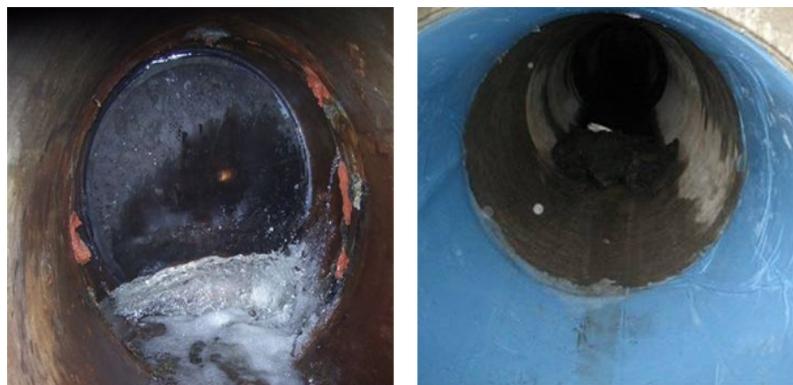
Figure 3: *Before and after images of Tugun Bypass, Gold Coast utilising non-invasive rehabilitation technologies.*

With only two weeks until the official opening and pressure to complete the project on time, the contractors were looking for a way to stop the large amount of groundwater infiltrating through joints in the large bore pipes underneath the newly finished motorway. There had been a number of attempts to fix the problem from other contractors using putty, expanding foam, injection or grouting. None were successful due to the water pressure pushing through the gaps back into the pipe.

The pipe was repaired utilising a non-invasive rehabilitation technology, this successfully prevented water from infiltrating into the 600mm diameter steel reinforced concrete storm

water pipe. The relining saved over three months delay in the opening of the Tugun Bypass. The cost savings was in the \$100,000's compared to conventional excavation options.

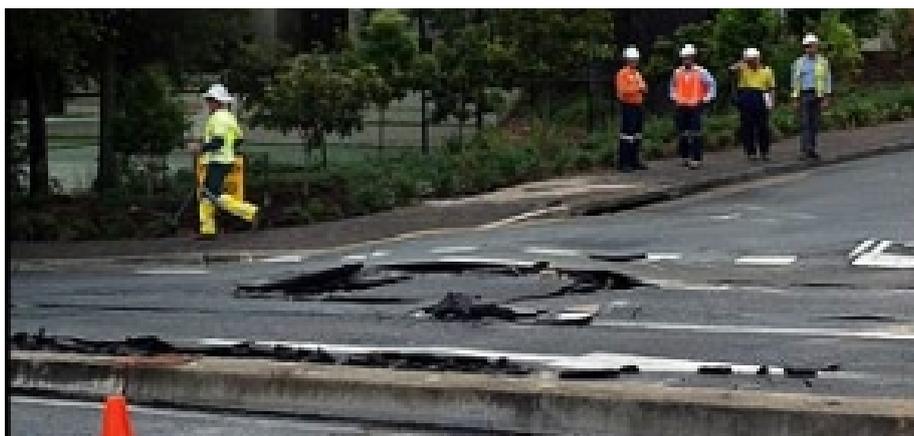
(Source: Gold Coast Bulletin, April 2013)

The below images are an example of the significant disruption caused by the damaged pipe in Surfer Paradise on the Gold Coast in April.

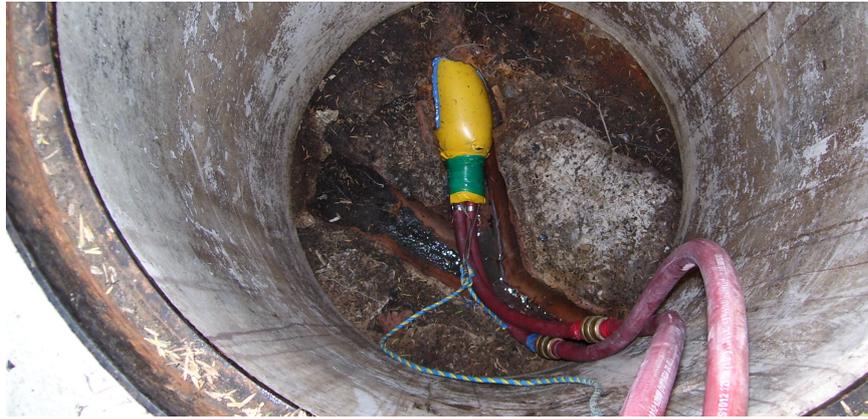
Figure 4: *Images of Zillmere Train Station, Brisbane utilising non-invasive rehabilitation technologies. This illustrates how utilising an existing access point, a line and bladder is inserted into the pipe and inflated, creating a structural repair.*

In another example, a busy rail route (Zillmere Train Station, Brisbane, see Figure 4) was under threat of collapsing as the tracks ran over a stormwater line that was in extremely poor condition. Closing the tracks would have resulted in major disruptions to commuters and would have involved a significant amount of excavation works.

The pipe ran from one manhole, underneath two sets of railway tracks, to another manhole located in a car park. It was several meters deep and excavation would have meant closing down the train lines that run from Brisbane to the Gold Coast. The line was cleared and 41 meters of stormwater line with seriously displaced joints was relined utilising a non-invasive rehabilitation technology, without any excavation and disruption to the rail system while the works were undertaken.

Using our latest resin technologies, and Hot Water Cure Systems, the line was structurally relined in less than 24 hours using a 3 man crew.
