# HOW TO TRAIN YOUR CENTRIFUGE: AN EXERCISE IN PROCESS OPTIMISATION AND THE BENEFITS OF INTER-CORPORATION NETWORKING

**Jarrah Feather**, *Wastewater Treatment Team Leader,*

East Gippsland Water

*76<sup>th</sup> Annual WIOA Victorian Water Industry Operations  
Conference and Exhibition  
Bendigo Exhibition Centre  
3 to 5 September, 2013*

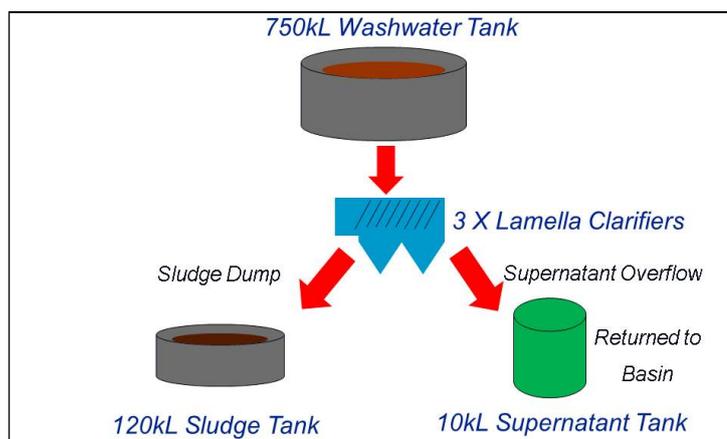
The washwater system at Woodglen WTP is comprised of a 750kL washwater tank, 3 lamella clarifiers, a supernatant return tank and sludge tank as detailed in Figure 1.

**Figure 1:** *Woodglen water treatment plant washwater system*

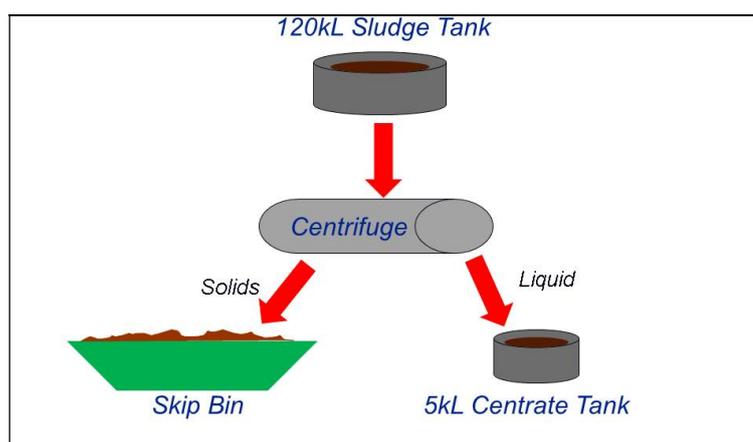
The sludge from the sludge tank is pumped through a centrifuge where it is dewatered and the cake deposited into a skip bin. The centrate is returned back through the washwater system or to a raw water storage (depending on quality) via the centrate tank and pumps as detailed in Figure 2.

**Figure 2:** *Woodglen water treatment plant sludge handling system*

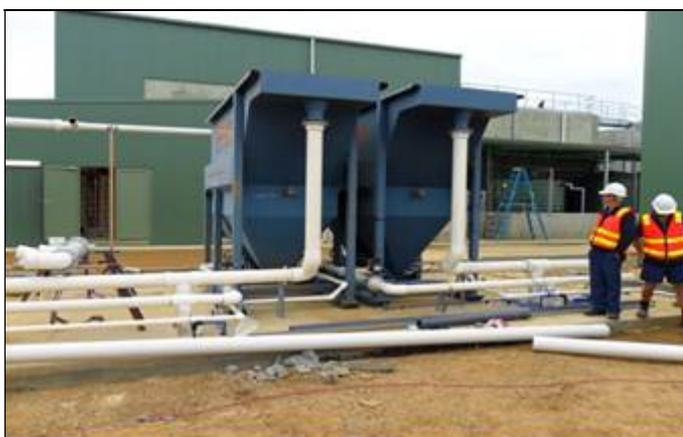
There was little that could be done about the lamella clarifiers themselves, apart from a complete replacement/augmentation which was not viable at the time. They are purpose built to produce high quality supernatant and were purchased for another treatment project and reused at the Woodglen WTP. The way they were operated was an area that could be improved and was the focus of some of the rectification works detailed below.

**Figure 3:** *Lamella clarifiers used to process washwater at Woodglen WTP*

Modifications made to lamella clarifiers and washwater system were as follows:

1. Installed pneumatic desludge valves on both lamella clarifier chambers
2. Installed site tubes for visual confirmation of optimal desludging
3. Installed speed restriction devices on desludge valves to reduce hydraulic shock
4. Installed floating pump on sludge tank to remove excess water (i.e. converting the sludge mixing tank to a thickening process)
5. Removed every second plate from within the lamella clarifiers to prevent interplate clogging
6. Increased supernatant discharge pipe diameter
7. Optimised polymer LT27 dose – reduced concentration of polymer batch and reduced dosage significantly from 100mg/L to 13mg/L
8. Built new sludge cake holding skip with spreading auger.

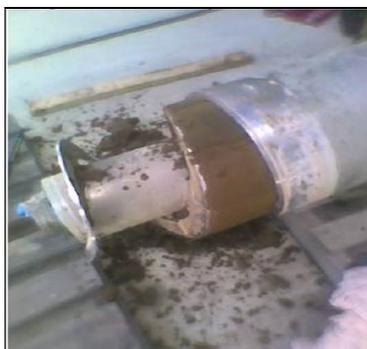
The improvements had obvious and significant impacts on cost and time, yet operators were still being frustrated by repetitive blockages and having to spend considerable amounts of normal work time and overtime nursing the centrifuge through its cycles. Soon after the above rectification works were completed, a significant blockage occurred that was not able to be cleared (see Figure 4 below). This led to an extended period of centrifuge downtime.

**Figure 4:** *Blocked centrifuge that led to significant period of down-time for the Woodglen WTP washwater system.*

Due to this long period of down-time, a tanker truck was contracted indefinitely to remove the non-dewatered sludge from the sludge tank. The tanker ran on demand for over 3 months and cost in excess of \$25K. The centrifuge supplier's service agent was employed to completely dismantle the centrifuge, unblock it and run a staff training session on how to get better and more reliable performance out of it.

Once unblocked, the centrifuge was reassembled, tested, thoroughly flushed and switched off indefinitely. There was great hesitation and reluctance from all departments within EGW to restart the centrifuge until there was some certainty that it would not block again. It was at this point that operations came to the conclusion that external help from within the industry was needed. Accordingly, a call was made to colleagues at Gippsland Water.
