WATER MAIN CLEANING – A NEW ERA

*8th Annual WIOA
NSW Water Industry Operations Conference and Exhibition
PCYC in Orange,
1 to 3 April, 2014*

Alan Butler, *Water & Sewer Technical Coordinator*, Wingecarribee Shire Council (WSC)

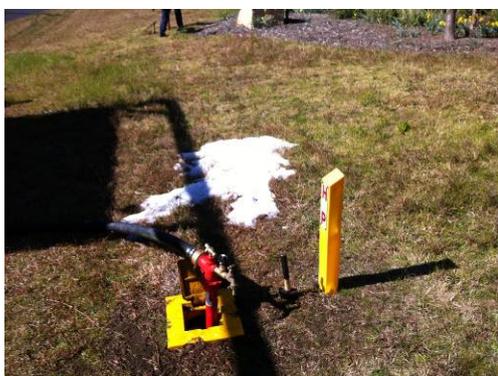
Figure 2: *Ice insertion*

Ice Pigging a relatively new technique for cleaning drinking water pipes using slush ice. The technique, known as Ice Pigging was invented for use in the food industry but has shown to have numerous benefits that can now be effectively applied to drinking water networks. There are two major benefits that ice pigging brings, the first is the volume of water to be disposed of is a fraction of the other techniques. If flushing a main usually generates 3 to 4 pipe volumes of water, and sponge pigging generates 3 to 3.5 pipe volumes of water that needs to be disposed of, ice pigging with its 1.5 pipe volumes of water is an environmentally sustainable option with a fraction of the disposal costs and water loss. The second benefit is the ease in which the ice pig is inserted into and withdrawn from the pipe. It is simply inserted through a standard hydrant and removed through a second further along the pipeline.

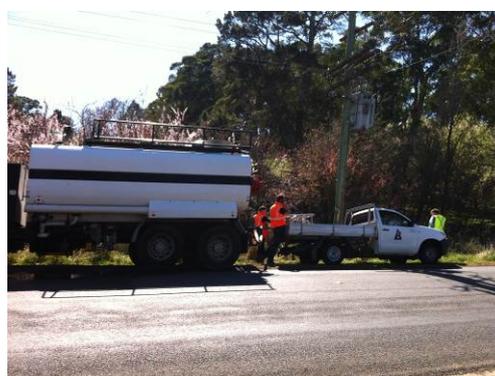
Figure 3: *Ice extraction*

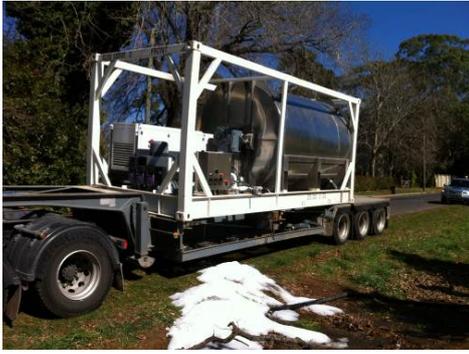
Figure 5: *Ice delivery Unit*

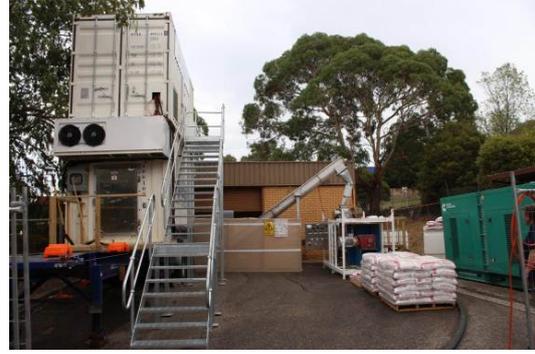
Figure 6: *Ice Making Plant*

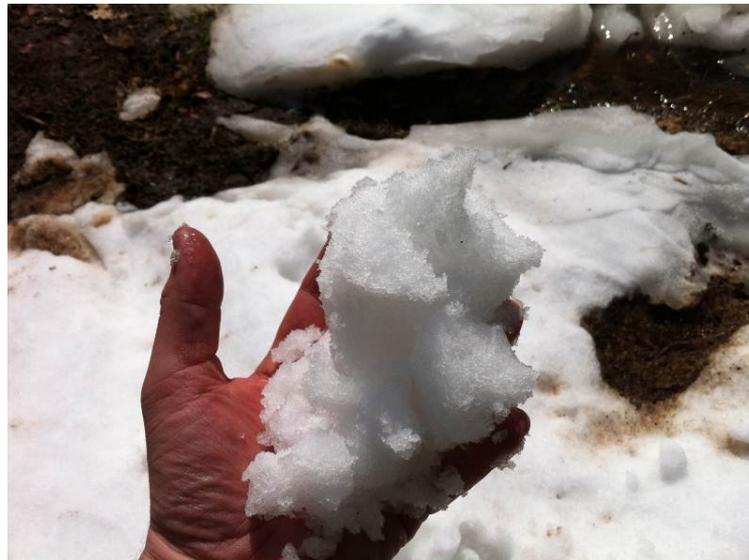
Figure 7: *Ice Slush for the Pig*

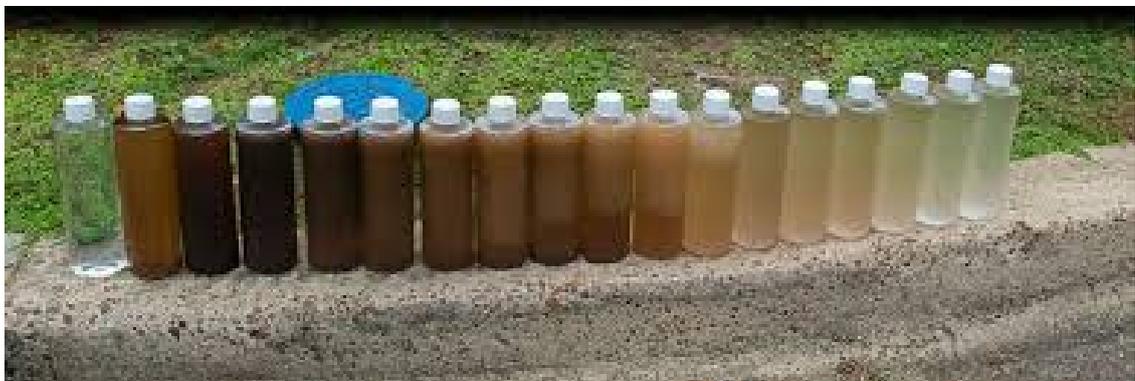
Figure 8: *Ice & Water samples during cleaning*
