WATER TREATMENT TROUBLE-SHOOTING AND INNOVATIVE SOLUTIONS

Mark Samblebe, *Manager - Technical Services and Innovation,*

*8th Annual WIOA
NSW Water Industry Operations Conference and Exhibition
PCYC in Orange,
1 to 3 April, 2014*

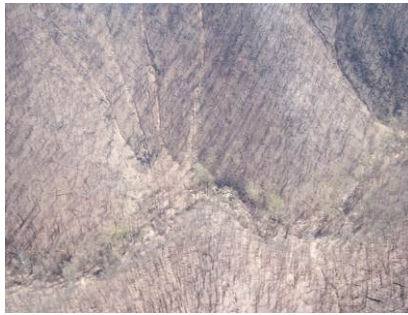
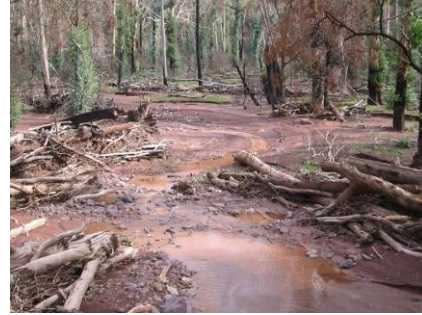
Figure 1: *Bushfire impacted catchments, Mitchell and Macalister Rivers.*

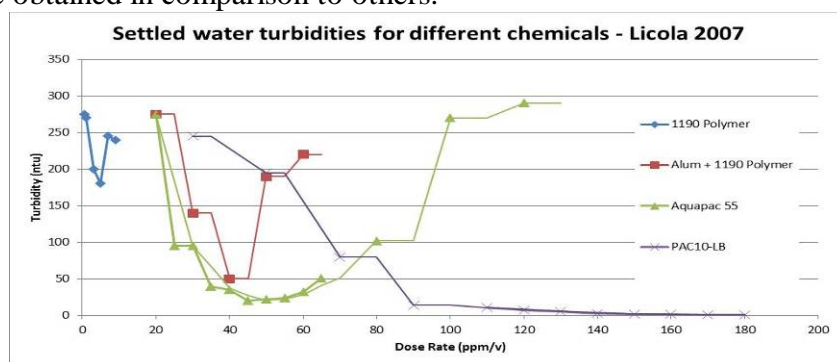
Figure 2: Settled water turbidity results for a range of chemicals tested at Licola

Similarly to Wangaratta's DF plant, Poly-Aluminium Chloride was selected at Licola, PAC10 – LB – a product with low basicity meaning its impact on pH was minimal or non-existent. This chemical also proved to have a very wide operating range where good results were obtained in comparison to others.

Despite favourable results in the jar tests it was difficult to achieve the same floc formation in the real situation. Further jar tests indicated that the chemistry was strongly dependent on mixing to ensure the coagulant wasn't just swamped with solids rendering the active charges trapped inside. A rapid mixer was installed, this consisted of a 200L drum with rocks in the bottom half, the inlet was diverted to the bottom of the drum and disruption of flow and mixing achieved delivering results, where good sized floc particles were observable before the water left the drum to the floc tank/settling zone of the pool.

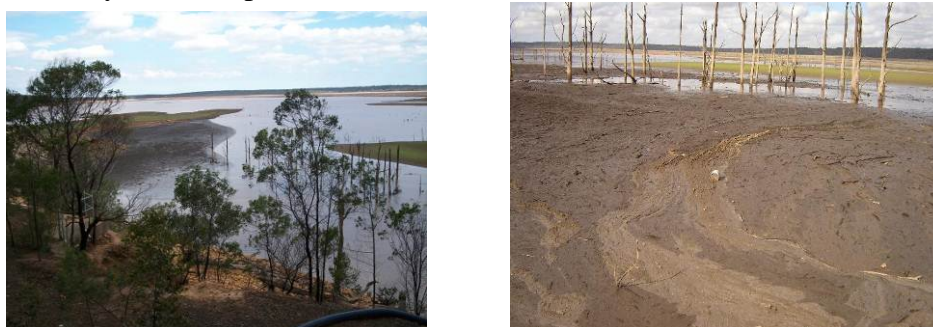
Figure 3: Coongulla raw water offtake buried in mud and debris.

Downstream from Licola, both the Coongulla and Maffra Water treatment plants drew water from the Macalister River. Coongulla was ultimately taken off line as the offtake was inundated by mud and debris.

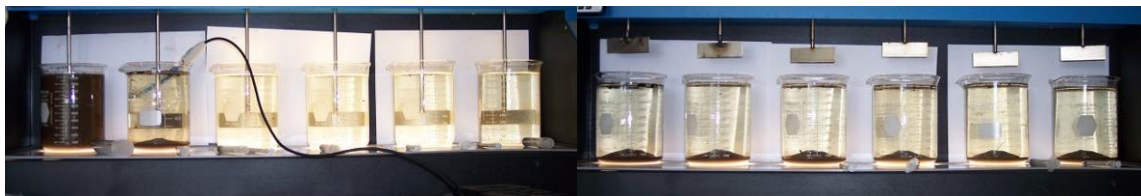
Figure 4: *Jar tests on the Macalister River water Licola.*
