OUT WITH THE OLD AND IN WITH THE NEW- THE
UPGRADE OF THE YOUNG SEWAGE TREATMENT
PLANT

Young Shire Council

8th Annual WIOA
NSW Water Industry Operations Conference and Exhibition
PCYC in Orange,
1 to 3 April, 2014

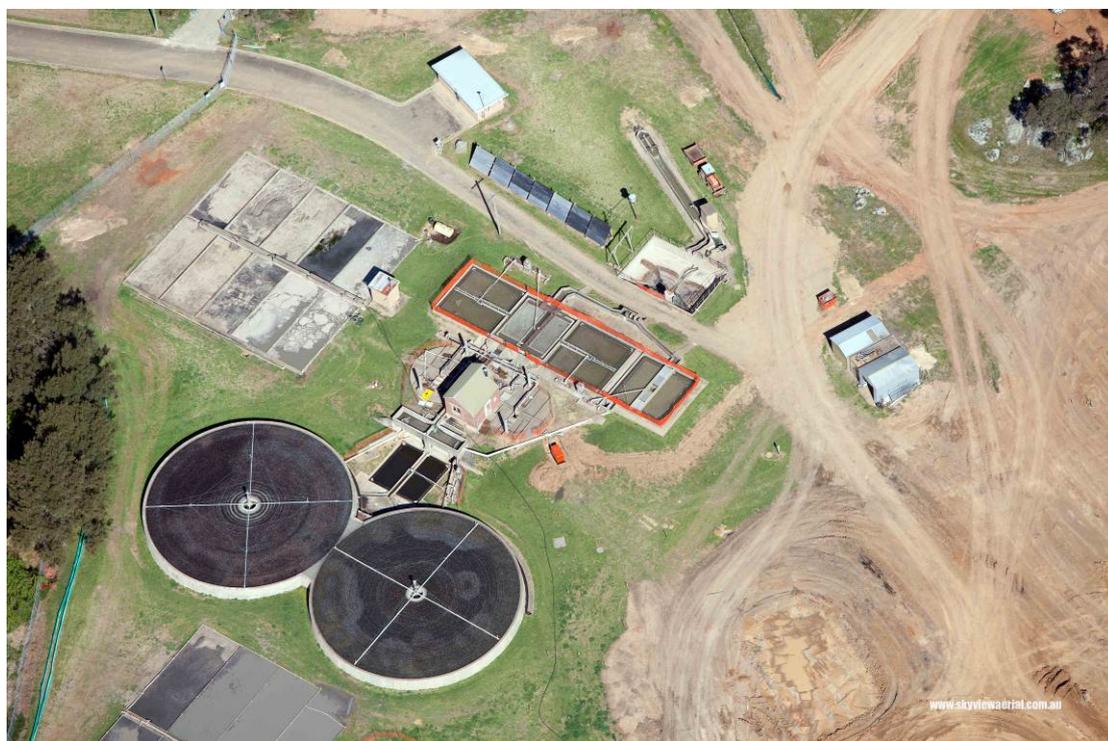
Figure 1: *Young's Trickling Filter Plant built in 1938.*

The original Young trickling filter plant had been designed to treat between 3,500 to 5,000 EP. It was commissioned in 1938 with a minor upgrade in the 1970's which included an inlet channel and flume with bar screenings, flow meter and a comminutor. A storm water balance tank was also installed with four submersible pumps to deliver flow up to the Imhoff tanks and sedimentation tanks. To cater for the extra flow an additional sedimentation tank was added including a separate pipe across to the dosing channels for the effluent and a valve in the tank to drain sludge off the directly into the No.1 Digester.

The two digesters were originally used as number 1 and number 2 with supernatant drawn off at different levels from the number 2. In the early 1980's the energy authority of NSW provided funding to install solar heating panels which ran water up through a header tank, then through the panel and into a boiler room which was controlled by a sundial. The sundial would turn the solar panels off when there was insufficient sun to heat up the water and turn a diesel boiler on to keep heating the water which was added to the number 1 digester into a set of six horse shoe like pipes and back around into either the boiler or the solar panels.

An additional humus tank was also installed to divide the flow coming from the trickling

filters between two humus tanks. The new humus tank had a sludge wet well with a submersible pump in it so they could return activated sludge back to the head of the works. Sludge from the number 2 digester was either pumped into the drying beds in the summer or into two sludge lagoons in the winter. Effluent was gravity fed to tertiary ponds for further cleaning with natural UV.

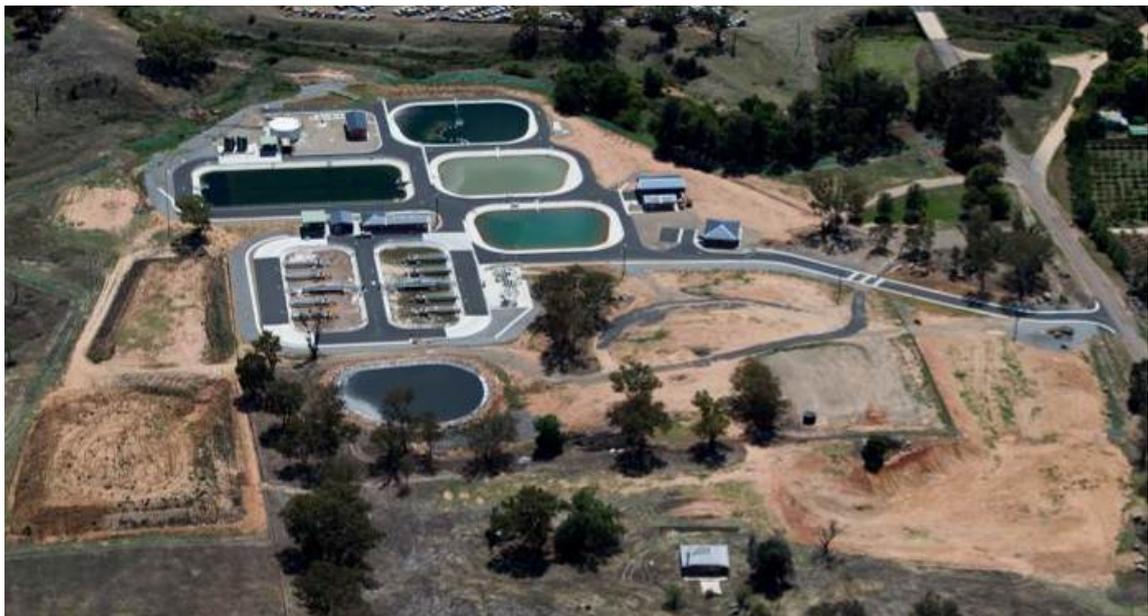
Figure 2: *Young's IDEA Plant March 2014.*

The upgraded treatment plant is designed as an activated sludge system. The plant process consists of the inlet; IDEA reactors; effluent balance tank; a disinfection system comprising of UV and chlorination; chemical dosing of alum, caustic and chlorine and sludge handling and dewatering system. The design plant load is 12000 EP with an average dry weather flow of 223L/EP/day. The inlet caters for screening >5mm and consists of a grit removal for 0.2mm. The inlet flow is recorded by flow measurement through the flume and also has a flow diversion for flows that exceed 412L/s that is bypassed to the effluent ponds.

The activated sludge process comprises BOD removal; suspended solids removal; nitrogen removal through nitrification & denitrification; intermittently decanted extended aeration cycle and sludge age. The IDEA reactors are activated bio-reactors producing secondary treated quality effluent. The tanks are fed from both ends to minimise short circuiting. The tanks can conduct full treatment for up to three times average dry weather flow (ADWF) and partial treatment for up to seven times ADWF. Typically, the IDEA tanks complete 8 cycles a day consisting of aeration, settling and decant.

Chemical dosing of alum for phosphorus removal and caustic for pH control is dosed into the IDEA tanks. The effluent is disinfected by UV, this can operate at full treatment up to 118L/s and partial treatment for flows up to 300L/s. Liquid sodium hypochlorite is then dosed into the effluent utilised for reuse into the rising mains. There are three sludge lagoons onsite which can be used periodically throughout the year with one being filled, one stabilising and one ready for dewatering. With the new plant came a more extensive regime of testing and monitoring. Onsite testing includes mixed liquor suspended solids, depth to sludge blanket, pH, and phosphorus, nitrates, ammonia and suspended solids.
