THE SUCCESSFUL USE OF GEOTUBES FOR EMERGENCY SOLIDS HANDLING

Gene Heffernan, Operator,

Seqwater

*39th Annual WIOA
Queensland Water Industry Operations Conference and Exhibition
Logan Metro Indoor Sports Centre, Logan
3 to 5 June, 2014*

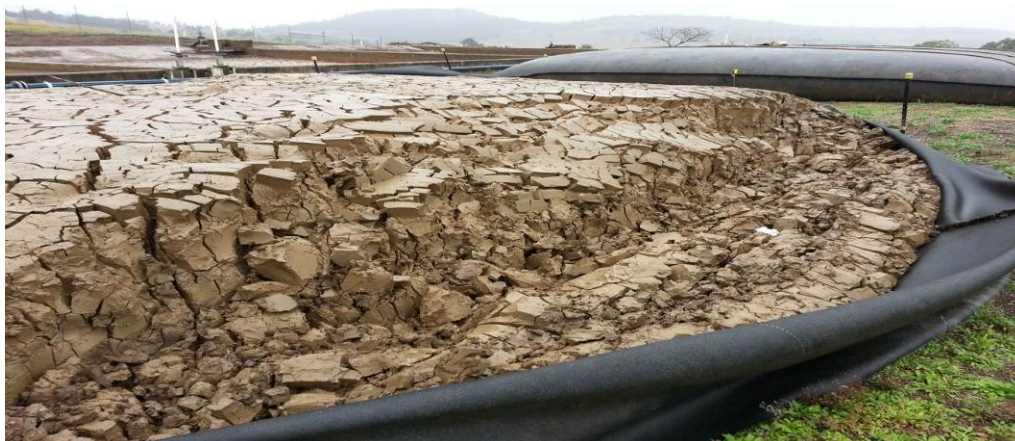
Figure 1: *Photo showing geotube cut open for disposal*

As part of a Flood Resilience Scheme adopted by Seqwater, a project to implement a solids handling upgrade on site was planned, requiring the existing 3 geotubes to be removed. On 3 May 2013, the geotubes that were installed two years prior were taken offline, and on 24 May they were cut open to help with the drying process. Two months later, approximately 400m³ of dried sludge from the geotubes was trucked off site to landfill.

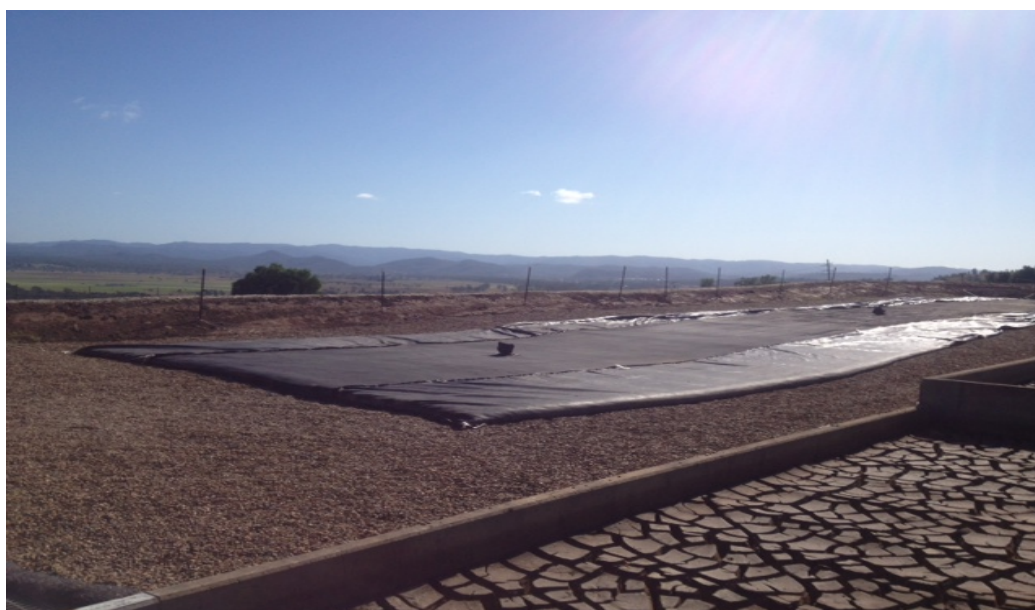
Figure 3: *New geotube being commissioned*

During the time of geotube installation the weather also was not very favourable, with three weeks of rain hindering the project and delaying the earth works. With the first of the two geotubes installed and completed, we began to commission the system. To pump the sludge to the geotube, we used the existing sludge pumps that feed the sludge drying beds. These are two submersibles that pump between 7-12 L/sec with valves used to divert the flow between the geotube and drying beds. Using a similar process to the first 3 geotubes, polymer was dosed to help separate the water from the solids. Polymer LT25 was added at a dose rate of 0.25 mg/L. A ripening period was also needed with the big geotube, which took approximately one week before clean effluent passed through, leaving the sludge behind.
