# **UNITYWATER'S REDCLIFFE SEWAGE TREATMENT PLANT – THE ROAD TO RECOVERY**

**James Castle, Treatment Plant Operations Manager,  
King Intrapaiboon, Manager Treatment Plants,  
Robin Cherry, Operator-in-Charge,**

*39th Annual WIOA  
Queensland Water Industry Operations Conference and Exhibition  
Logan Metro Indoor Sports Centre, Logan  
3 to 5 June, 2014*

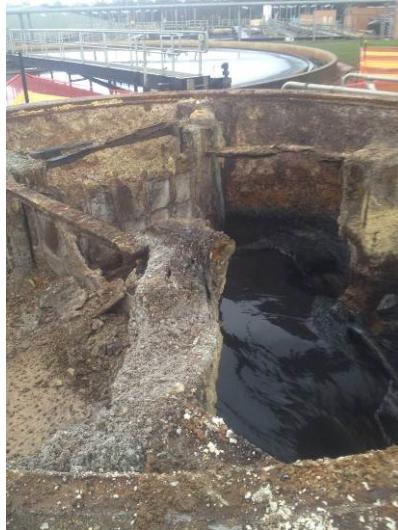
**Figure 1:** Existing primary clarifier flow splitter with covers removed

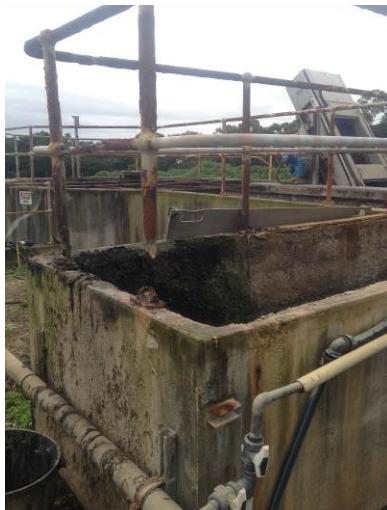
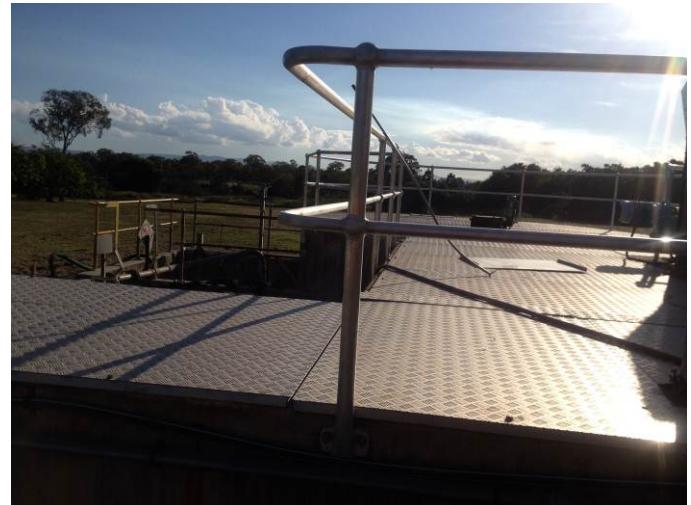
**Figure 2:** *Inlet works with deteriorated walkways removed (left); after making the area safe (right)*

- Refurbishment and reinstatement of normal operation of the step screen
- Reinstatement of grit vortex mixer and improvements to the grit removal system

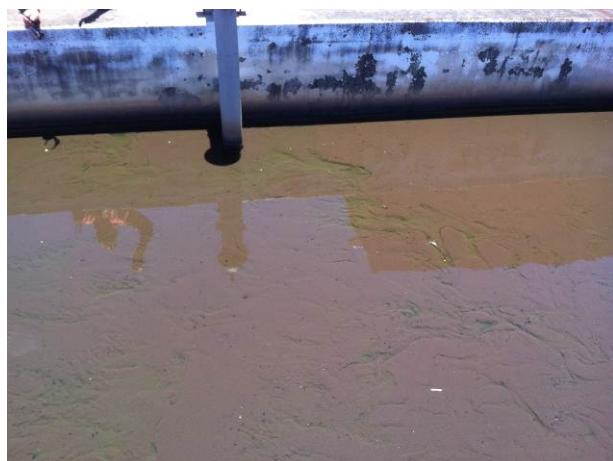
- Ammonia profiling of the reactor demonstrated that nitrification was occurring in the bioreactor, but ammonia levels would suddenly increase within a particular cell
- Lifted an a-recycle pump for an electrical check – electrician stated there were no issues and pump was rotating correctly
- Undertook a dye test within the reactor- identified short circuiting (see Figure 3)
- Lifted the pump again – electrician stated that there was nothing wrong with the pump
- Thought that the pump must not be sitting properly and therefore pumped down the bioreactor and identified that despite the a-recycle pump impeller rotating, flow was going in the opposite direction
- Lifted the pump for a third time – identified that the VSD was intermittently faulting
- Checked the other a-recycle pumps – found 3 of 4 pumps with the same issue.

**Figure 3:**      *Bioreactor 4 dye test*
