# WATER TREATMENT TROUBLE-SHOOTING AND INNOVATIVE SOLUTIONS

**Mark Samblebe**, *Manager - Technical Services and Innovation,*

*39th Annual WIOA  
Queensland Water Industry Operations Conference and Exhibition  
Logan Metro Indoor Sports Centre, Logan  
3 to 5 June, 2014*

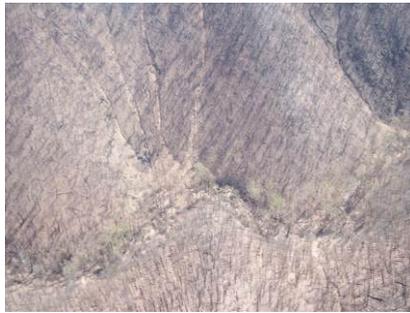
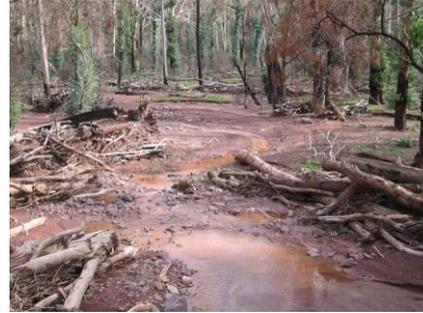
**Figure 1:** *Bushfire impacted catchments, Mitchell and Macalister Rivers (Vic).*

From an emergency event in Yarrawonga in 2002 caused by draining of Lake Mulwala for remedial works on the dam wall where manganese levels up to 0.42mg/L were observed and later in a separate event at Springhurst we saw Mn as high as 1.2mg/L. To the 2003 & 2007 bushfires which after heavy rain led to mud slides in the catchments and raw water turbidities commonly over 1000ntu and up to 4000ntu in Wangaratta and Licola, Coongulla, and Maffra. Similar turbidities were seen in a dirty water event at Moe in 2007, caused by heavy rain in an unburnt catchment predominantly occupied with potato farms that had recently been ploughed leading to significant erosion.

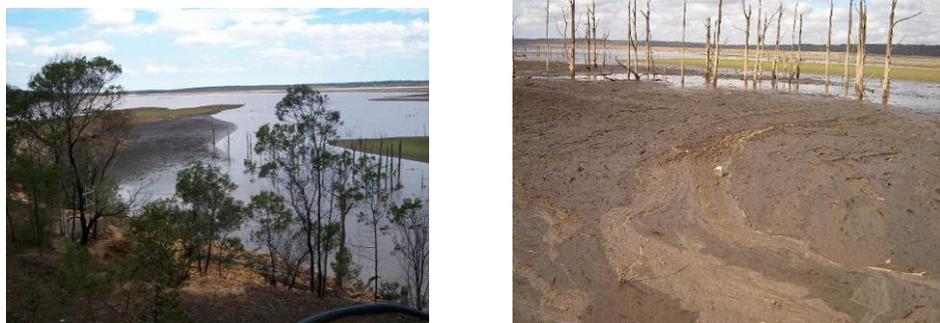
**Figure 3:** Coongulla raw water offtake buried in mud and debris.

Downstream from Licola, both the Coongulla and Maffra Water treatment plants drew water from the Macalister River. Coongulla was ultimately taken off line as the offtake was inundated by mud and potable water had to be trucked in.

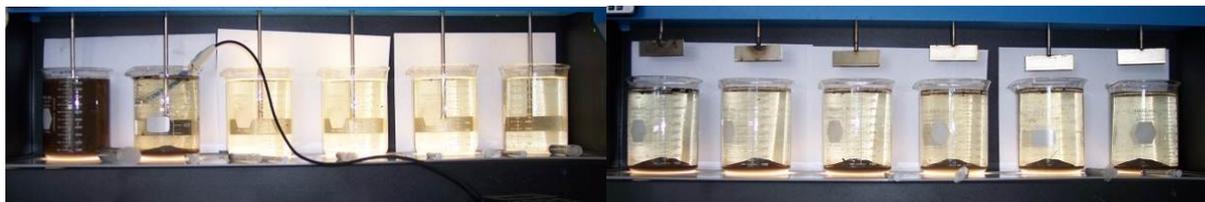
**Figure 4:** *Jar tests on the Macalister River water Licola.*
