UNITYWATER'S REDCLIFFE SEWAGE TREATMENT PLANT – THE ROAD TO RECOVERY

James Castle

Unitywater

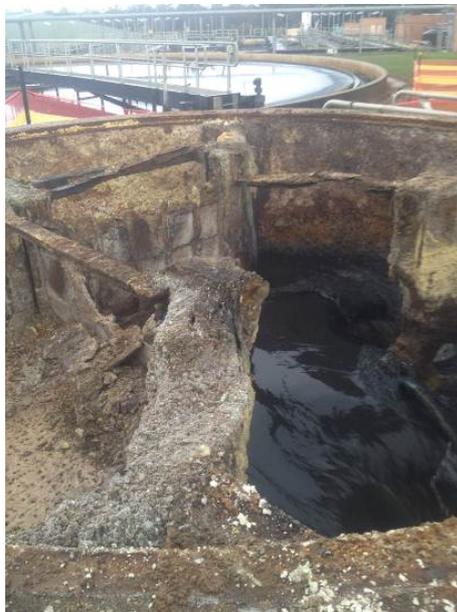
Figure 1: *Existing primary clarifier flow splitter with covers removed*

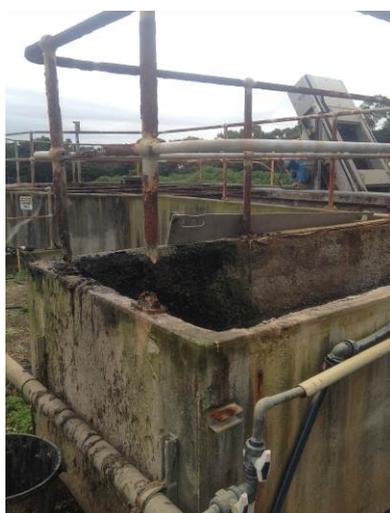
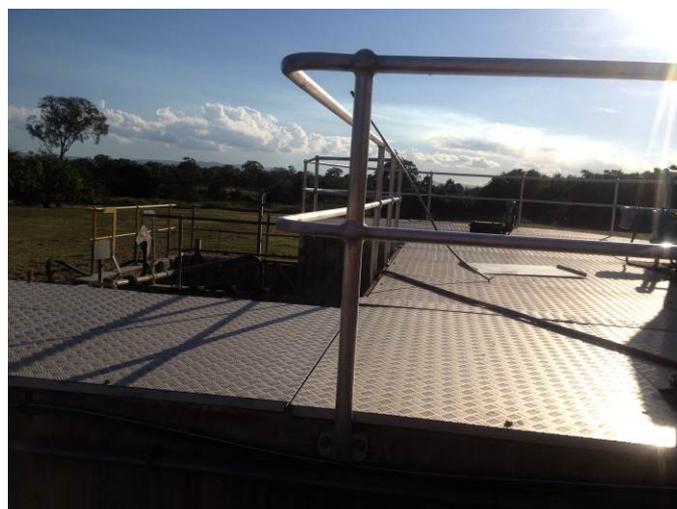
Figure 2: *Inlet works with deteriorated walkways removed (left); after making the area safe (right)*

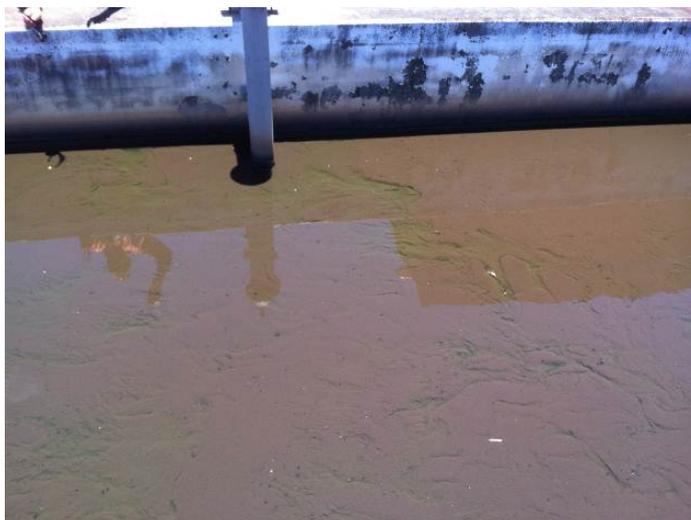
- Ammonia profiling of the reactor demonstrated that nitrification was occurring in the bioreactor, but ammonia levels would suddenly increase within a particular cell
- Lifted an a-recycle pump for an electrical check – electrician stated there were no issues and pump was rotating correctly
- Undertook a dye test within the reactor- identified short circuiting (see Figure 3)
- Lifted the pump again – electrician stated that there was nothing wrong with the pump
- Thought that the pump must not be sitting properly and therefore pumped down the bioreactor and identified that despite the a-recycle pump impeller rotating, flow was going in the opposite direction
- Lifted the pump for a third time – identified that the VSD was intermittently faulting
- Checked the other a-recycle pumps – found 3 of 4 pumps with the same issue.

Figure 3: *Bioreactor 4 dye test*
