**OUR JOURNEY:
ONE COUNCIL'S EXPERIENCE FROM A SERIOUS
INCIDENT**

Craig Hamilton, WHS Co-ordinator,

Mackay Regional Council

*40th Annual WIOA
Queensland Water Industry Operations Conference and Exhibition
Clive Berghofer Recreation Centre,
University of Southern Queensland, Toowoomba
16 to 18 June, 2015*

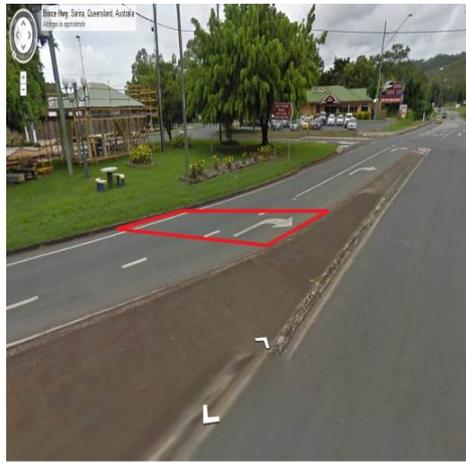
The trunk sewerage main concerned serviced approximately 2,000 properties, and was located in the Sarina CBD, under the Bruce Highway.

Figure 1: *The Site – Looking South along Bruce Highway*

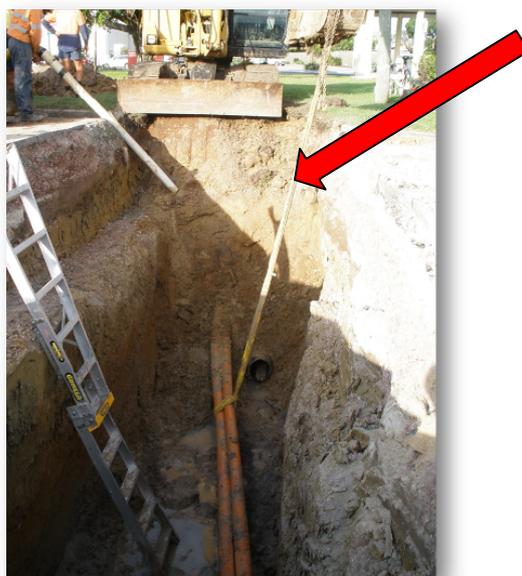
- Supervisor instructs his work team to attend site and investigate.
- The Supervisor was in regular contact with the work team, and directs their efforts from home. After initially failing to locate the blockage, at 10:30pm the Supervisor instructs the work team to move their focus to the sewerage main.
- The work team requests the Supervisor attend site. He arrives on-site at midnight Saturday 10 October.
- Work continues throughout the early morning to locate the blockage and unblock the pipe.
- Having located the blockage, at 6:30am attempts to clear the blockage were deemed ineffective.
- The Supervisor sent the night crew home, and arranged crews to attend site to conduct excavation and replacement works.
- Excavation work commenced and continued throughout the morning. The initial work included installing benching on only two sides of the trench.

- At an approximate depth of 3.5 metres, the length of blocked sewerage main was located. The cause of the blockage was a piece of electrical conduit which had been underbored through the pipe.
- Workers enter trench to locate the pipe. It is determined that the trench needs to be widened in order to gain better access to the pipe.
- Widening the excavation is completed by removing the benching on the south-side of the trench, which is not reinstated.
- Workers re-enter the trench to commence pipe repairs.
- At 2:45pm a section of the 3.5 metre trench wall collapsed, pinning a workers upper body and legs with dirt.
- Fire Brigade and Ambulance were called.
- Worker was stabilised and not immediately moved. Fire Brigade assisted with extraction, worker was treated and taken to local hospital.

Figure 2: *The Excavation – Showing Conduit, Pipe and Location of Wall Collapse*

Investigation showed that there was a failure to identify all hazards and risks, both initially and as works progressed. Those that were identified were not controlled adequately, only soft controls such as 'keep a look out' and 'be aware' were identified. Risks were also poorly communicated between crews on-site and at change of shift.

Regulation 2011 and the Code of Practice for Excavation Work 2012 – which talks about risk management, planning, controlling risks, and excavation methods. Of note, all sides of a trench which is greater than 1.5 metres in depth, must be benched, battered, or shored. Those less than 1.5 metres should be monitored, as workers have been killed and seriously injured in those as little as 600 mm deep. Persons within a trench must isolate sources of energy eg water, sewer, electricity to prevent hazardous exposure.

Investigation found that the Supervisor was temporarily absent from site during pivotal moments of activity, including when the southern side was benched. At these times a person was not designated to be in control of the workplace.

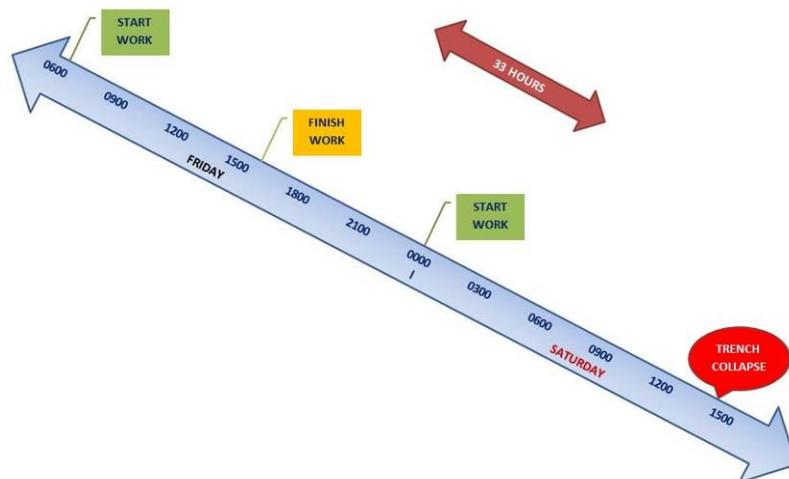
Figure 3: *Investigation Determined that at the Time of the Incident, the Supervisor had been Awake for 33 hours and was On-site for 15 hours.*

Mackay Regional Council has addressed this issue by implementing and monitoring compliance with a Fitness for Work Procedure.

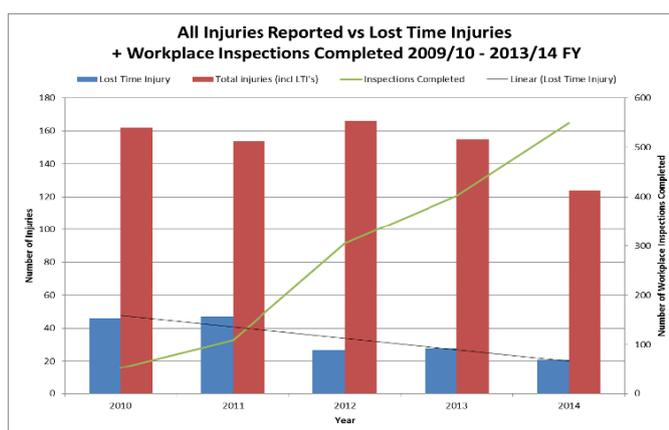
In the time since the incident, scheduled hazard inspections have been increased and are monitored. Hazard inspections assist in increasing hazard awareness in the workplace, and have assisted in the decrease in injuries and injury severity.

Figure 4: *Injuries Reported, LTIs Recorded, and the Increase in Workplace Hazard Inspections*
