FROM PREHISTORIC TO ARTESIAN GOLD - A JOURNEY IN WATER QUALITY IMPROVEMENT

Geoffrey Johnson, *Head Plumber and WTP Operator,*

Richmond Shire Council

*40th Annual WIOA
Queensland Water Industry Operations Conference and Exhibition
Clive Berghofer Recreation Centre,
University of Southern Queensland, Toowoomba
16 to 18 June, 2015*

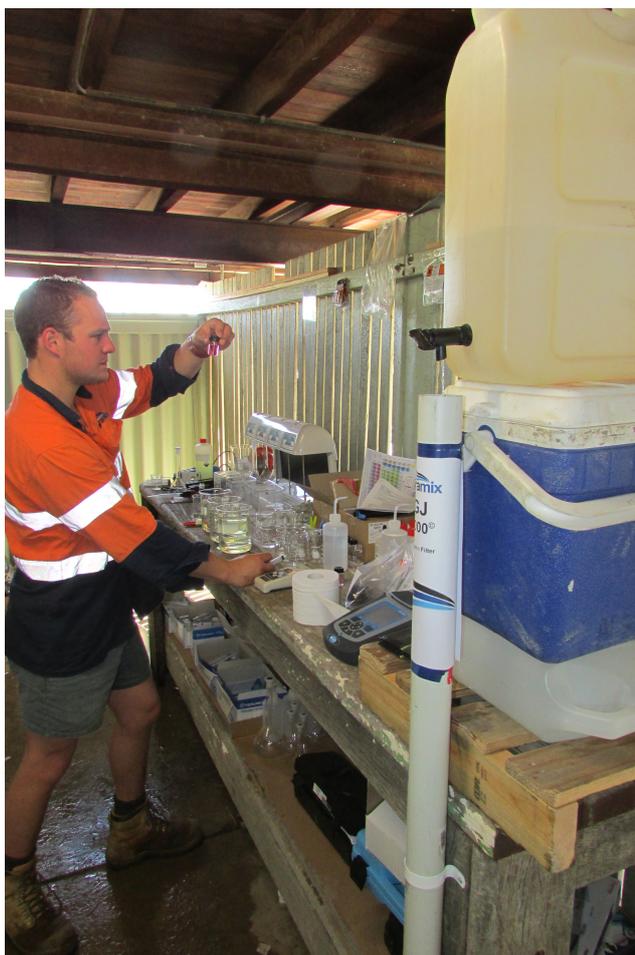
Figure 1: *A Temporary Laboratory Established Under a House.*

Aeramix offered a novel approach to development of the process utilising extensive on-site assessment of the process options and subsequent pilot scale testing to ensure a process that made maximum utilisation of the assets council had already purchased. They were also willing to utilise and engage council staff in their investigations into process options and then continue to utilise council staff and local contractors in the construction and commissioning of the plant supporting the local community. This gave us as RSC plumbers, soon to be WTP operators a much improved understanding of the plant and how it was to operate once completed.

Results were promising after pilot scale testing and assessment of different filter media configurations, where samples entered into the QLD Water Directorate – Orica water taste test, not only won the best water in the north west, but also won the best tasting water in all of Queensland. An achievement that set the bar high for expectations when the full scale plant was delivered.

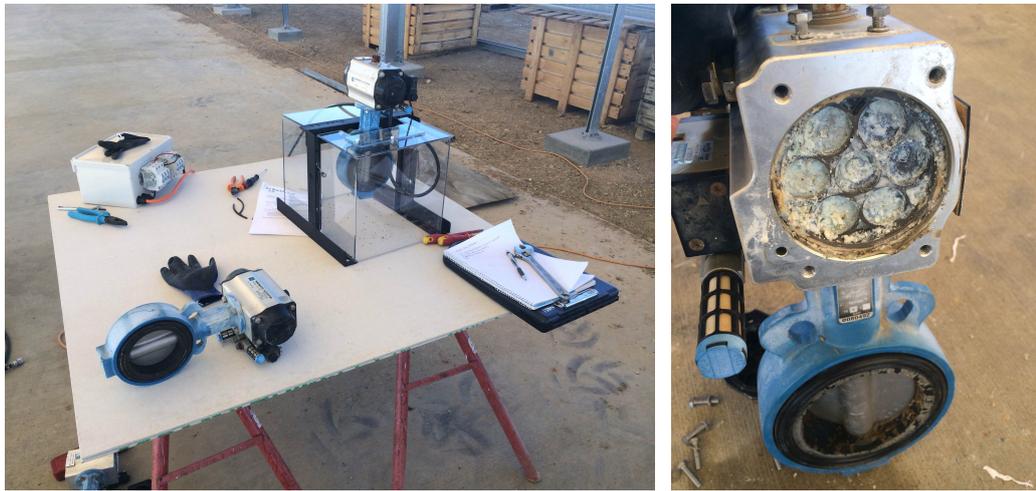
Figure 2: *Actuator Test Bench and a Failed Actuator Damaged by Water*

We developed procedures and processes for testing of equipment and worked closely with the team to assess and quality test key pieces of equipment. This was a time consuming but in the end very worthwhile activity as multiple failures of equipment were identified along the way which would have caused havoc in commissioning had they not been identified prior to installation.

Although 95% of the pressure vessels passed the pressure testing, the pneumatic actuators were a different story. Of approximately 140 actuators that came with the skid mounted systems, something like 25% failed due to a variety of malfunctions. Fortunately we identified enough actuators in working order to satisfy the design requirements of the plant and so far there have been no failures. The team certainly did their best to minimise cost and utilise this equipment, however we were aware of the inherent risks using the second hand components would place on the ongoing operation and performance of the plant.

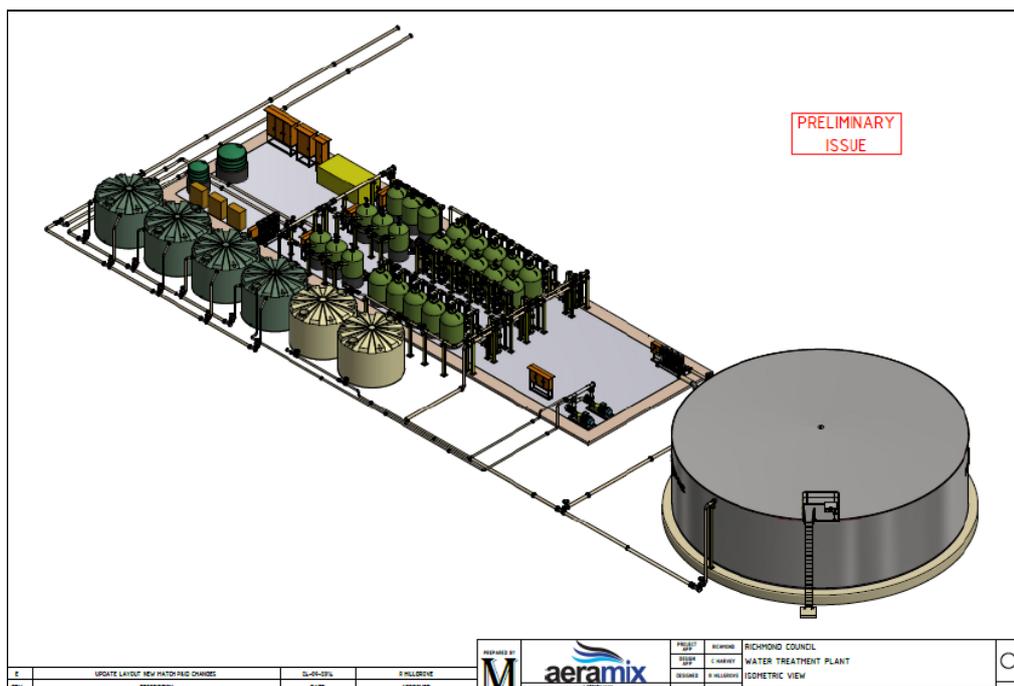
Figure 3: *3D Image of Proposed WTP Layout*

The detailed design and 3D drawings looked promising and the reconfigured components were arranged to fit an existing slab. Although the initial design only had two trains of 6 filters, council had additional vessels they were keen to utilise, so a revision produced a design with three trains of five filters with three flocculation tanks each. This also provided redundancy and capacity to maintain supply during planned or corrective maintenance.
