# TOOWOOMBA WATER SUPPLY NETWORK WESTERN TRUNK MAIN REPAIRS AND CHALLENGES

**Ken Dickson**, *Senior Coordinator (Water and Wastewater Maintenance),*

Water Services Group, Toowoomba Regional Council

*40th Annual WIOA  
Queensland Water Industry Operations Conference and Exhibition  
Clive Berghofer Recreation Centre,  
University of Southern Queensland, Toowoomba  
16 to 18 June, 2015*

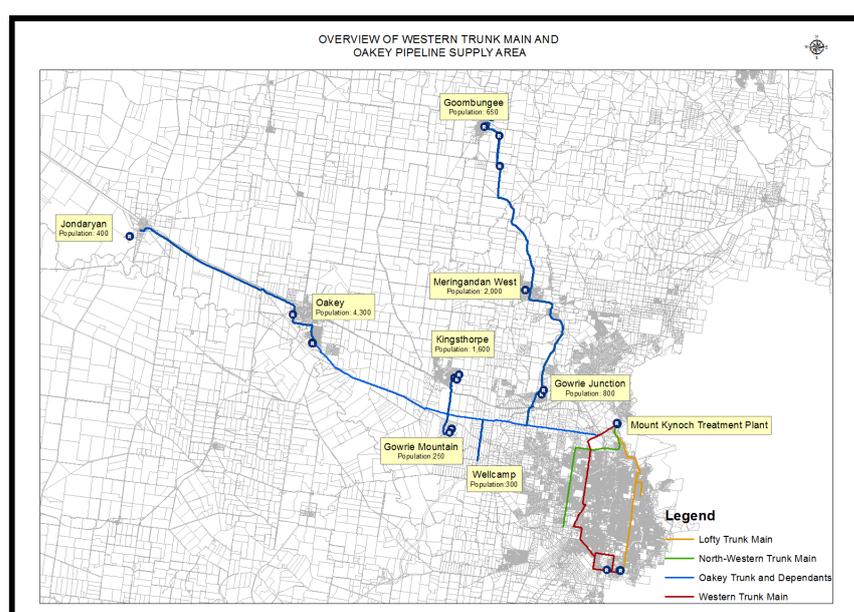
**Figure 1:** *Extent of Water Supply from the Western Trunk Main*

Western Trunk Water Main (WTM) is one of the critical water mains in the Toowoomba water supply network. The WTM delivers treated water from the Mount Kynoch Water Treatment Plant (KWTP) to the western part of Toowoomba City and to outlying western townships and areas including Oakey, Kingsthorpe, Gowrie Mountain, Gowrie Junction, Meringandan, Goombungee, Toowoomba Enterprise Hub – Charlton and the Brisbane West (Wellcamp) Airport via the Toowoomba - Oakey pipeline.

The WTM operates at a high pressure (up to 2,000 kPa) and was originally designed to distribute water to the western suburbs of Toowoomba. In 1998, the Toowoomba – Oakey pipeline was connected to the WTM to supply water to Oakey and western townships. Figure 1 provides the details.

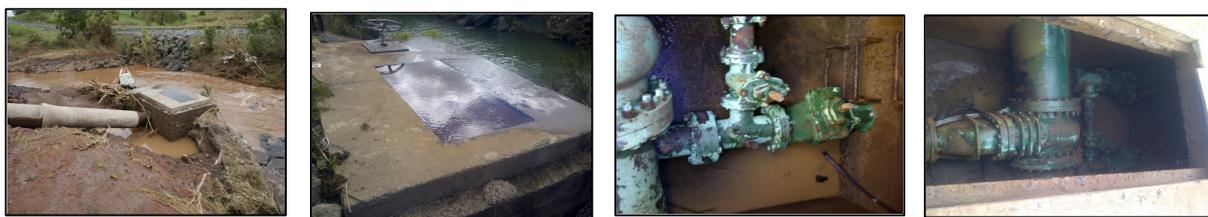
**Figure 2:** Condition of the Gowrie Creek WTM Valve Chamber and Pipework

When constructed, a combined isolation valve and scour valve in a valve chamber was installed on the western bank of at the Gowrie Creek for operational and maintenance purposes. As a result of Gowrie Creek bank erosion over the years, the valve chamber was in the flow path of the creek. This contributed to the erosion of the western bank during the 2011 floods. The isolation valve and the associated steel fittings were badly corroded and there were some leaks due to corrosion and pitting. Figure 2 illustrates the condition of isolation valve installation at Gowrie Creek.

Whilst replacement of the installation was required, due to other operational and maintenance issues at that time, an emergency repair was completed by welding a piece of steel over the leak. These repair works were completed within two days, with a reliable water supply maintained from available reservoir storages. However, the risk of failure was very high as the isolation valve, pipes and fittings were in very poor operational condition.

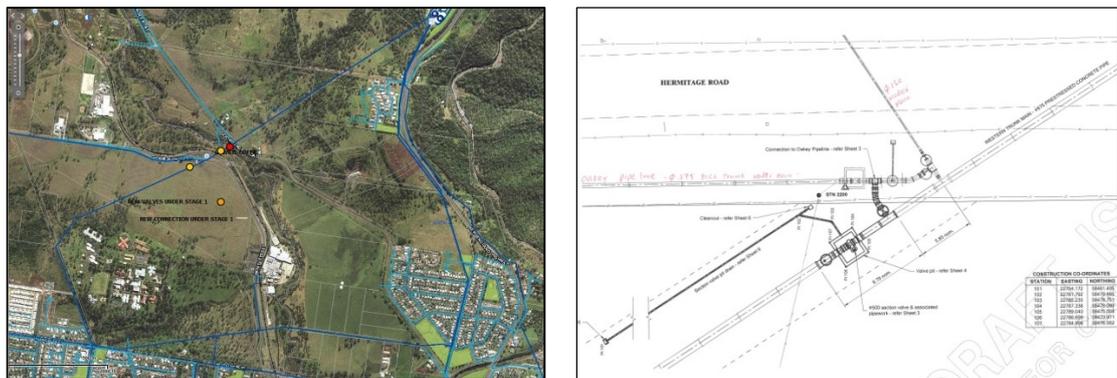
**Figure 3:** Stage 1 Works

Due to the strategic location of the Gowrie Creek isolation valve and the Toowoomba - Oakey pipeline offtake point, there was an opportunity to create an alternative water supply to the Toowoomba - Oakey pipeline by back feeding from the Toowoomba western water supply using the NWTM via the WTM. In doing so, a continuous water supply to western townships would be in place during isolation of the KWTP to Gowrie Creek section of the WTM. However, this required installation of two additional DN675 isolation valves in the WTM and DN450 pipework and an isolation valve for the second feeder line to the Toowoomba - Oakey pipeline (Refer Figure 3). The estimated cost was \$400,000 and the installation was estimated to be completed within 7 days.

It was necessary to investigate a temporary (7 day) alternative water supply option until the alternative permanent water supply connection was completed. To manage the 7 day period, two DN100 temporary supplies were planned from the reticulation system via a hydrant and DN100 reticulation connection, along with the available reservoir storages.

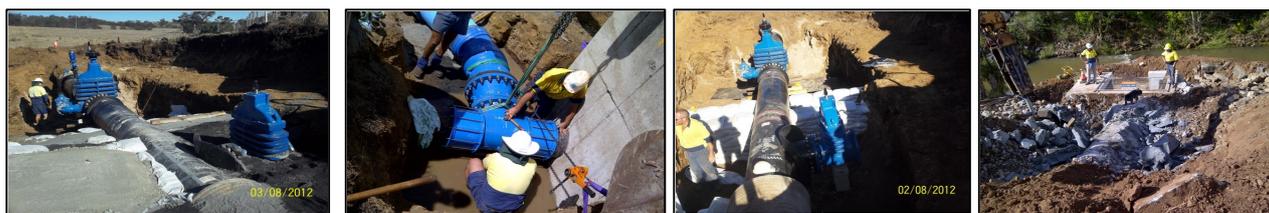
**Figure 4:** Construction Photos

The Gowrie Creek valve and pipework replacement works were completed with great success, with minimal wet weather delays.

All efforts were made to replace these two valves in the NWTM. Draining of one of the Mount Kynoch reservoirs was required. Staff in Water and Waste Services Group worked as a team, which displayed a great team spirit. As a result, and within short period of time, both valves in operational condition and the NWTM were back in operation. This allowed the water supply trial for the Gowrie Creek valve repair works to progress successfully.
