FREE CHLORINE BURN OF PORTLAND'S RETICULATION NETWORK

Ben Foster, *Treatment Operations Officer,*

*78th Annual WIOA Victorian Water Industry Operations
Conference and Exhibition
Bendigo Exhibition Centre
1 to 3 September, 2015*

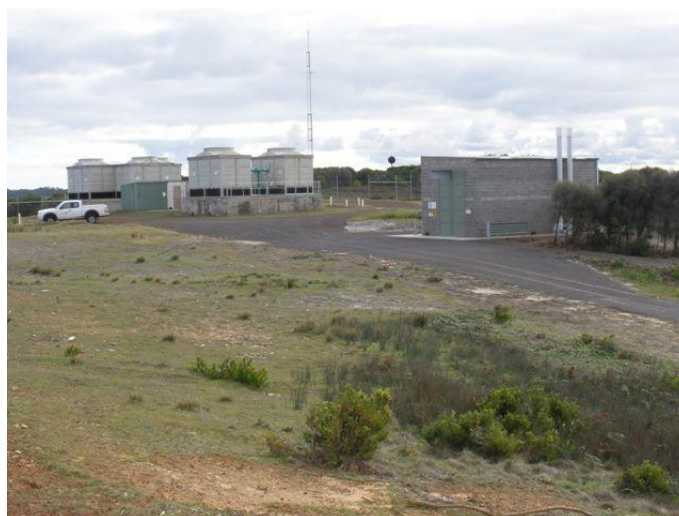
Figure 1: *Bald Hill WTP-Portland*

The chlorine burn was scheduled for October 2014 to January 2015 when water usage was at its peak, using the two bores at the Bald Hill WTP (figure 1) to provide the free chlorinated water to the system, then return to a total chlorine system after three to four weeks.
